RESPONSE OPERATIONS TO THE UNION FAITH RELEASE

LT Michael C. Long
U.S. Coast Guard Marine Safety Office New Orleans
1615 Poydras Street
New Orleans, Louisiana 70112

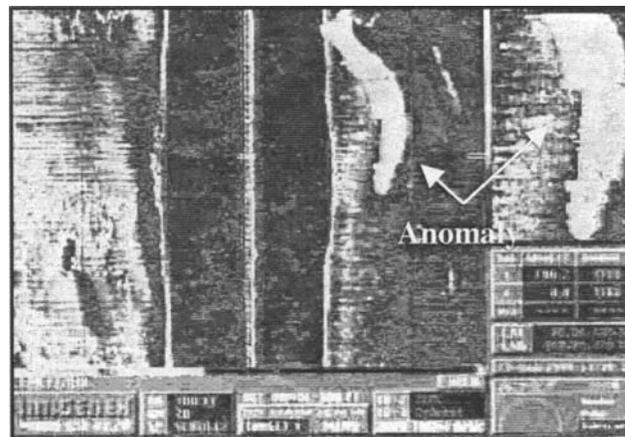
Figure 4. U.S. Army Corps of Engineers' side-scan sonar imagery.

On August 13, 1999, MSO New Orleans and the ACOE conducted a joint bottom survey of the previously dredged area utilizing side-scanning sonar, magnetometers, and fathometers to determine possible sources. The survey team found no anomalies in the area where dredging had previously occurred. But when the survey extended well outside of the previously dredged area, a very large object was found situated in the middle of the Mississippi River, approximately 150 yards down river from the Greater New Orleans Bridge and in the vicinity of where the oil was observed surfacing (Figure 4).

Analysis of side-scan sonar imagery led MSO New Orleans' personnel to suspect that the source of the oil might be the sunken

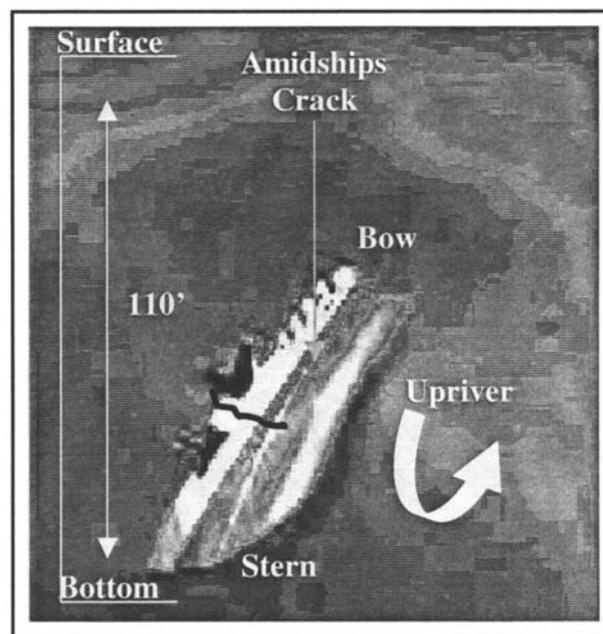
Figure 5. *Union Faith* river bottom orientation.

freighter *Union Faith*. Following this theory, the Oil Spill Liability Trust Fund (OSLTF) was accessed to contract commercial divers to verify the identity of the submerged object and determine if it was the source of the persistent oil leak. By the third dive, it was positively confirmed that the underwater object was the *Union Faith* and that it was the source of the leaking oil. Divers found the wreck lying on its portside beam, bow upstream, with approximately 25 gallons of oil per day escaping through an extensive hull fracture located amidships and extending below the mudline (Figure 5).
