National Transportation Safety Board

Marine Accident Brief

Engine Room Fire Aboard Cruise Ship *Carnival Liberty*

Accident no.	DCA15FM035
Vessel name	<i>Carnival Liberty</i>
Accident type	Engine room fire
Location	West Indian Company Dock, Charlotte Amalie, St. Thomas, US Virgin Islands 18°20'N, 64°55.3'W
Date	September 7, 2015
Time	1133 Atlantic standard time (coordinated universal time – 4 hours)
Injuries	None
Property damage	\$1.725 million est.
Environmental damage	None
Weather	Daylight, clear skies, temperature 86°F (30°C), southeast winds at 10 knots
Waterway information	Port of Charlotte Amalie, St. Thomas

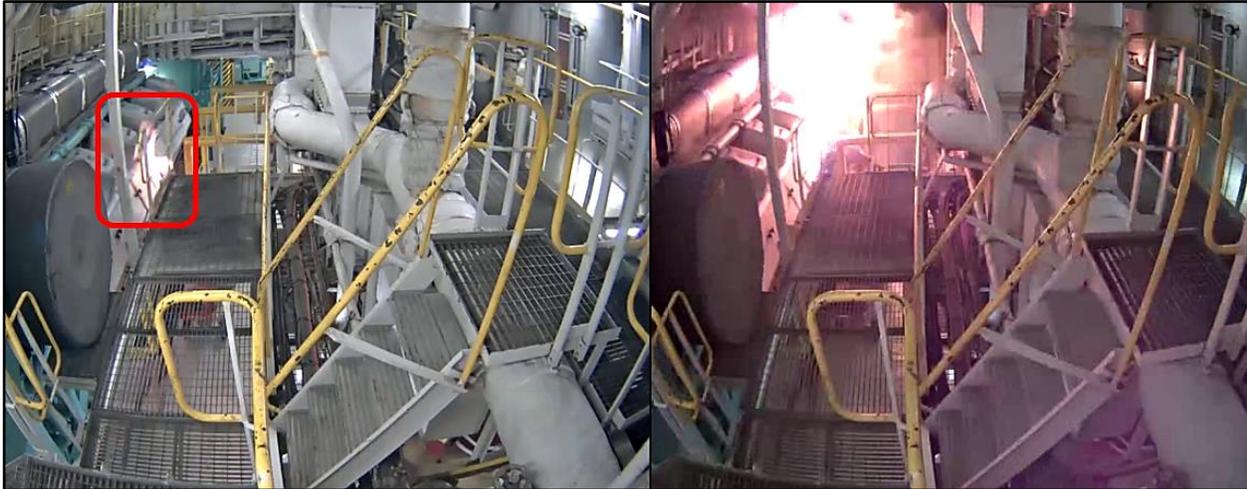
In the forward engine room, the fire patrolman assigned to the hot work near DG 1 heard an explosion. He turned in the direction of the sound and saw black smoke coming from the opening of watertight door 7 that was just a few steps away from him, forward of DG 4. He went to the door opening and saw a fire on DG 4 in the aft engine compartment. Recognizing the fire was too big to fight, he closed the watertight door, which was allowed to be open in port, and radioed the bridge via his handheld radio to alert the crew there to call “alpha code,” which is the emergency code for fire. Knowing that the HI-FOG system was in manual mode because of the ongoing hot work, the fire patrolman called his supervisor (the chief fire patrolman) and requested that he ask the ECR crew to set the HI-FOG system back to automatic mode. He then went to stairway 100, nearby in the forward engine compartment, where he knew that the local HI-FOG activation buttons were located.

Images from the ship's closed-circuit television of DG 4 from forward looking aft. The red box on the left image highlights the first visual sign of open flame. The right image shows the same area less than 1 second later.

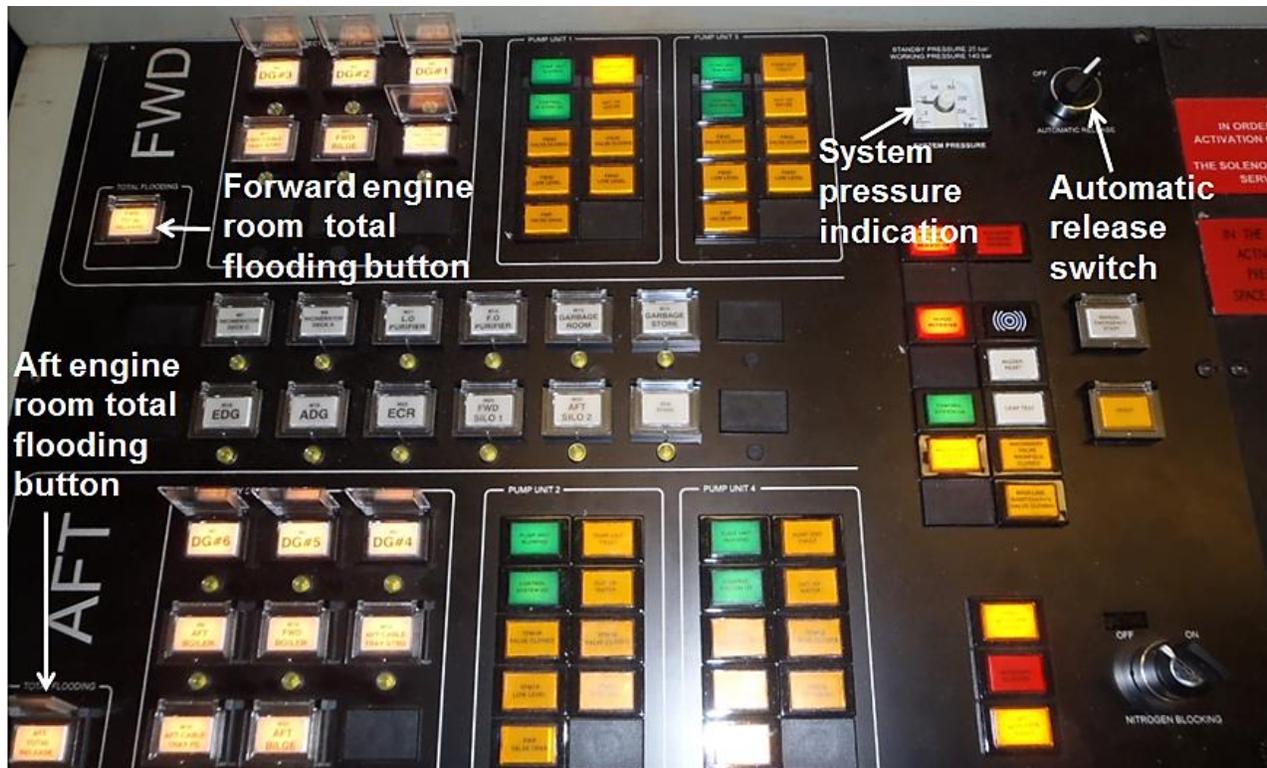
The HI-FOG control panel in the ECR at 1207, about 35 minutes after the fire started. The panel indicates that all section valves in both the forward and aft engine rooms are open. The system pressure in this picture is 26 bar. (Photo by Carnival Cruise Line)

The HI-FOG system continued to operate with low-pressure readings and, at 1203, the master asked the chief engineer why the system did not have adequate pressure. The chief engineer informed the master that all pump skids were running and that the “total flooding” section valves were open in both the forward and aft engine rooms. To address the low pressure, the chief engineer requested that the HI-FOG system be reset, which would stop the water-mist in both engine rooms, and they could then reactivate the system in the aft engine room where the fire originated. About 1211, the ECR crew shut down the HI-FOG system to reset it. Doing so restored all locally activated section valves to the closed position, and the operating pressure began returning to normal. About 2 minutes later, the ECR crew informed the bridge crew that the HI-FOG system was back online with “total flooding” mode in the aft engine room. The bridge crew requested the safety officer to have the fire squads take temperature readings on bulkheads adjacent to the aft engine room to verify that the fire was extinguished.

It is significant that the crewmembers were unaware that the HI-FOG system was incapable of delivering total flooding to both engine rooms simultaneously, and that they then had to use the CO₂ system to try to extinguish the fire. Furthermore, they did not consider, nor did any checklist specify, returning the HI-FOG system to automatic from manual mode immediately after confirmation of a fire. According to the system manufacturer, returning the HI-FOG system to automatic mode would have activated the HI-FOG section valves only in affected areas (based on smoke- and flame-detector activations). The NTSB concludes that comprehensive crew training and familiarity regarding the use and limitations of fixed water-based local application systems in machinery spaces are crucial to safe operations. The NTSB therefore recommends that Carnival Corporation & PLC implement ship-specific familiarization training regarding the use and limitations of fixed water-based local application systems in machinery spaces.

Implement ship-specific familiarization training regarding the use and limitations of fixed water-based local application systems in machinery spaces. (M-17-18)

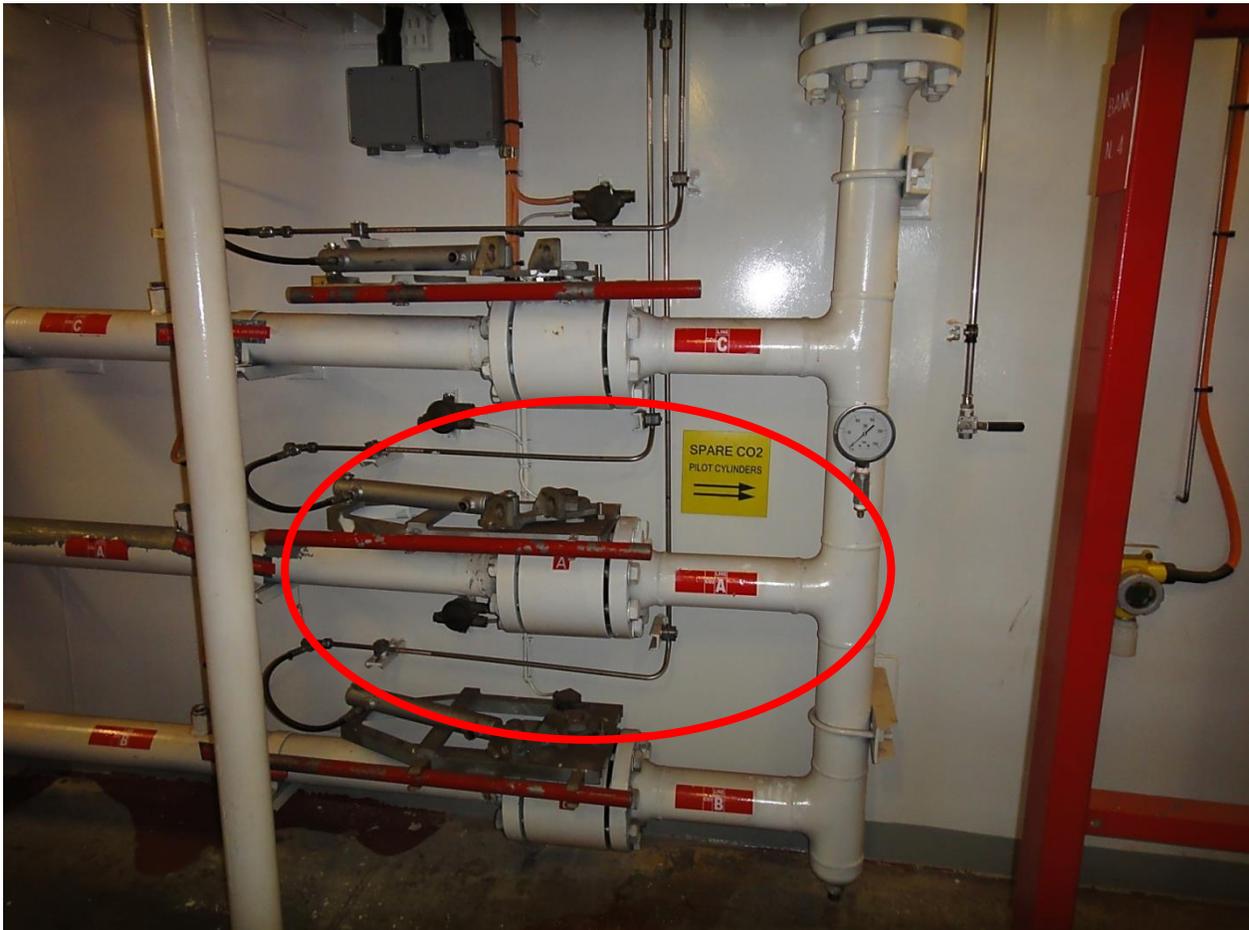
However, a valve that directed the CO₂ toward the aft engine room did not operate properly and triggered a gas leakage alarm in the CO₂ room on deck 11. An engineer whose emergency duty was to stand by at the CO₂ room heard the alarm, donned a self-contained breathing apparatus (SCBA), and entered the space to investigate. Inside, he noticed that directional valve A was partially open, so he kicked the hydraulic arm to ensure that the valve was completely open. Investigators were later provided with a postaccident maintenance test report.¹⁰ It identified a

missing gasket for one of the pilot cylinders as the reason for the partial opening of the directional valve. The report stated that the missing gasket and, in turn, the partially open directional valve “generated a loss of pressure inside the directional valve control line.”

CO₂ directional valve A that had to be kicked to a fully-open position.

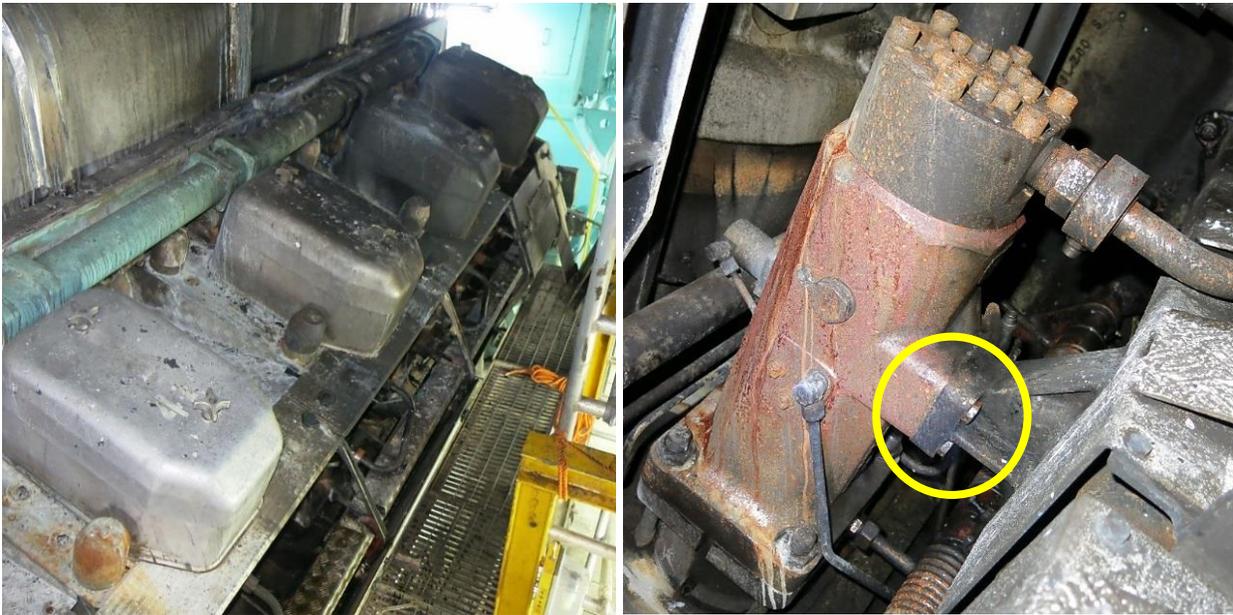
The fire on DG 4 originated from the fuel supply inlet flange for cylinder A2's high-pressure fuel-injection pump. Investigators found that one of the four flange bolts was missing and another was loose but attached.¹² The missing bolt was found in the gallery for the cylinder bank and was collected for laboratory examination along with the loose bolt still attached to the flange.

Left, location of the fire in the A bank of DG 4. Right, fuel-injection pump for cylinder A2 with suspect flange circled in yellow after the fire.

The NTSB concludes that the source of the fuel spray was loosened bolts on the fuel supply inlet flange to DG 4, likely resulting from improper tightening during prior maintenance and vibration of the piping over time.

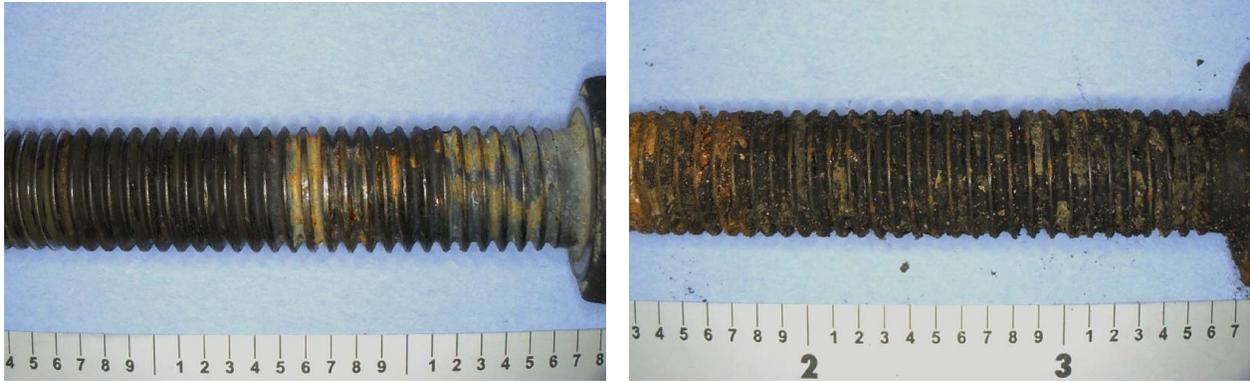
The laboratory examination of the two bolts, conducted at NTSB headquarters in Washington, DC, confirmed that neither bolt was deformed or showed signs of being stretched. Further, the detached bolt had no wear on its threads; the attached but loose bolt had rotational wear in three of its threads (11–13).

Subsequent testing by a commercial laboratory of the two bolts, along with the two remaining bolts from cylinder A2 (not examined by the NTSB), found no signs of excessive or insufficient bolt preload such as thread-root cracking or plastic deformation of the threaded bolt shank.

Left, the bolt found attached to the housing of the fuel-injection pump for cylinder A2. Discoloration and residue can be seen in some of the threads. Right, the bolt that was found detached.

The Wartsila 46 diesel engine instruction manual that was provided to investigators specified tightening torques for multiple bolt connections for the fuel-injection pump.¹³ Specific torque values for the bolts that connected to the fuel supply inlet flange were not included; however, the torque value for their dimensions and strength class was outlined in a general table called “Tightening Torques for Other Screws and Nuts.” It recommended that torque-measuring tools be used when tightening screws and nuts. None of the crewmembers that investigators interviewed were present at the time of the last maintenance and did not know if torque-measuring tools, which were available aboard the ship, were used when reconnecting the fuel-injection pump.
