National Transportation Safety Board

Marine Accident Brief

Fire aboard Vehicle Carrier *Courage*

Accident no.	DCA15RM024
Vessel names	<i>Courage</i>
Accident type	Fire
Location	North Sea in the approaches to the English Channel, about 57 miles* east-northeast of Harwich, United Kingdom, 52°04.8' N, 002°48.0' E
Date	June 2, 2015
Time	2215 British summer time (coordinated universal time + 1)
Injuries	None
Damage	\$10 Million in vessel damage, \$90 Million in cargo loss
Environmental damage	None
Weather	Visibility unrestricted at night, winds 34–40 knots, seas 24 feet
Waterway information	The English Channel and its approaches from the east and west are some of the busiest waterways in the world, providing access to Europe's largest ports; there was significant vessel traffic on the night of the accident

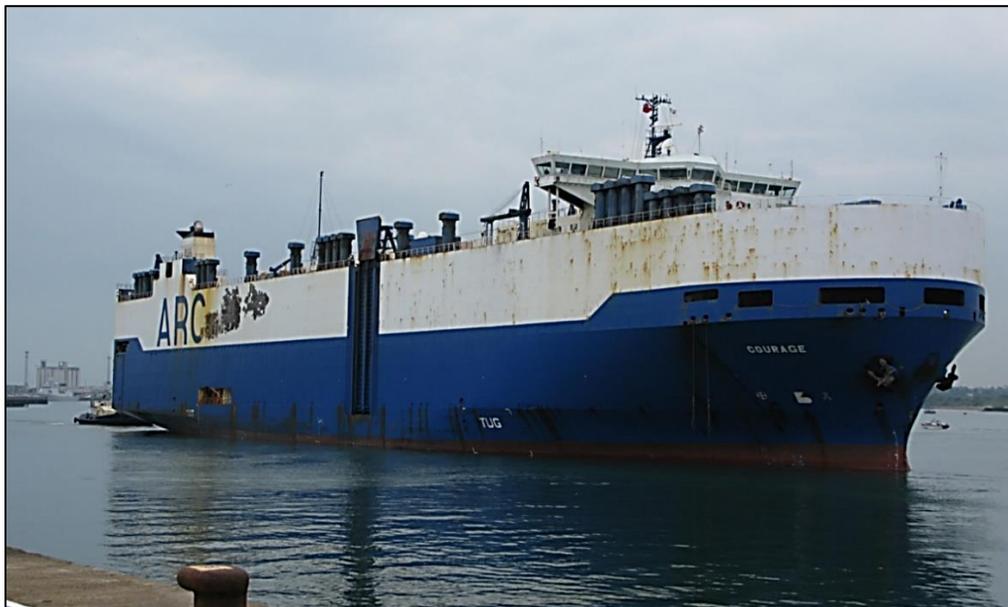
About 2215 local time on June 2, 2015, the US-flagged roll-on roll-off (ro-ro) vehicle carrier *Courage* was transiting from Bremerhaven, Germany, to Southampton, United Kingdom, when a fire broke out in its cargo hold. The accident resulted in extensive damage to the vessel's hold as well its cargo of vehicles and household goods. As a result of the damage, estimated at \$100 million total, the vessel's owners scrapped the vessel.

***Courage* just after the accident, with scorch marks on the starboard aft side as a result of the fire. (Photo by US Coast Guard)**

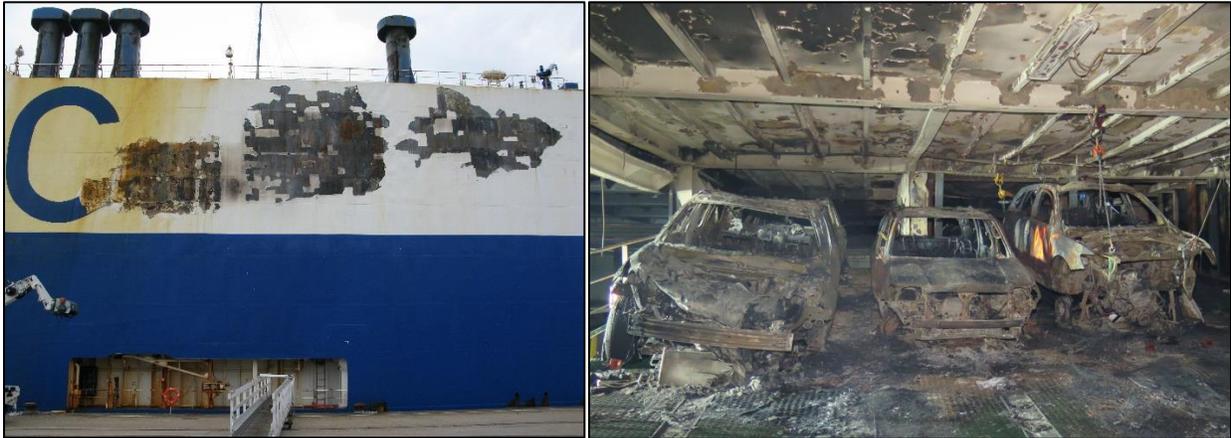
Fire investigators hired by the vessel owner and working with the US Coast Guard examined the affected spaces and identified the likely origin to be a ramp on the starboard side, aft, from Deck 8 to Deck 10 (the moveable Deck 9 was almost completely pressed up to the bottom of Deck 10). Vehicles on this ramp were completely destroyed by fire, and there was substantial damage to the ramps from Deck 10 to Deck 11 and from Deck 11 to Deck 12 that were immediately above this area.

Left photo shows exterior damage to *Courage* starboard side in the vicinity of the fire. Right photo shows damaged ramp and destroyed vehicles near the origin of the fire. (Photos by Coast Guard)

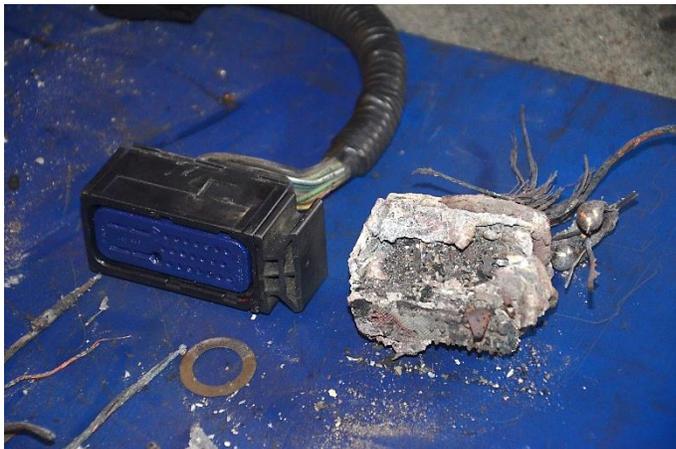
The vehicles on the ramp from Deck 8 to Deck 10 were all personally owned vehicles and included a 2002 Ford Escape SUV. Model years 2001 through 2004 Ford Escapes and Mazda Tributes (which shared the same chassis and many components as the Escapes) were the subject of recalls in 2007 and 2010 due to non-crash related fires or thermal events in the vehicles' engine compartments. Brake fluid leaking from the master cylinder reservoir cap had been reported to enter the vehicles' Automatic Braking System (ABS) wiring harness electrical connectors causing short-circuits, melting, and fires. As of early 2012, the National Highway Traffic Safety Administration (NHTSA) was aware of 260 vehicles that had experienced non-crash related fires or thermal events.¹ The Ford Escape that was destroyed by the fire in the *Courage* cargo hold had not been serviced to replace the faulty parts that were the subject of the Ford recalls. The owner had been overseas for a number of years and was not aware of the recalls prior to the accident.

ABS module from 2002 Ford Escape, where the fire likely started on board *Courage*, pictured next to a sample undamaged module. (Photo courtesy of Minton, Treharne & Davies Ltd.)

Fire investigators recovered the ABS module for the Ford Escape along with other evidence from the vehicles on the ramp where the fire was believed to have started. A joint forensic examination of this evidence was conducted in Bremerhaven in January 2016. Visual examination of the module was inconclusive and additional tests were planned.

In March 2017, the ABS module was examined using CT scans during testing conducted at Southampton University in the UK. CT scan images provided to NTSB fire investigators

clearly showed that the two end connectors (a positive and a negative) of the ABS module had significant localized arcing damage, while other wiring in the module was relatively undamaged. The amount of localized arcing damage was consistent with electrical arcing/shorting in this area and not external exposure to a fire. Thus, fire investigators concluded that the ABS module was the likely source of the fire.

The National Transportation Safety Board determines that the probable cause of the fire on the vehicle carrier *Courage* was electrical arcing in the automatic breaking system (ABS) module of a vehicle carried on board.
