Report on the investigation of the
grounding of the ultra-large container vessel

CMA CGM Vasco de Gama

Thorn Channel, Southampton, England

22 August 2016

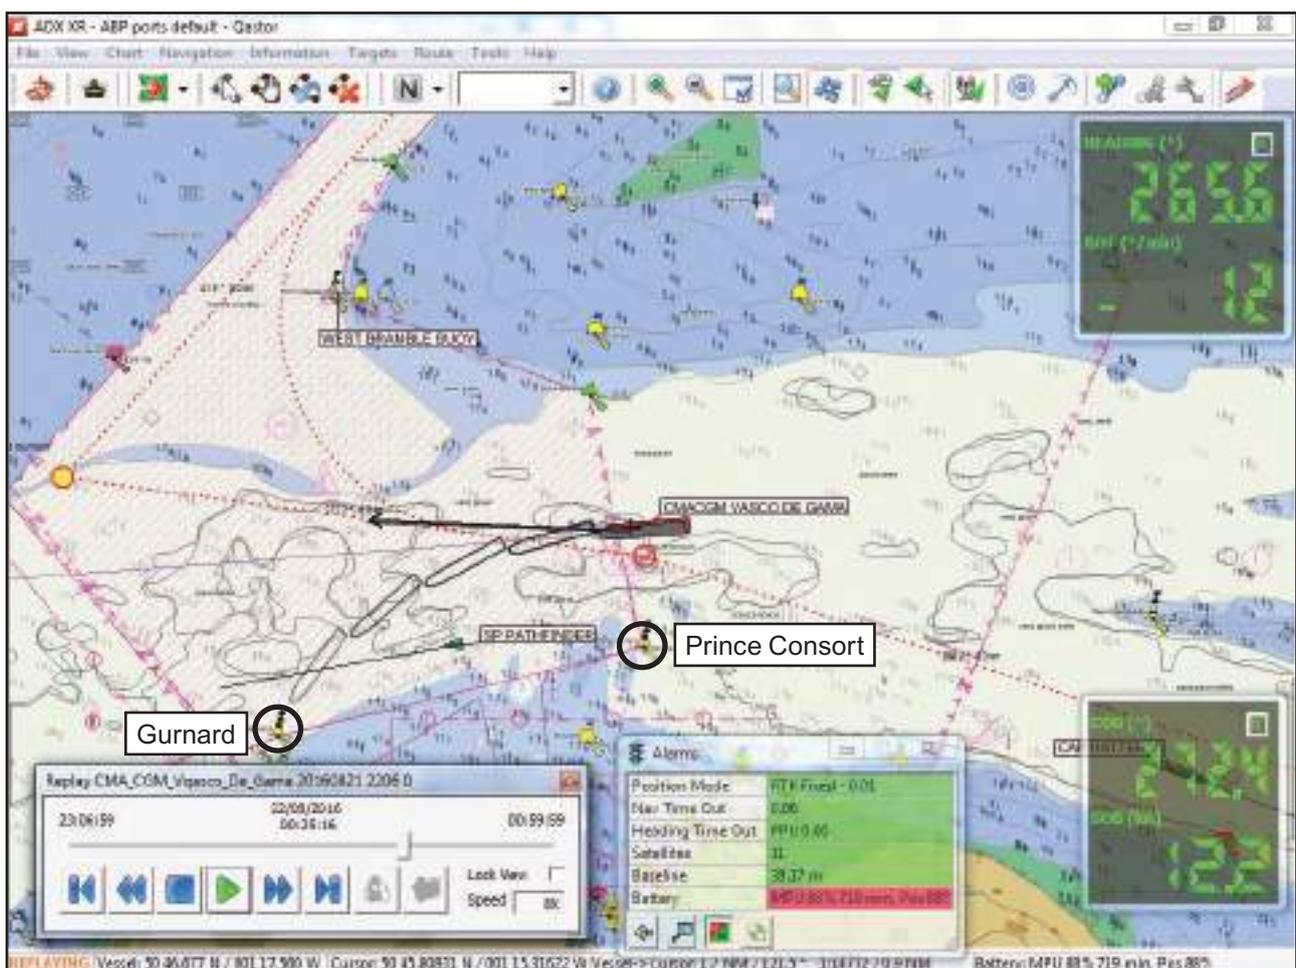
Figure 6: PPU screenshot showing *CMA CGM Vasco de Gama* passing Prince Consort buoy

At 0021, *CMA CGM Vasco de Gama* passed abeam of *Cap Hatteras* on a heading of 289° in a position 0.5nm to the east of the Prince Consort buoy. The lead pilot then gave the helmsman a series of courses to steer that, over the next 4 minutes, brought *CMA CGM Vasco de Gama* onto a heading of 260°. During the turn, the vessel passed 0.25nm north of the Prince Consort buoy (**Figure 6**) at a speed of 11.9kts. The VTS officer began his countdown on the VHF radio when the vessel was 6 cables away from the Gurnard buoy (**Figure 7**).

The passing of *Cap Hatteras* conventionally port to port, just east of the Prince Consort buoy, probably put *CMA CGM Vasco de Gama* further north on its approach to the Precautionary Area than the lead pilot initially intended. However, this deviation did not appear to cause any concerns to him, the assistant pilot or the bridge team, and subsequent contingent actions were not discussed. The lead pilot had been in similar positions before, but on those occasions he executed bigger alterations of course to port and/or achieved a greater ROT to travel further south into the Precautionary Area.

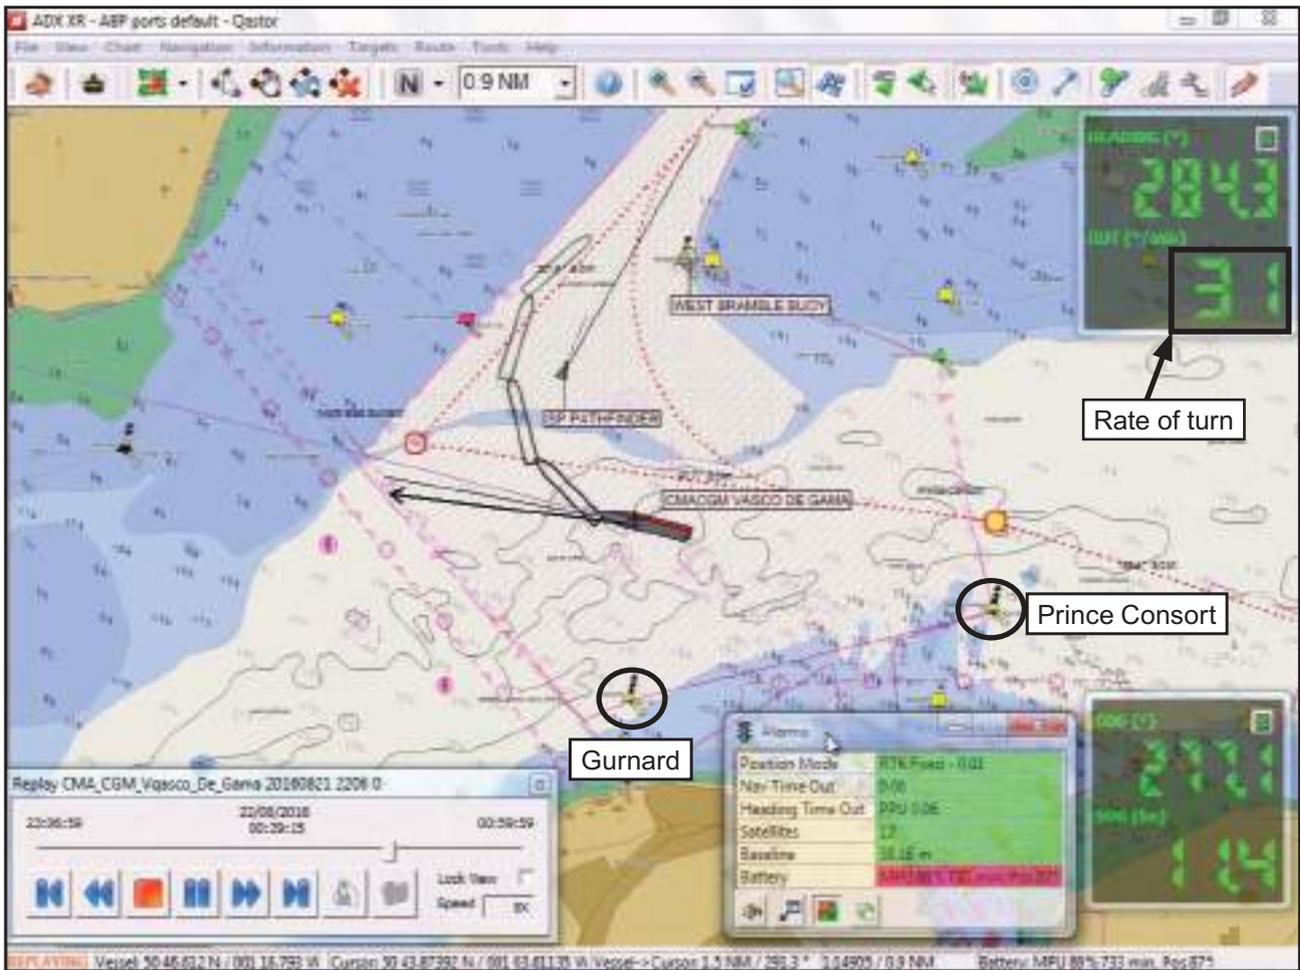
Figure 8: PPU screenshot showing the commencement of the turn

Initially, the vessel's rate of turn (ROT)³ climbed to 31° per minute (**Figure 8**), but the pilots soon began to discuss their concerns about the effect of the vessel's stern coming into the wind. A few seconds later, as the ROT began to drop (**Figure 9**), the lead pilot asked "where is all this tide when you want it"? The lead pilot explained to the assistant pilot that he began his turn to starboard early and that the engine was set to full ahead. At the same time, the master expressed similar concern to the OOW in his native language, Romanian.

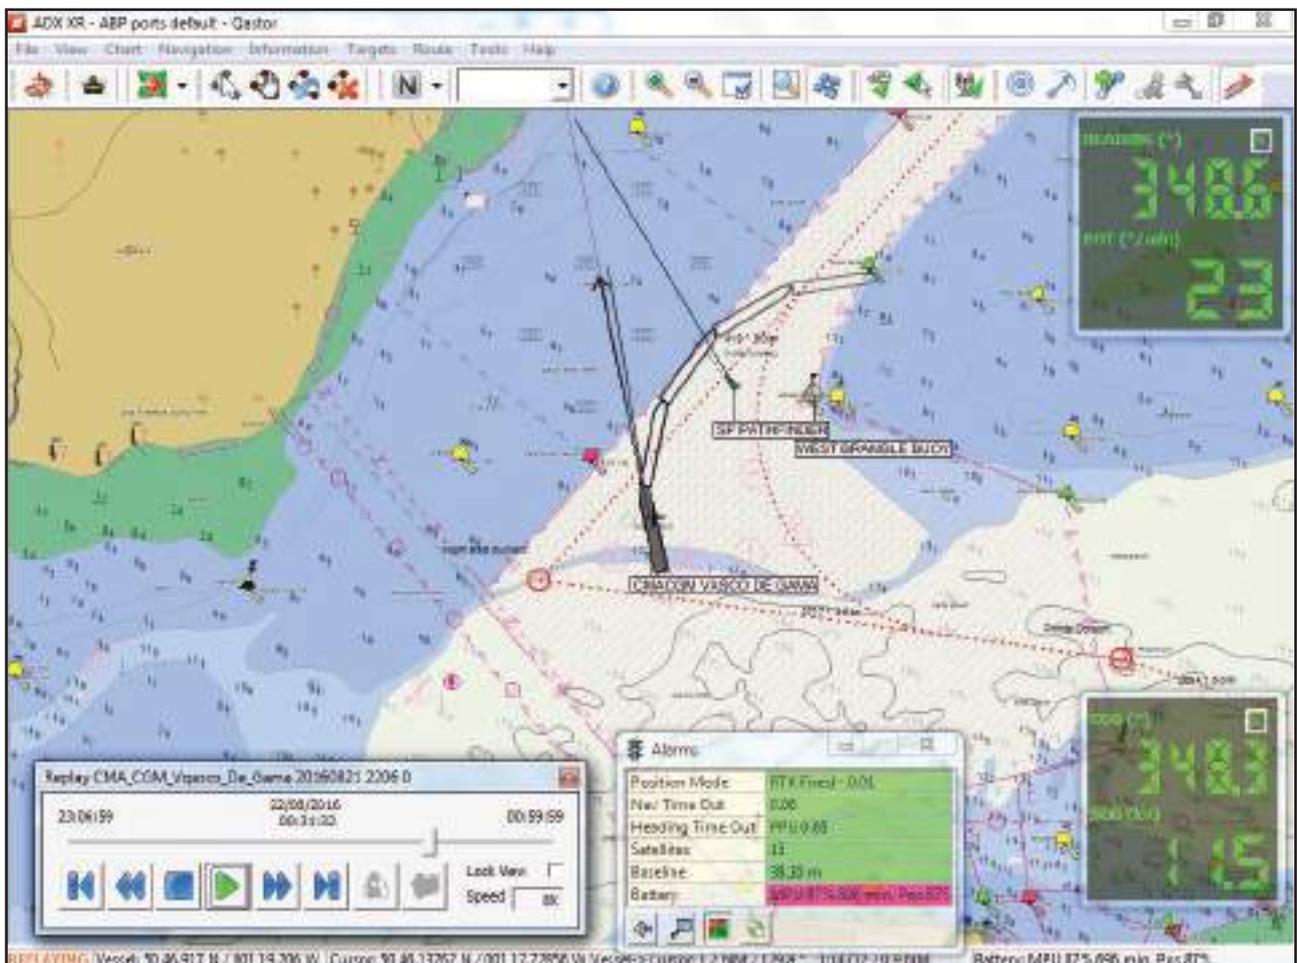
Figure 9: PPU screenshot showing CMA CGM Vasco de Gama losing rate of turn

As the vessel approached the westward edge of the dredged channel and entered shallower water, the lead pilot told *CMA CGM Vasco de Gama's* master that they must keep going. At 0031, with the ROT continuing to drop, the VTS officer called the pilots on VHF channel 12 and advised them that the vessel appeared to be leaving the channel (**Figure 10**). The lead pilot acknowledged the VTS intervention. The VTS officer then alerted the local tug skippers and placed them on standby to provide rapid assistance if needed.

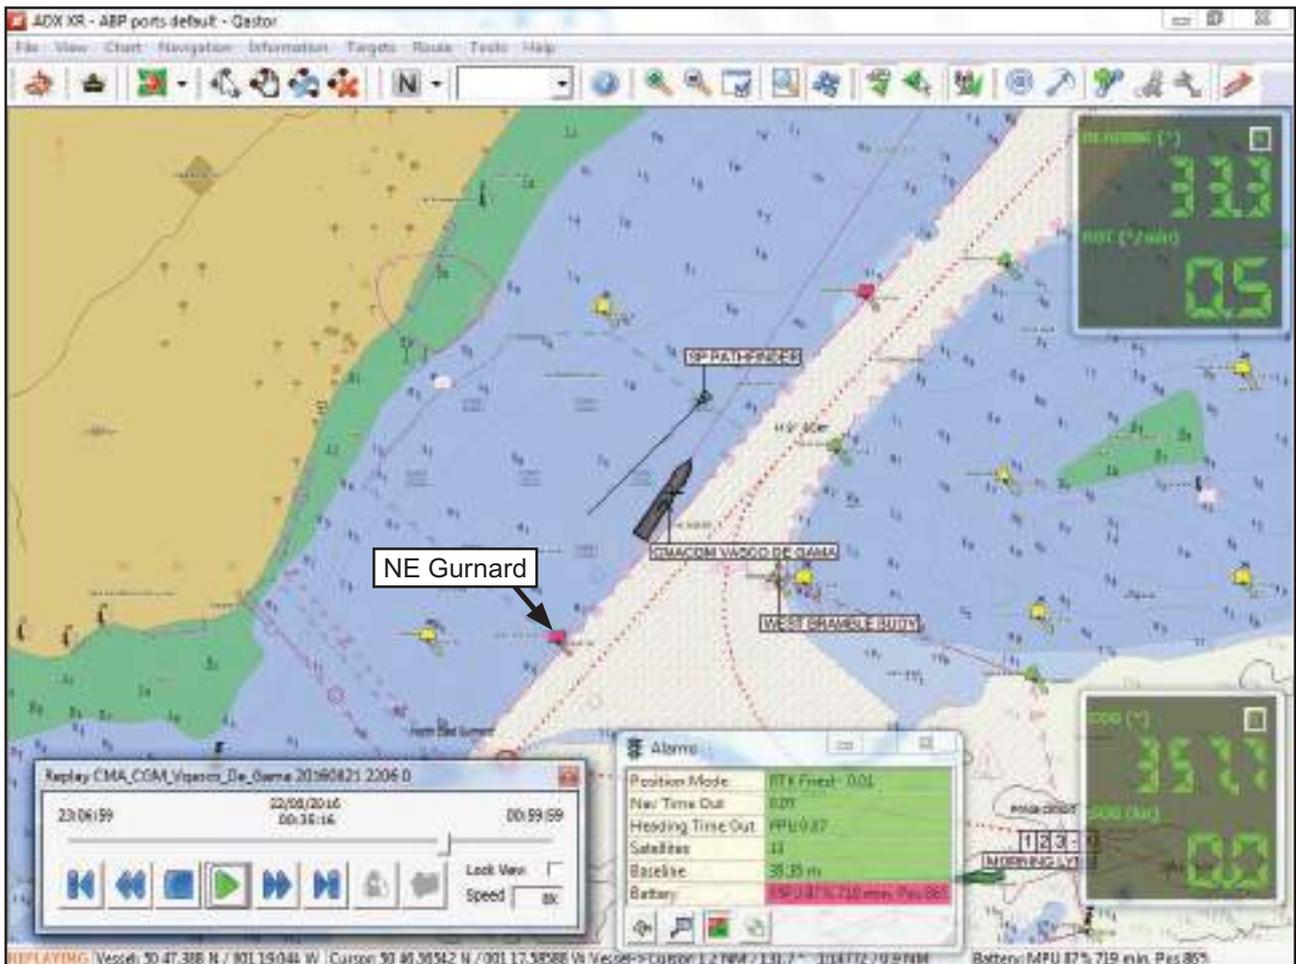
Figure 11: PPU screenshot showing the grounding position

At 0032, in position 50° 49.4'N 001° 19.02'W, about 0.4nm north-north-east of the north-east Gurnard buoy (**Figure 11**), *CMA CGM Vasco de Gama* grounded on the gently shelving seabed with the engine at full ahead. As *CMA CGM Vasco de Gama* slowed, the lead pilot tried to use the bow thrusters to drive the vessel back into the

While inbound to the Port of Southampton, *CMA CGM Vasco de Gama* grounded in position 50° 49.4'N 001° 19.02'W, about 0.4nm north-north-east of the north-east Gurnard buoy (**Figure 11**) while under pilotage through the Thorn Channel Precautionary Area. The grounding occurred on a flooding tide, about 2 hours before high water Portsmouth. The vessel had no propulsion or steering control defects, or power restrictions.

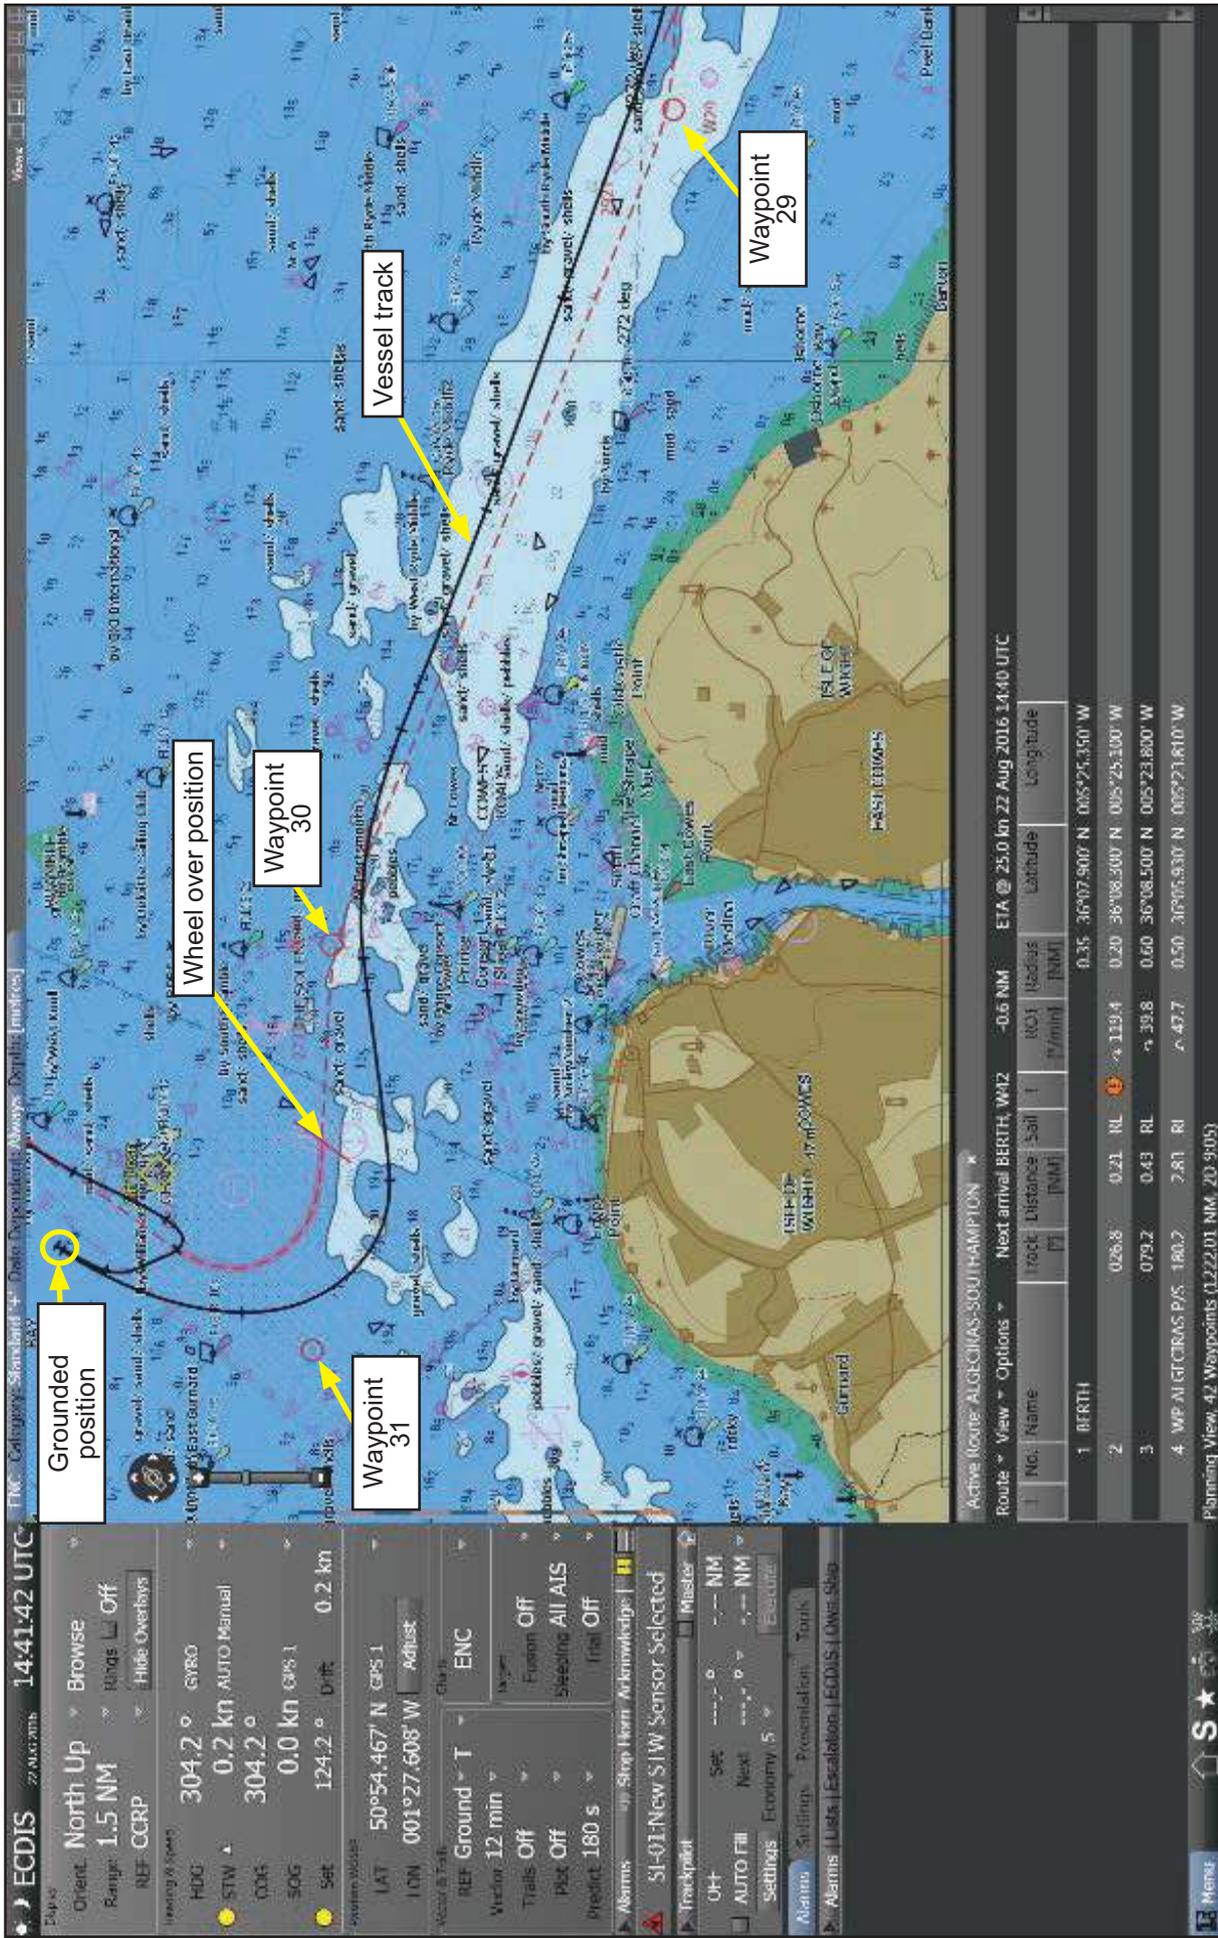
Figure 17: ECDIS screen display at time of grounding

The ECDIS units had three display modes: *base*, *standard* and *full*. When in *full* mode, the user was able to customise the display by application of user defined settings. This could reduce the amount of information presented. The bridge manual explained that the *base* mode provided the absolute minimum level of information and that the *full* mode displayed all the information contained in the electronic chart. The bridge manual warned that the amount of data contained in the *full* mode tended to overload the screen and recommended that the *standard* mode be used for navigation. CMA CGM Vasco de Gama's ECDIS units were set to the *full* mode with few user defined settings applied, and the two-colour option selected.
