Ministry of Infrastructure and Transport

DI.G.I.FE.MA.

3RD DIVISION - MARINE INVESTIGATIONS

Fires on board ro-ro pax ferries *Lessons learned*

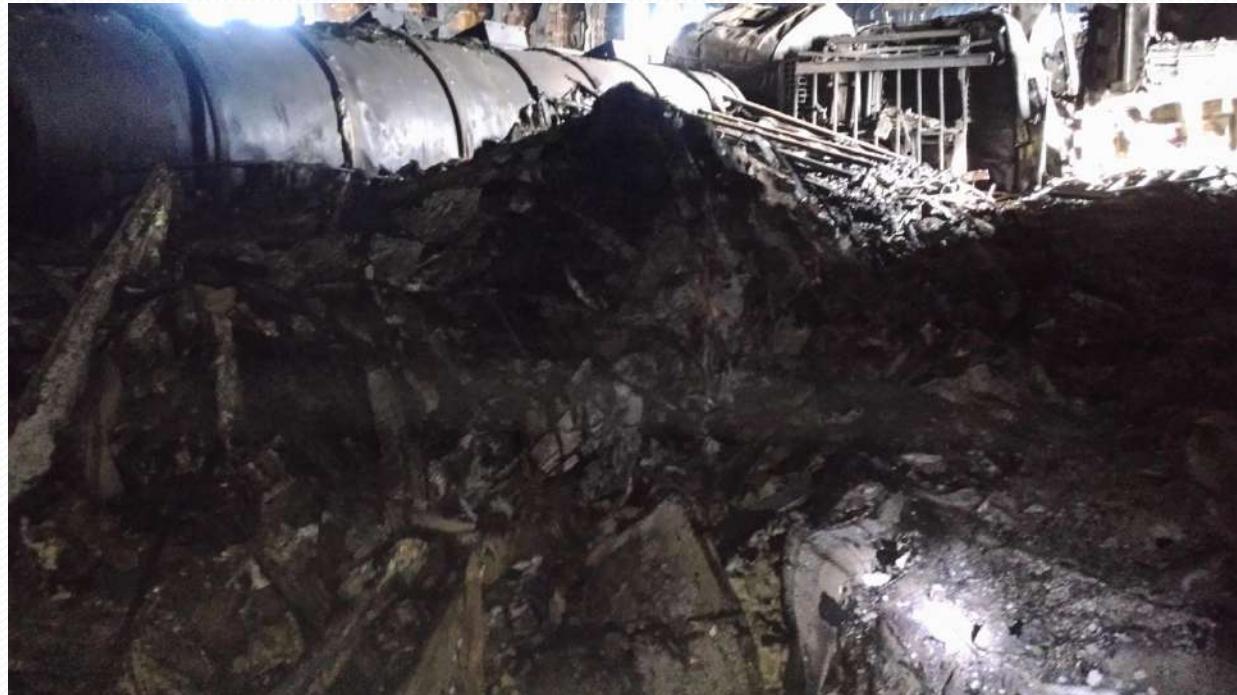
M/n Norman Atlantic is at the moment in Bari under seizure by the Judicial Authority; The garage ramp has been opened but it is still difficult to enter deck 3 and 4 because are full of burned materials.

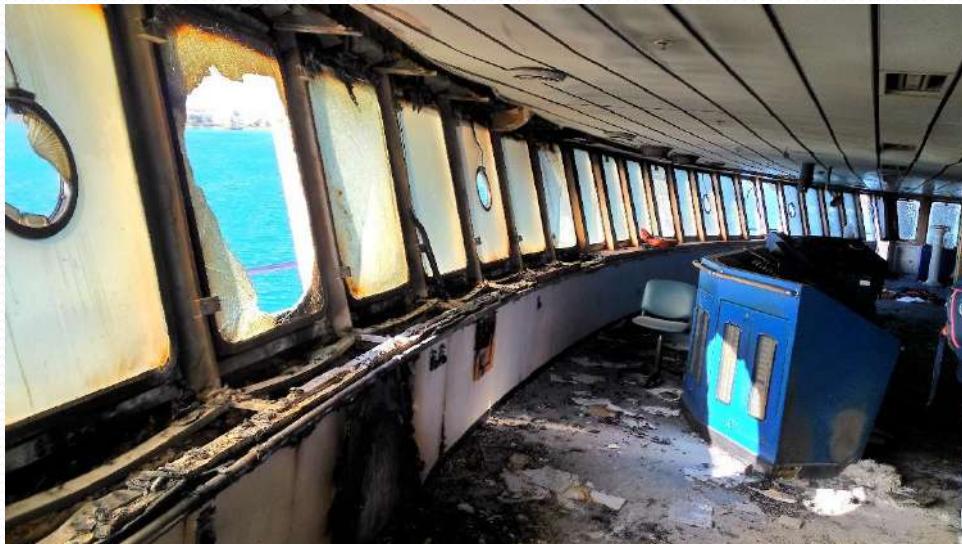
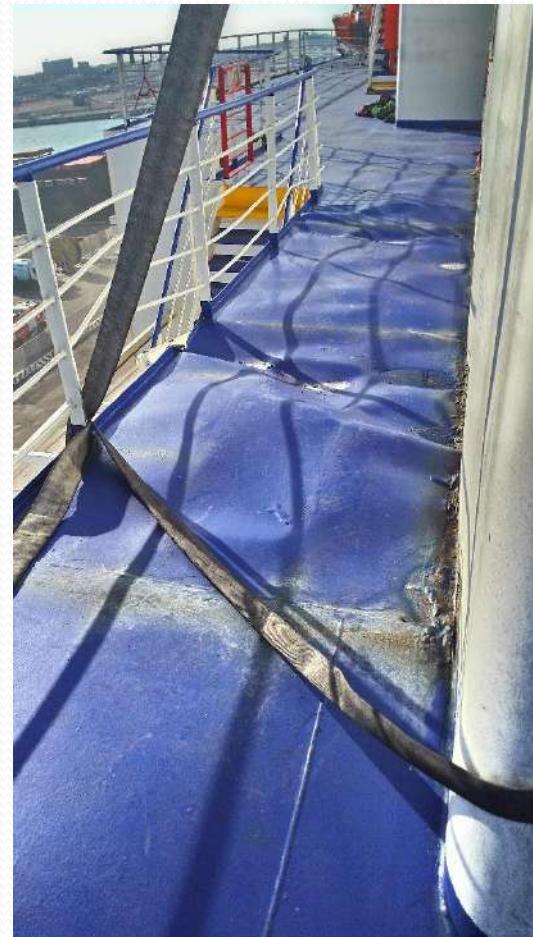
- M/v Norman Atlantic was severely damaged by the high temperature originated by the fire from Deck 3 up to the upper decks
- The average temperature reached on Deck 4, in the open ro-ro cargo space, was estimated to be higher than 1000 C°
- The only safe area available to passengers and crew was on the fore part of Deck 8

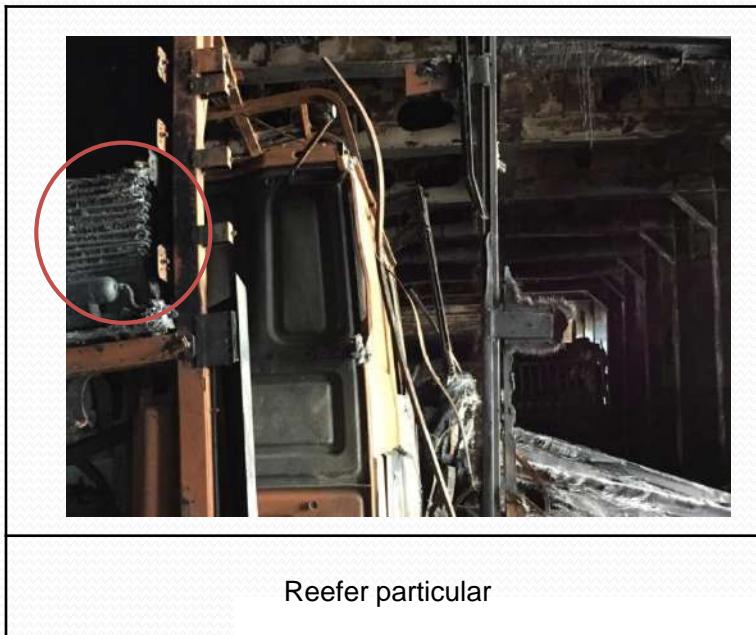
The most possible cause can be referred to an **abnormal demand of electric users associated to a trailer.**

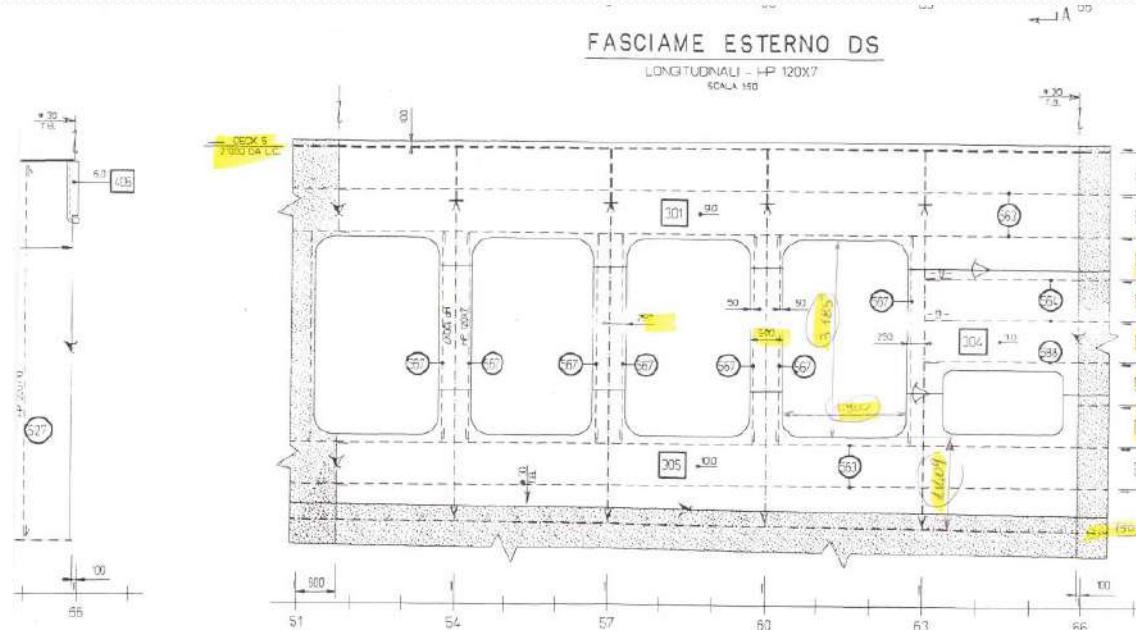
The preliminary analysis of the behavior and the performance of the fume plume to cross-wind, the environment in which it developed the fire (deck 4) is considered particularly important since it is similar to a garage with **large side windows and one side, the stern one, completely open** and with no means of closing.

Number of openings per side: 20

Dimensions: l 1,9m x h = 3,185 m

Total openings surface per side: 121 mq

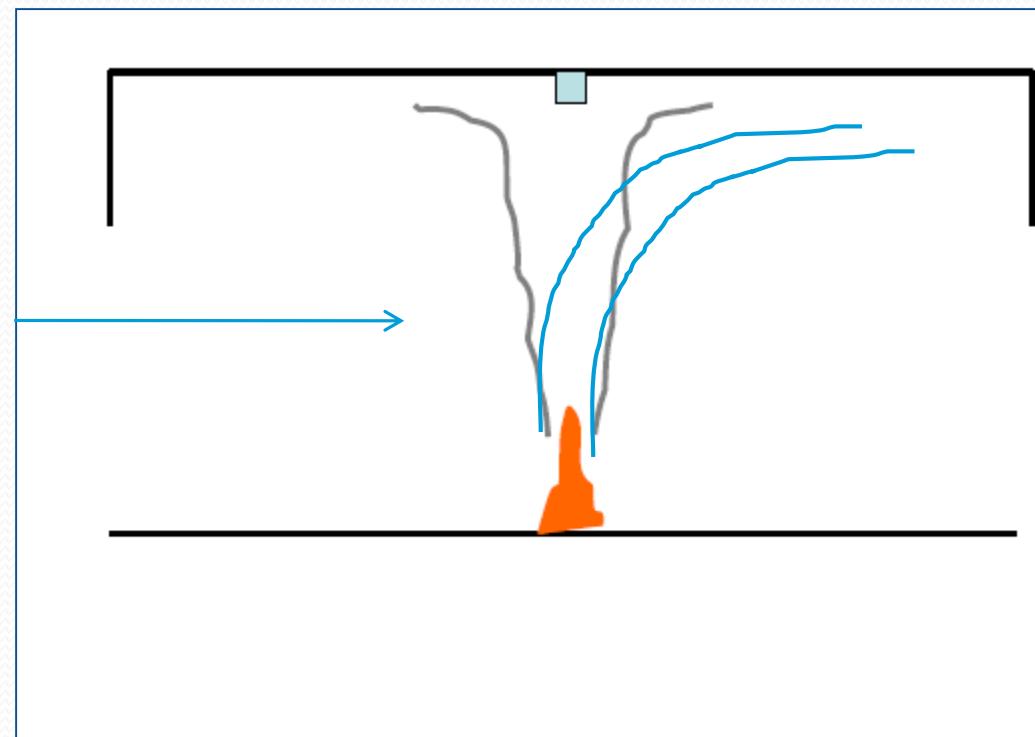
The relative high speed of the wind and its direction has certainly influenced the course of the plume and the layering of the smoke. **These factors might have influenced the response of the smoke detectors.**

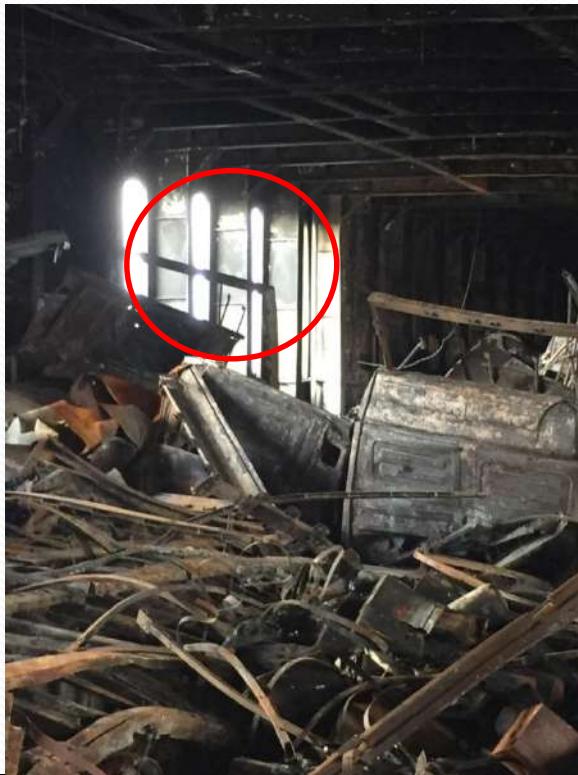
Evidence of the structure, almost intact, despite the heat due to the high fire load

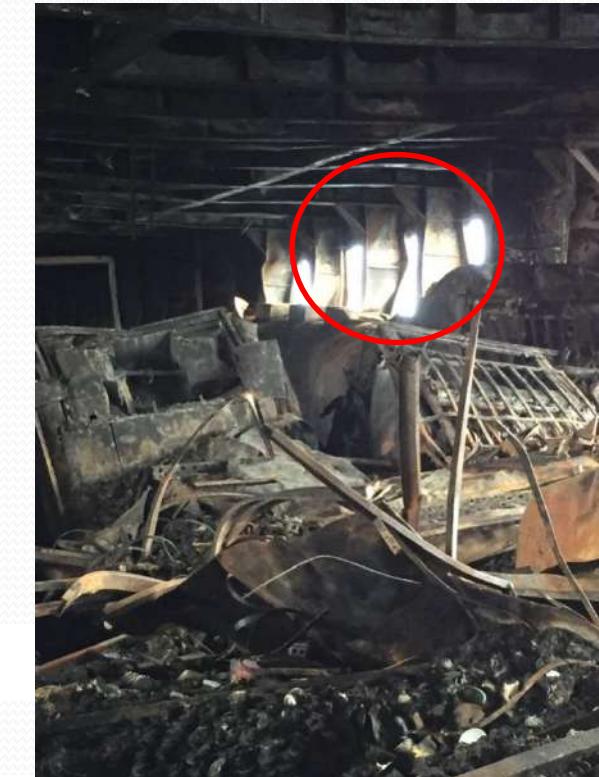
The detrimental effects of the wind are highlighted by the deformations that can be found on the ship.

Evidence of major deformations of the structure due to the heat caused to the high fire load and effect of the wind direction

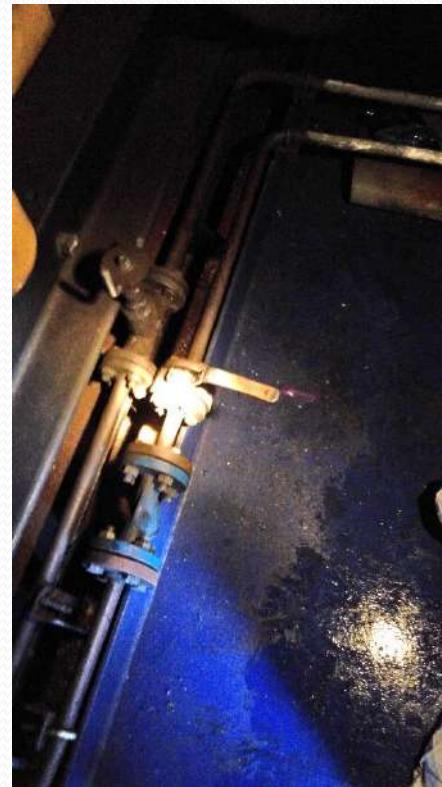
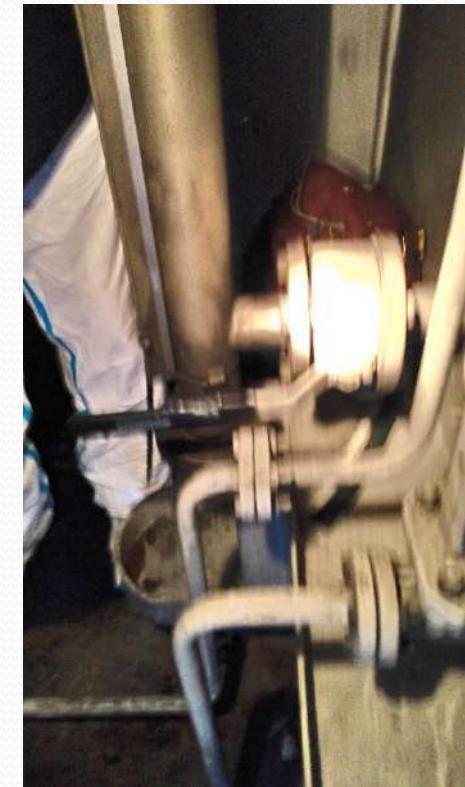
- It was also stated that the EDG was controlled and operated manually by the Chief Engineer and Electrician. However, during last inspection on board **the EDG fuel tank was found almost full** and the relevant fuel valves were closed.

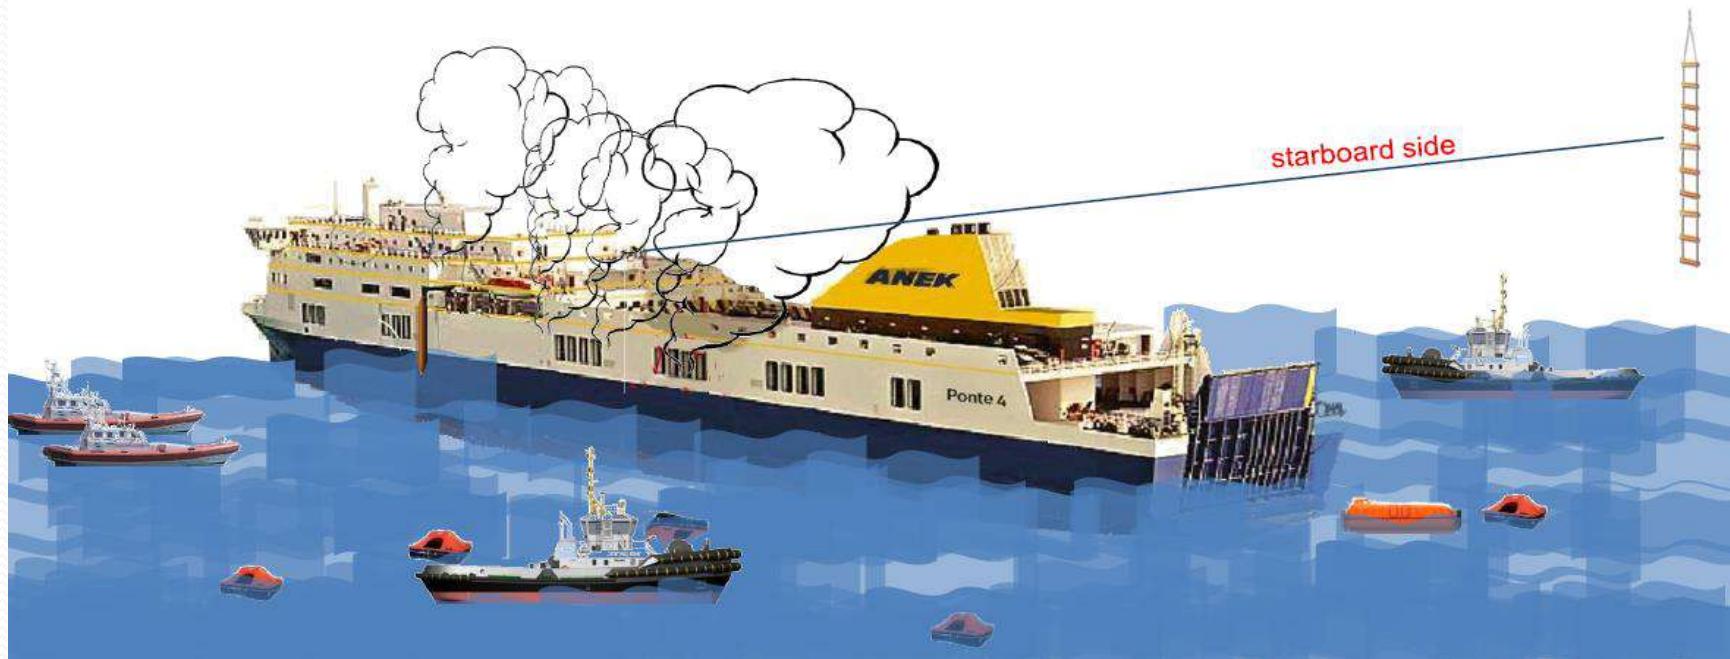
RIGHT SIDE- HIGHER FLAMES AND SMOKE

- All evacuation means and safety equipment on this side were unusable.

- Captain of Norman Atlantic reported that the rafts were launched into the sea directly by passengers without a specific order;
- The chute was unusable because obstructed by two people who had remained trapped inside and damaged due to adverse weather conditions and flames.
- The many attempts to tow had a negative result. The tugs could only place the bow of the unit toward the direction of the wind in an attempt to limit roll movements and control the direction of the smoke;
- SAR naval units suffered damages in an attempt to get closer to the hot hull.

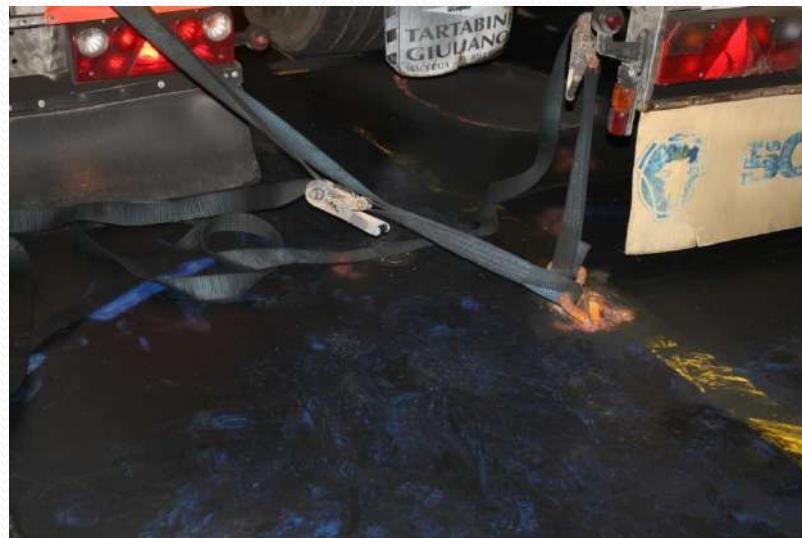
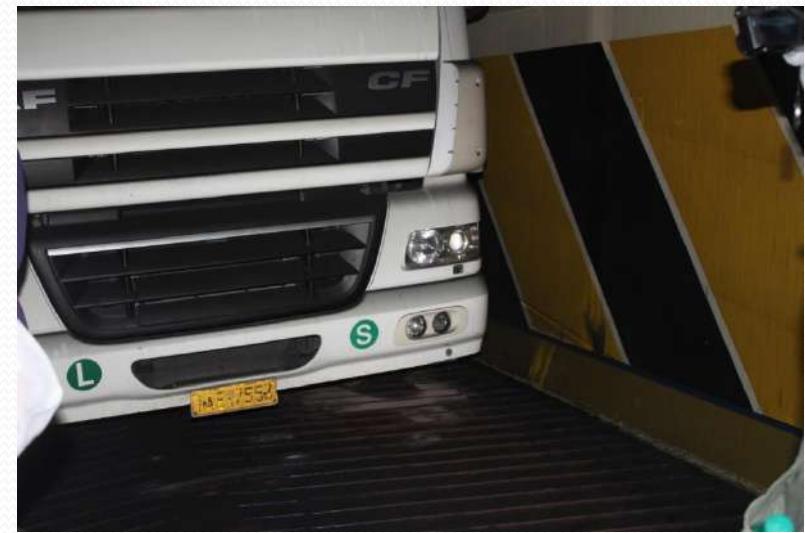
- During last access on board in July it was possible to visit Deck 1 and 2 and some trucks were found not properly lashed.

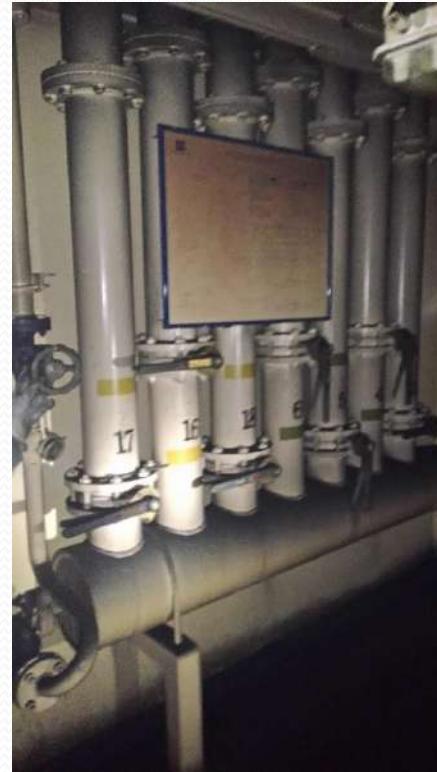
..... the valves found open on board were those...

corresponding to Deck 3....

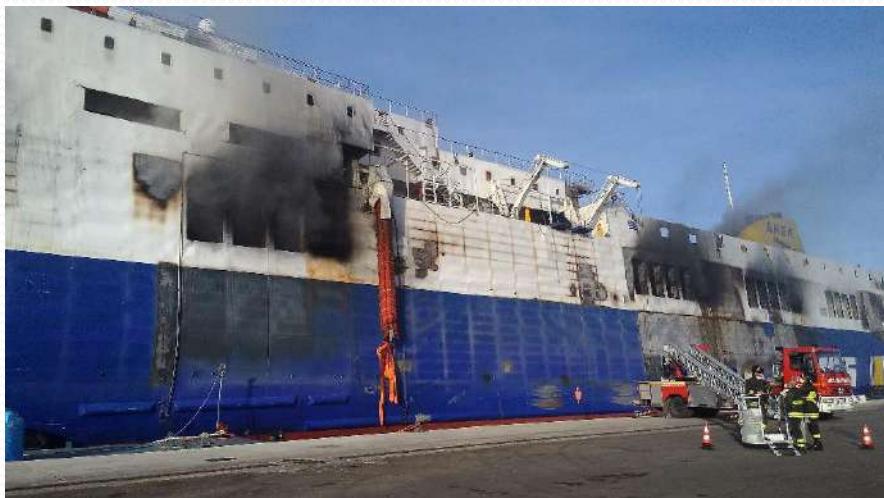
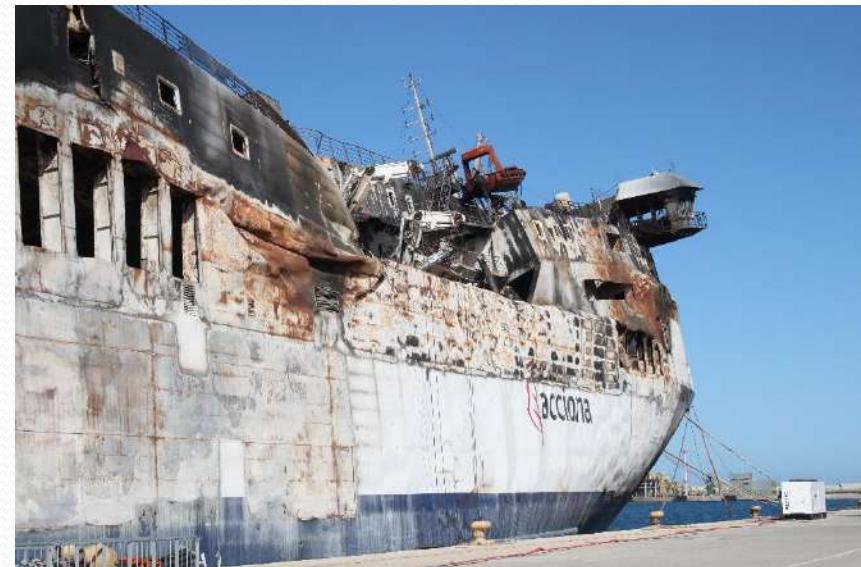
But Fire started in the same area ... **Deck 4 (open garage) frame 168** and even if in presence of a prompt activation of the Drencher system and quick intervention of the F team, M/V Sorrento **was lost as well.**
