Loss of propulsion on passenger cruise ship *Norwegian Star*

Bass Strait, 22 NM SW of Cape Liptrap, Victoria | 10 February 2017

ATSB Transport Safety Report
Marine Occurrence Investigation
MO-2017-003
Final – 24 May 2018

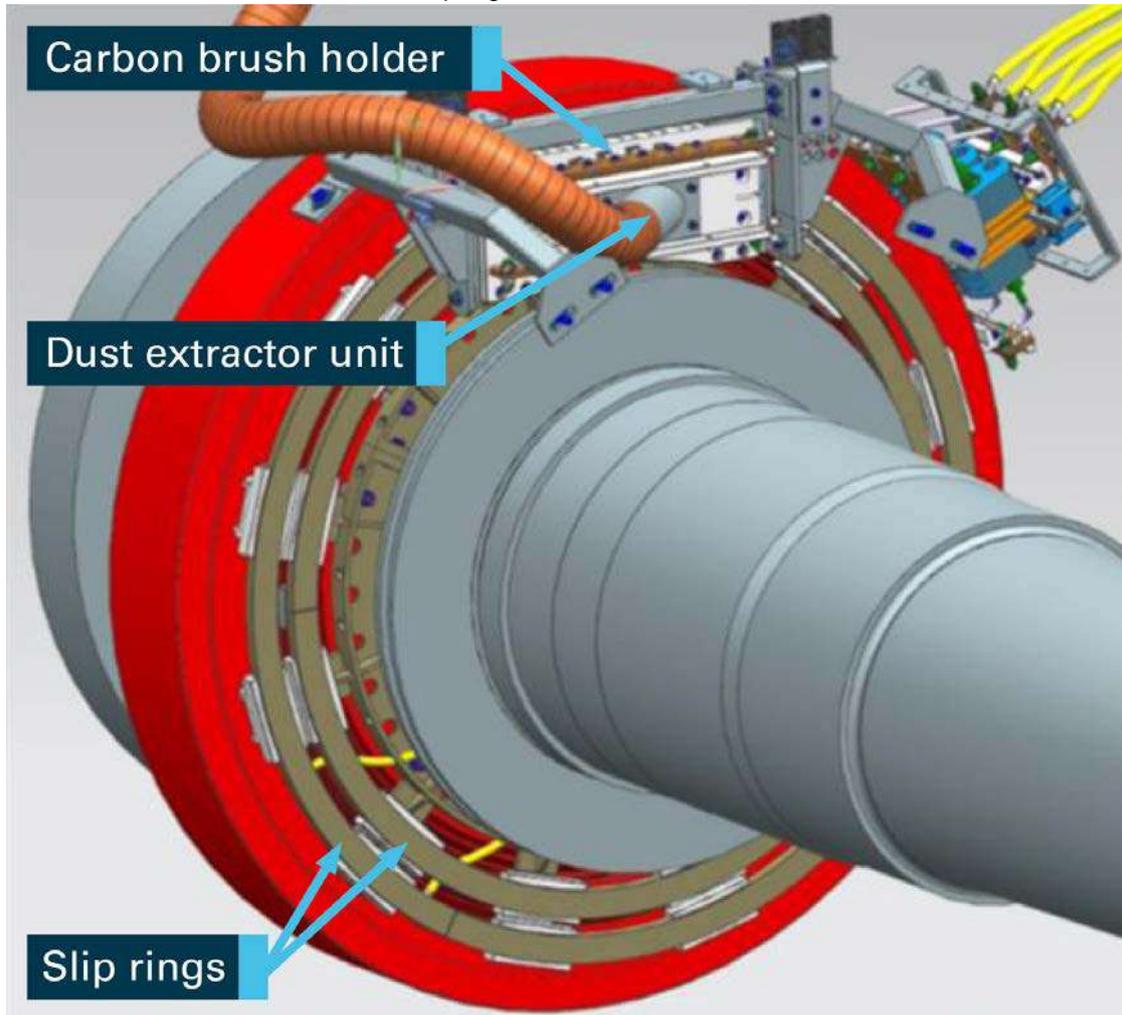
Figure 4: Modified starboard exciter unit with sliprings and brushes

When the brushless starboard exciter unit failed on 11 December 2016, NCLH (in consultation with ABB) decided to repair the unit by modifying it from a brushless system to a slipring unit with brushes. The modification to a slipring unit involved the installation of two concentrically mounted sliprings on the existing exciter rotor, and diode bridge assemblies, carbon brush assembly and dust removal unit mounted on the stator hub assembly (Figure 4). The effect of the modification was to bypass the defective exciter and supply the field of the synchronous motor directly from a new external variable DC supply.

- There was an error made in the design of the modified exciter unit used in the repair of the starboard propulsion unit. Clearance between the brush holders and the sliprings was less than required.

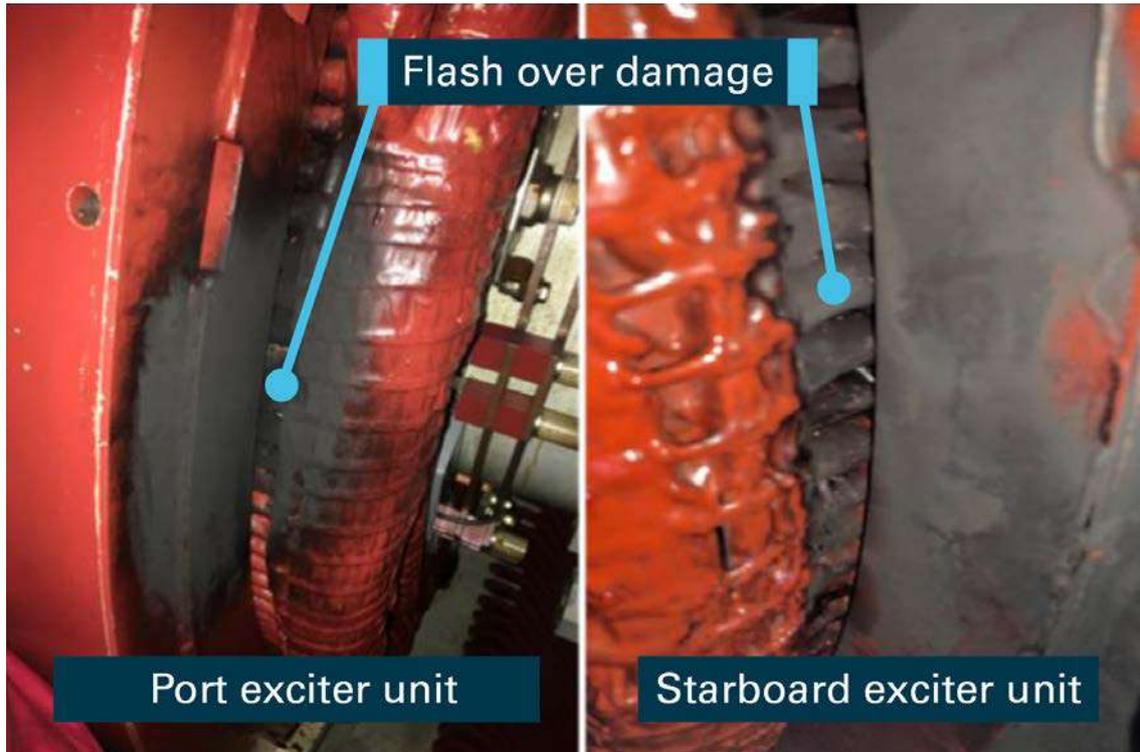
Figure 5: Flashover damage from the port and starboard exciter units

Inspection of the starboard and port exciter units after their first-time failures (on 11 December 2016 and 24 January 2017 respectively) found evidence of flashover marks on the stator windings in both units (Figure 5), suggesting a similar cause of the flashover and failure.

There are a number of factors that can lead to flashover, including insulation breakdown and insulation damage as a result of bearing failure. Post-incident inspection by Norwegian Cruise Line Holdings Ltd (NCLH) found no evidence of bearing failure and therefore this has been discounted as a possible failure mechanism.

Based on the evidence available, deterioration of the insulation material remains the most probable cause of the failures of the brushless exciter units. *Norwegian Star's* Azipods were the oldest in the fleet and had the highest running hours. Age, heat, moisture and contamination are all possible factors that may have contributed to this deterioration.

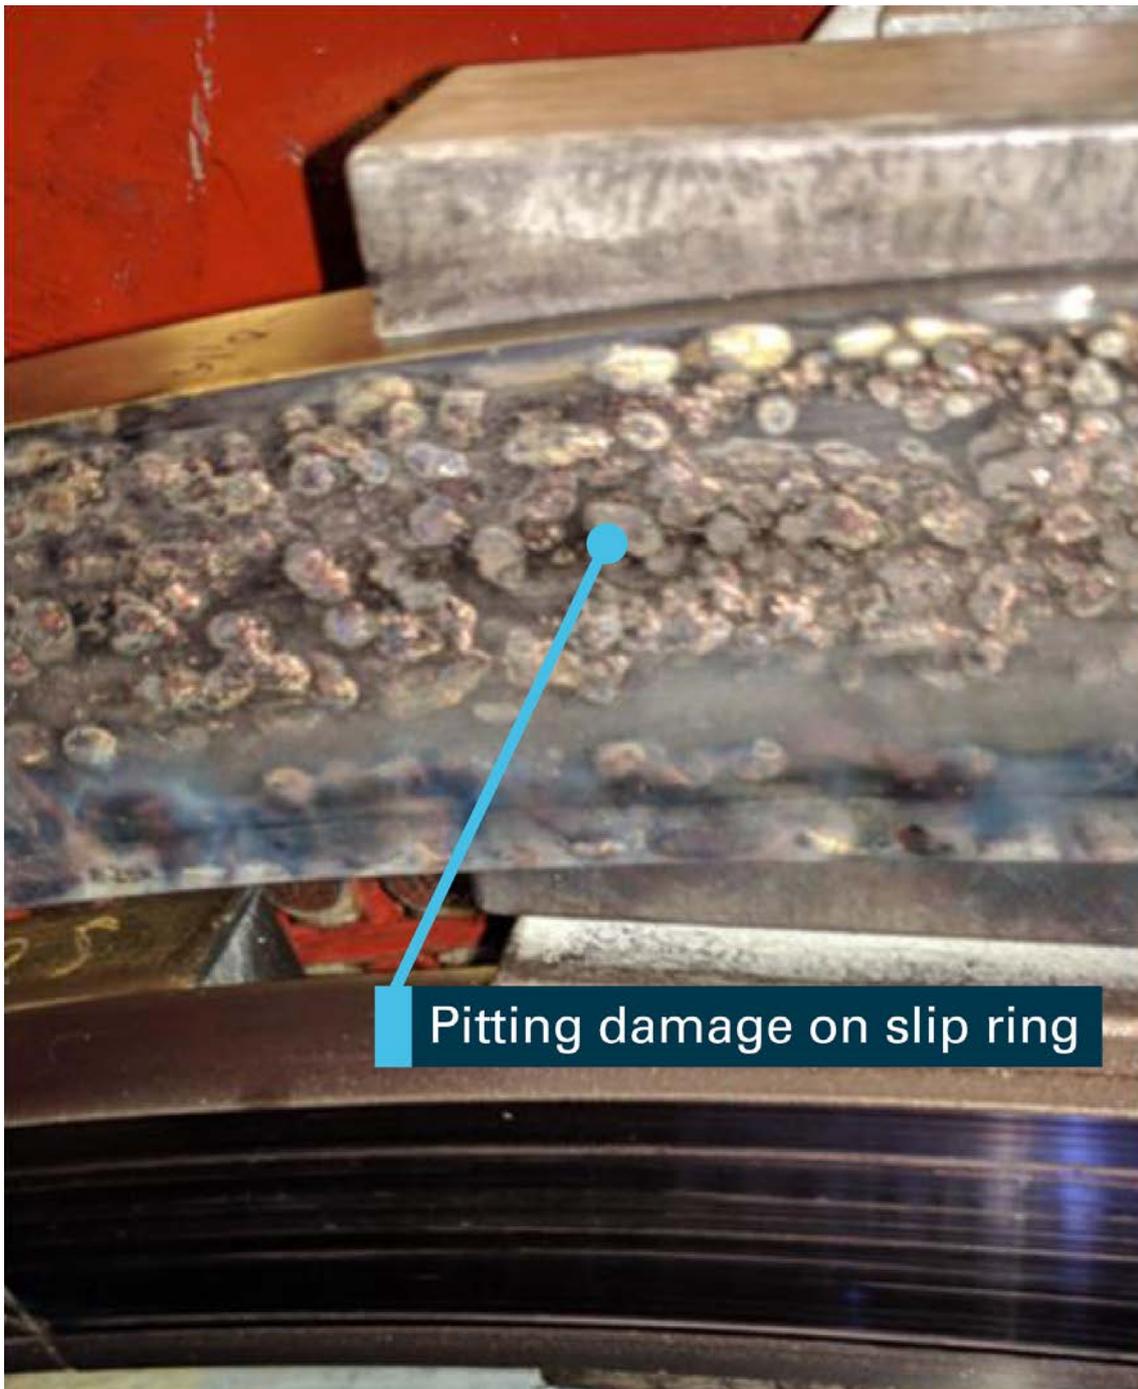
Figure 6: Arcing damage on the outer slipring

On 10 February 2017 while *Norwegian Star* was transiting Bass Strait, the modified exciter unit installed on the starboard propulsion unit failed, rendering the ship without propulsion. Pitting on the outer slipring was observed (Figure 6). Brush holders were also damaged (Figure 7).

Detailed examination and assessment by ABB found that the damage to and failure of the unit was the result of insufficient clearance between the brush holder and sliprings. It was identified that axial movement and thermal expansion of components was more than had been allowed for in the design.
