**REPUBLIC OF CYPRUS
MARINE ACCIDENT AND INCIDENT
INVESTIGATION COMMITTEE**

Investigation Report No: 4E/2018

Very Serious Marine Casualty

**Manoverboard fatality from “ELBTRADER”, in the Port of
Dublin - South Ireland, on 12/01/2018**

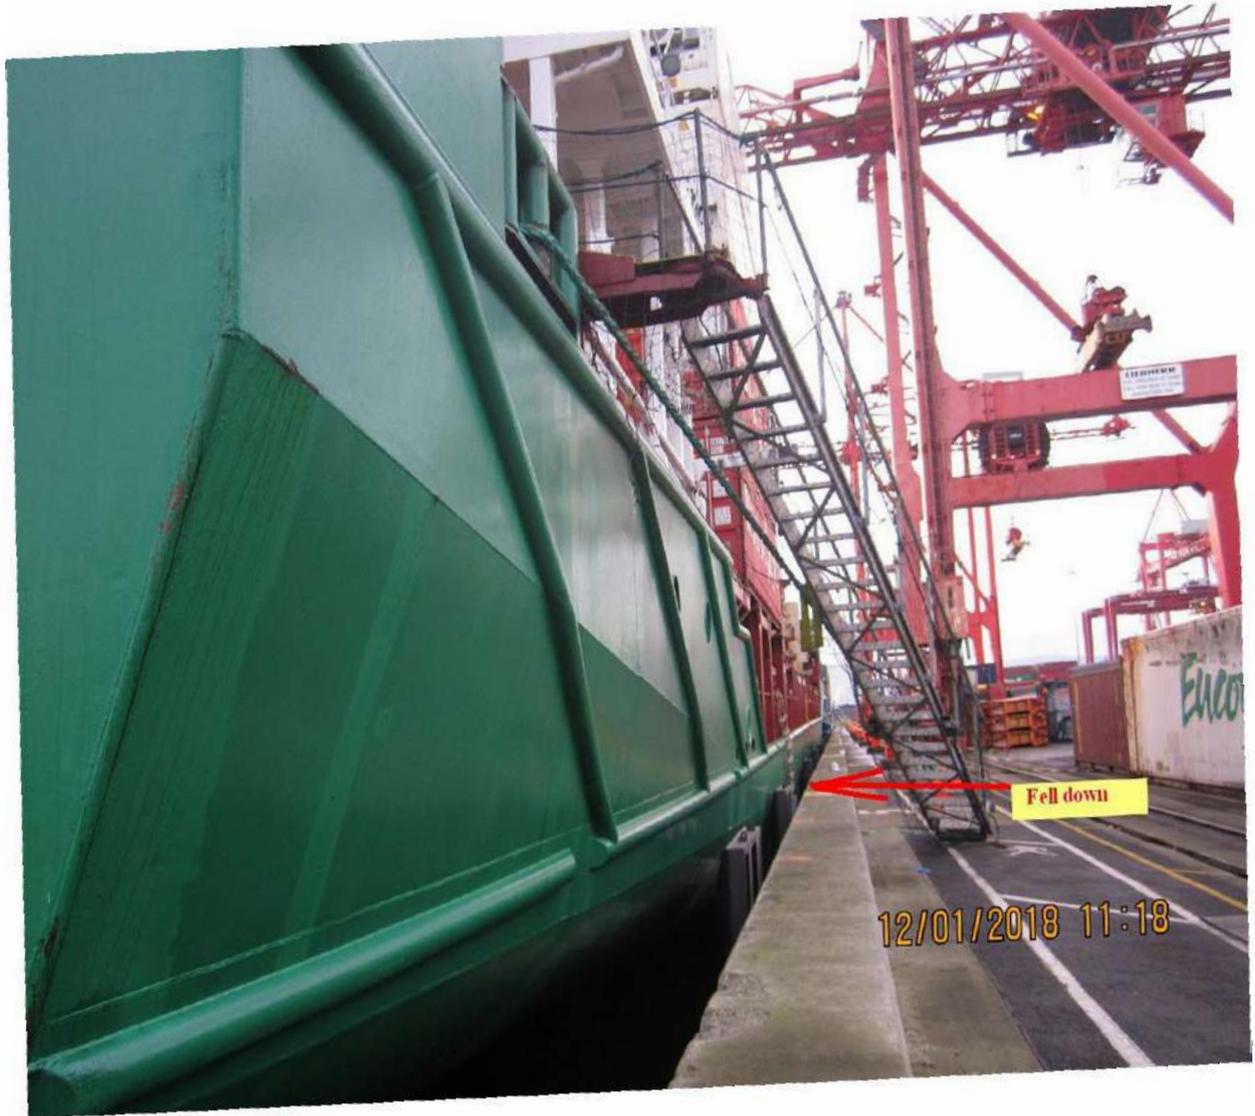
Vessels aft stbd side. Gangway's Upper and Lower Platform. Monkey Ladder at the point of fall.

Before the accident, the gangway was hoisted up. It was hanging 3-4m over the quay. The two visitors were waiting for a while, at the Poop Deck, near the gangway's upper platform.

At about 05:42 Hrs LT, they attempted to jump over the vessel's stbd bulwark to the quay. On jumping over the bulwark, one of them, fell overboard, in the gap between the vessel and the quay.

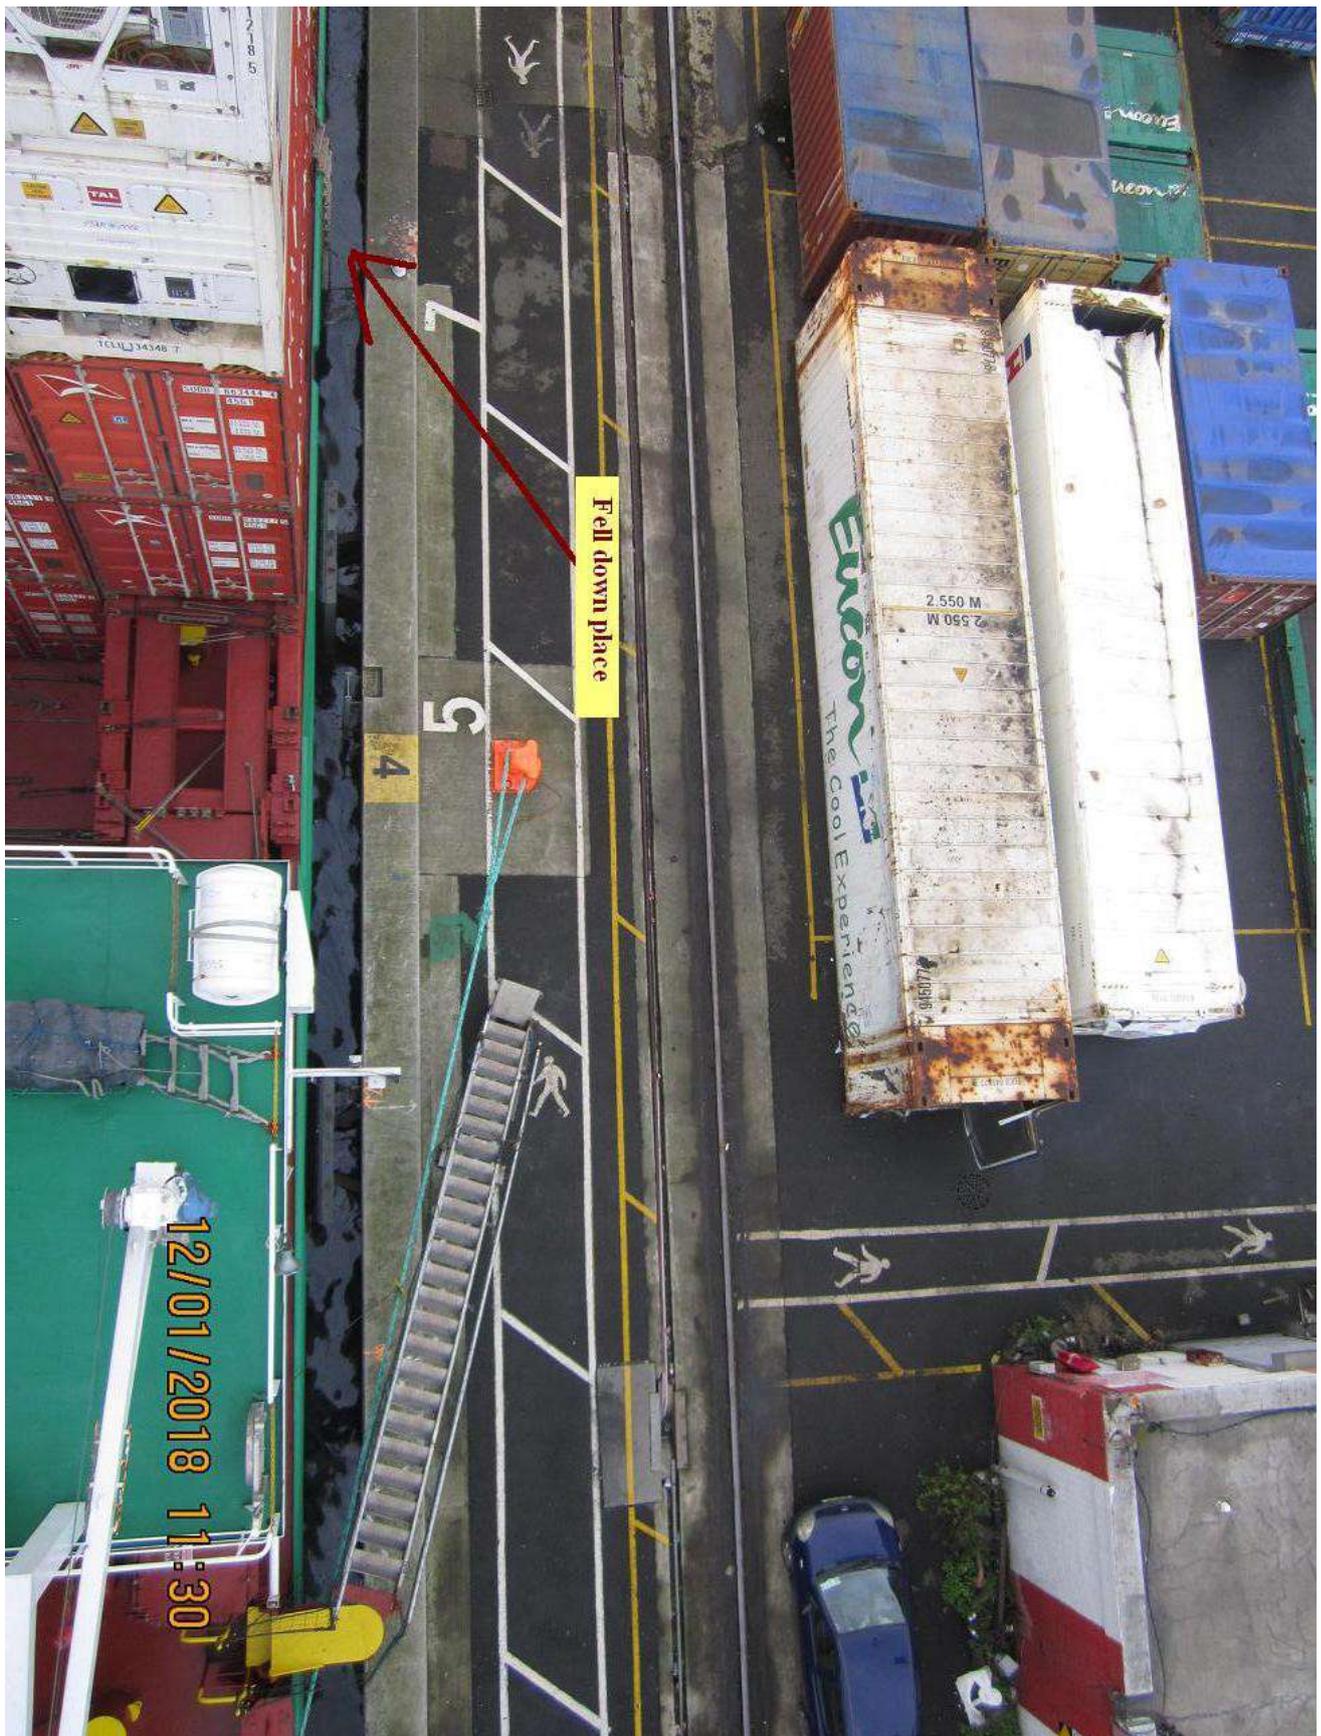
Fall down place indicated by arrow. A rope attached on the gangway's lower platform can be pulled for gangway's positioning on the quay.

Continuous monitoring and necessary adjustments should and could had been made by the OS / Gangway Watchman. He could adjust the gangway every half an hour, without needing assistance from the AB on watch. Nevertheless, he opted to hoist the gangway 3-4m over the berth. When the need arose to lower it, the AB of the watch was required to go to the berth to heave the gangway's rope which was fixed on the lower platform, in order to properly place the gangway on the berth.

The Gangway Duty, by hoisting up 3-4m and by under-controlling the gangway, violated the above-mentioned requirements. He performed a Work-Around Violation, i.e., the consequences and risks of violating the correct procedure was determined by him, to be the best course of action.

- Proper safety attitude.
- Proper assertiveness.
- Proper supervision.
- Proper gangway controlling.
- Using always the appropriate equipment (gangway) for ship access.
