INTERIM SAFETY INVESTIGATION REPORT

REPORT NO.: 17/2019

MV ADAM ASNYK Collision with MV DK IMAN in position 38° 58.8' N 120° 46.0' E 08 September 2018

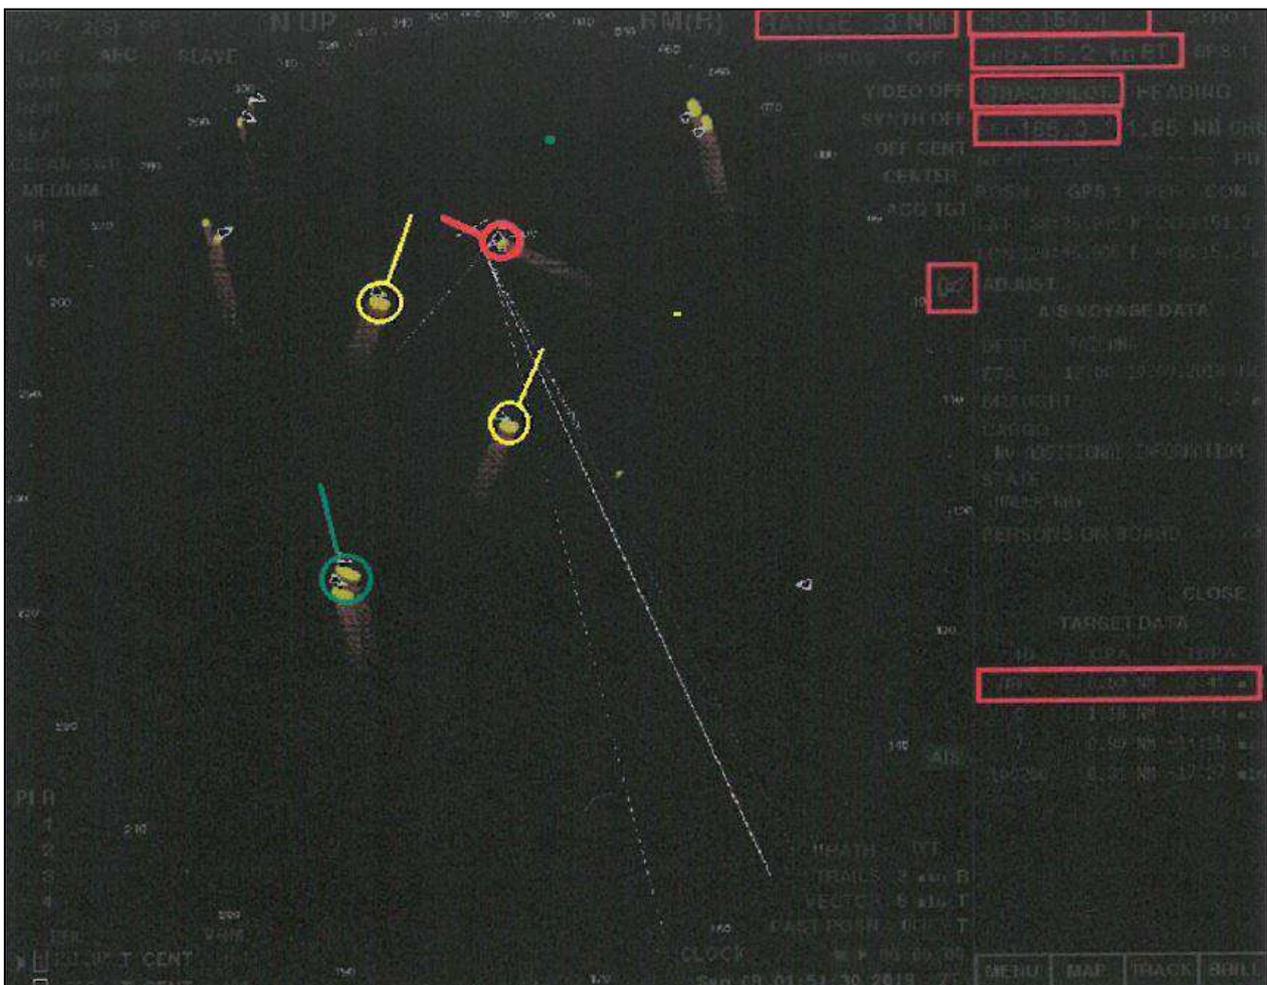
Figure 1: Radar screenshot at 0151:44

At 0151:26, while *Adam Asnyk* was on a course of 150°, the second officer noticed *DK Iman* lying about 0.25 nm off the port bow, heading towards *Adam Asnyk*. A few seconds later, it was noticed that *DK Iman* was altering her course to port, thereby bringing her on a collision course with *Adam Asnyk* (Figure 1).

At around 0151:44, the second officer instructed the third officer to call the master to the bridge, while he switched over to manual steering and continued altering the course of the vessel to starboard. It was noticed that the course of *DK Iman* was being continuously altered to port.

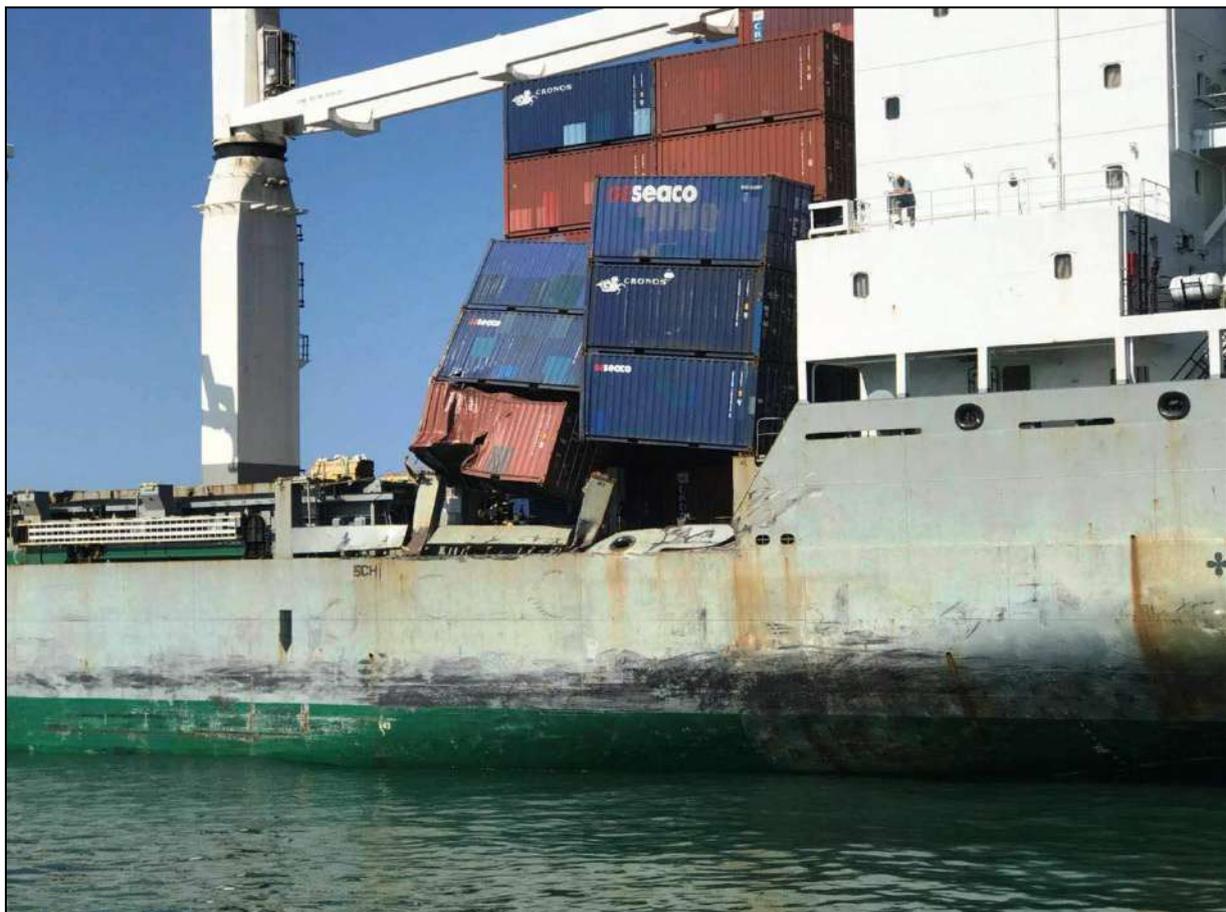
Figure 2: Damages sustained by *Adam Asnyk*

Adam Asnyk sustained minor damages above the water line. The damages were located on the vessel's port side, just forward of her accommodation, as can be seen in Figure 2.

Damages were reported to a section of the bulwark, three container support pillars, three air vents and mooring bitts in the vicinity. In addition, the shore connection pipes for sewage and steam, and a cable of the emergency stop for the oily water separator were damaged.

Six empty containers, which were above the damaged pillars, had also sustained structural damages.

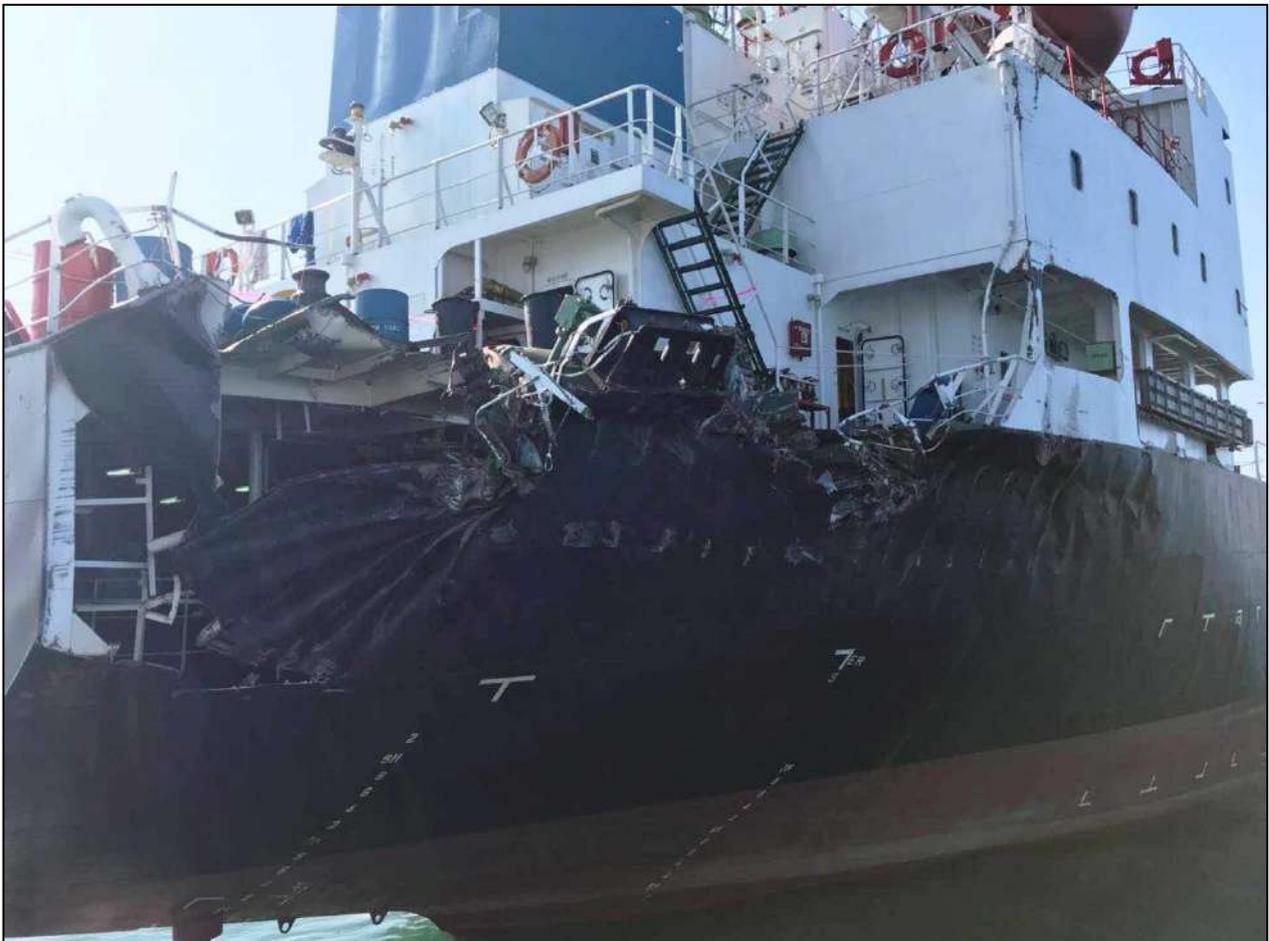
Figure 3: Damages sustained by *DK Iman*

As indicated in Figure 3, the vessel sustained serious structural damages to her starboard side shell plating in way of the poop deck and engine-room. There was also damage to the railing and bulwark on the aft deck. Damages were also on the mooring equipment and several air vents.
