Final Report

Marine inquiry MO-2018-203
Grounding of container ship *Leda Maersk*
Otago Lower Harbour, 10 June 2018

Approved for publication: September 2019

Transport Accident Investigation Commission

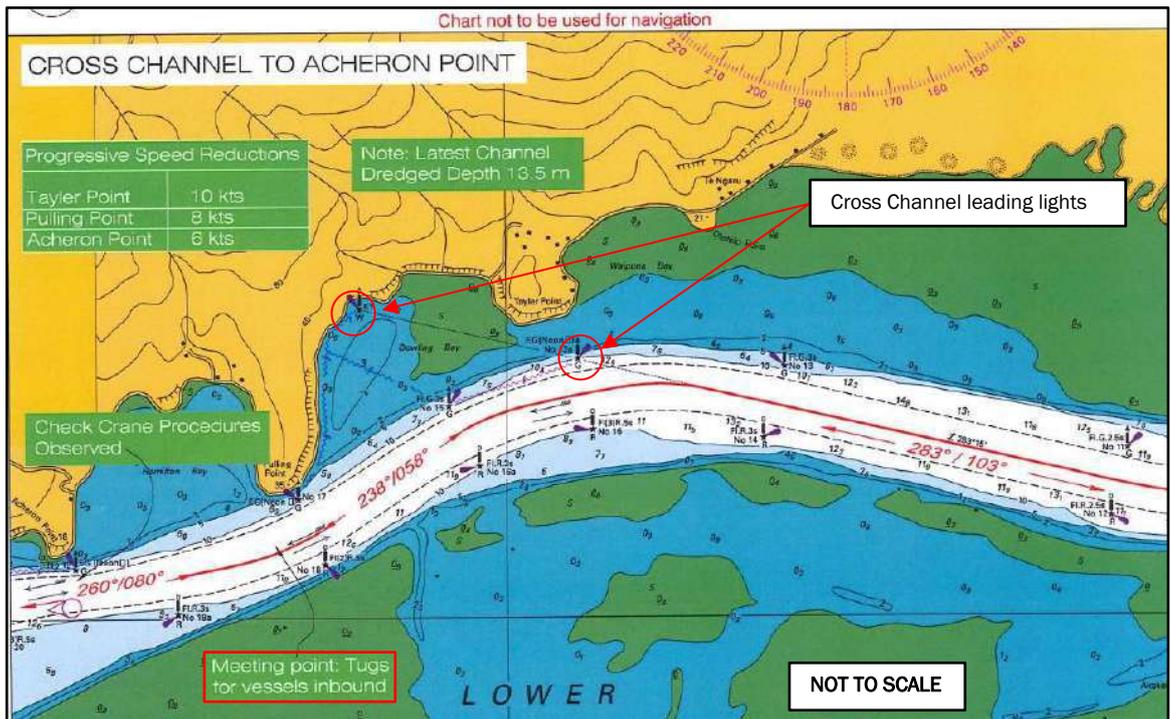
Figure 1
Page from the Otago Lower Harbour Pilotage Guide showing the Cross Channel leading lights

- 3.2.5. Between 1806 and 1810, when the ship was lined up with the Cross Channel leading lights⁹ (see Figure 1), the pilot's PPU indicated that the ship was slightly off track. The pilot checked the settings on the PPU and found that there was an 18-metre offset to starboard¹⁰ to allow for the position of the PPU aerial in relation to the ship's centreline. The offset was causing the PPU to indicate that the ship's position was 18 metres, approximately half the ship's breadth, further to port¹¹ than it really was. The pilot was unable to remove the offset so decided to discontinue using the PPU for monitoring the ship's progress. Instead the pilot

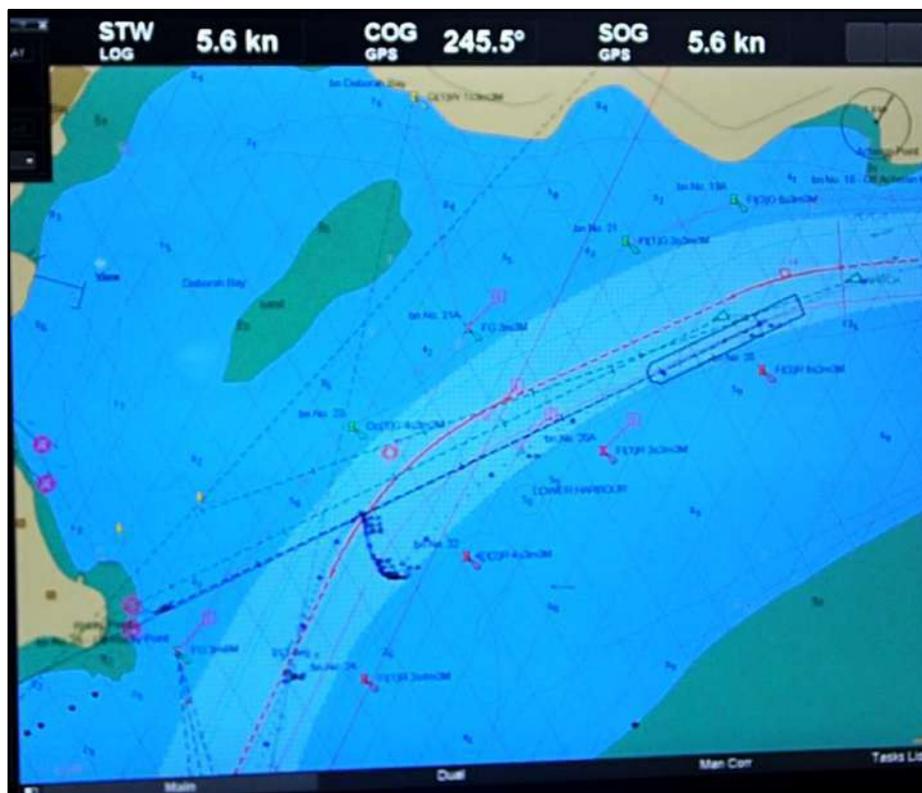
Figure 5
The *Leda Maersk*'s position at 1824 from the ECDIS replay

4.2.6. The ECDIS display (Figure 5), the radar display (Figure 6) and the pilot's PPU (Figure 7) clearly showed this drift towards the left bank of the channel.

representation of the surrounding channel. The diamond hatching in Figure 5, which is known as the shallow pattern, indicates “non-navigable” water that is shallower than the safety contour programmed into the ECDIS. However, the settings were such that there were no navigable areas of water shown on the ECDIS, despite the presence of the navigable dredged channel. Figures 10 and 11 show how the ECDIS display can be optimised to give the bridge team a better understanding of the surrounding navigable and non-navigable waters.

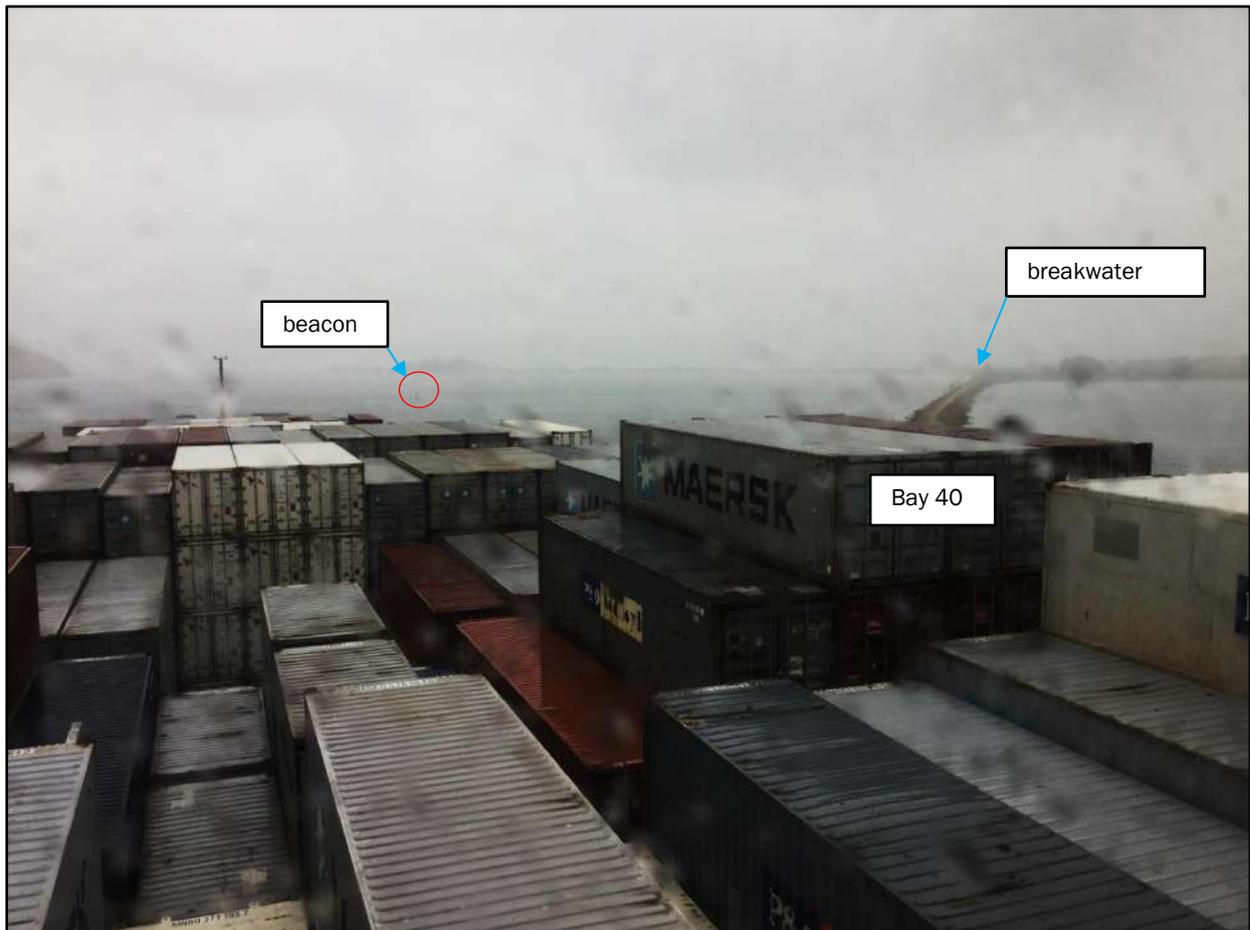
Figure 8
 Example of an L-class ship where the beacon is about to be lost from view and the breakwater is obscured by the containers stowed six high
 (Photo courtesy of Port Otago)

- 4.2.10. Additionally, containers had been stacked six tiers high near the extremities of the ship. On the L-class container ships this was known to cause bridge teams to lose sight of channel beacons passing close by the ships. As the ship drew closer to the left bank, from where the pilot was standing the pilot would have lost sight of the left bank channel markers below the container stacks. Figure 8 shows an example of how containers stacked in this manner can affect visibility.

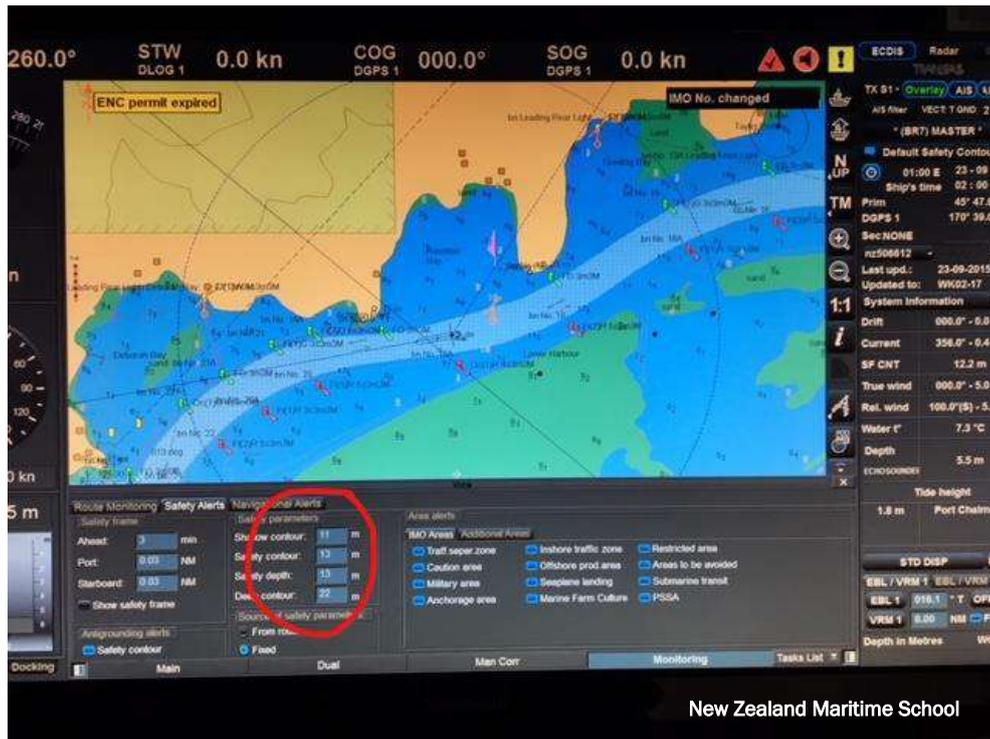
Figure 10
ECDIS safety settings closely aligned with the operator’s guidelines²⁹

- 4.11.10. The ECDIS safety settings were not consistent with the settings recommended in Maersk's policy and guidance documents, nor were they optimised to give the bridge team the best
