SAFETY INVESTIGATION REPORT

REPORT NO.: 19/2019

October 2019

MV *BALGARKA* **Crew members' fatality and serious injuries** **during repairs in a shipyard** **28 October 2018**

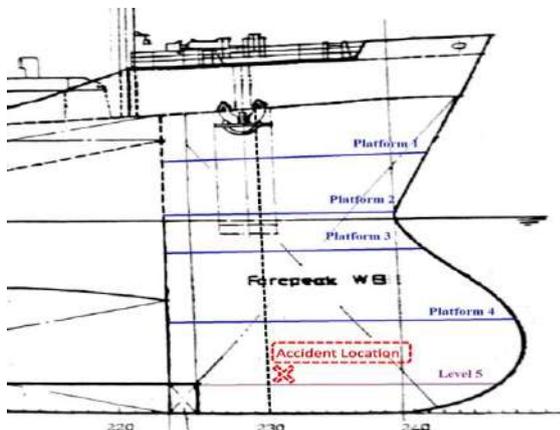
Figure 1: Forepeak tank configuration

The forepeak tank, located forward of cargo hold no. 1, extended throughout the entire height, from the main deck to the bottom shell plating. In order to provide structural strength (and facilitate access), four horizontal platforms were fitted, thereby splitting the height of the forepeak into five levels (Figure 1). Vertical ladders fitted between platforms and the bottom of the tank, provided means of access to all five levels.

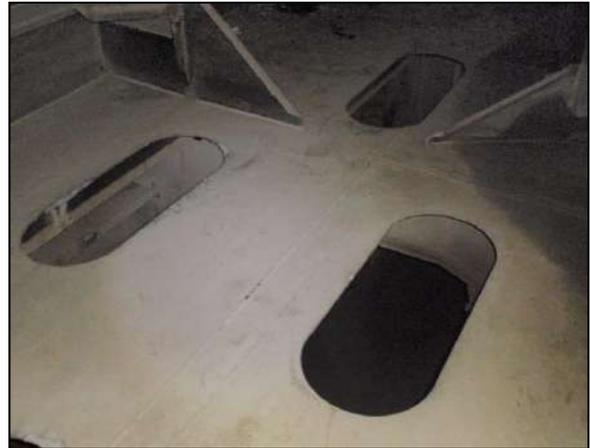
Figure 2: Configured platform nos. 1 to 4

While platform nos. 1 to 4 were fully configured platforms with access and drain openings (Figure 2), the bottom most platform no. 5 (where the accident happened) was structured differently, with deep longitudinal girders and face plates of the bottom longitudinal stringer (Figure 3).

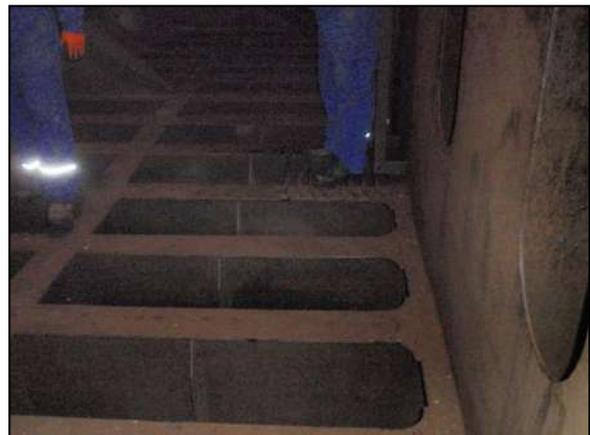
Figure 3: Platform no. 5 with deep wells

The depth of the bottom longitudinal girders was about 1.9 m, and the face plates were about 0.25 m wide, providing just enough stepping space.

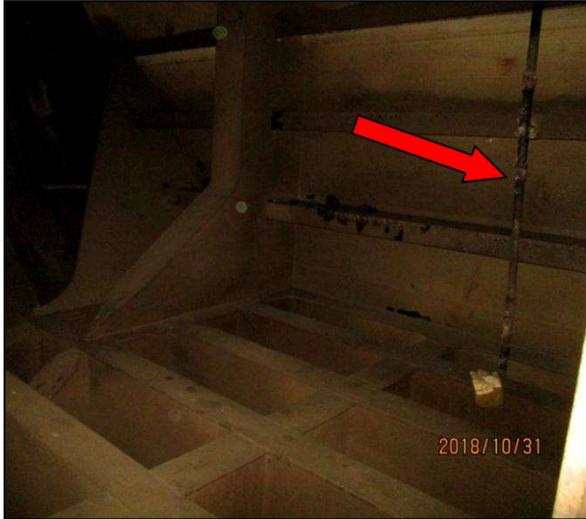
Figure 4: Valve spindle inside the forepeak tank

spindle passing the whole height of the tank, split in sections by cardan joints and supported at several locations through the platforms. The valve spindle (Figure 4) was located about 1.5 m from the access ladder.

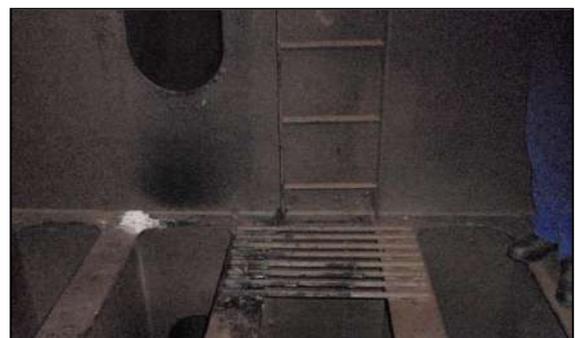
Figure 5: Vertical ladder on platform no. 5

Soon after, both fitters’ clothes were on fire; while fitter 2 managed to reach the ladder and climb up to the upper platform (Figure 5), fitter 1 did not manage and remained trapped inside the bilges of the forepeak tank (Figure 6).

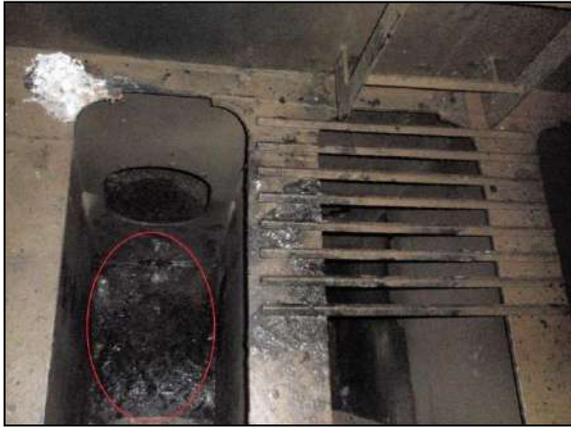
Figure 6: Bilges inside the forepeak tank

There were no structural damages reported as a result of the fire inside the forepeak tank. However, smoke damage was visible, especially inside the space bilges. In view of the missing physical evidence, the MSIU was unable to determine whether any of the equipment used by the fitters had been damaged.
