Fire on board *BBC Xingang*

Newcastle, New South Wales, 11 December 2017

ATSB Transport Safety Report
Marine Occurrence Investigation
337-MO-2017-011
Final – 25 May 2018

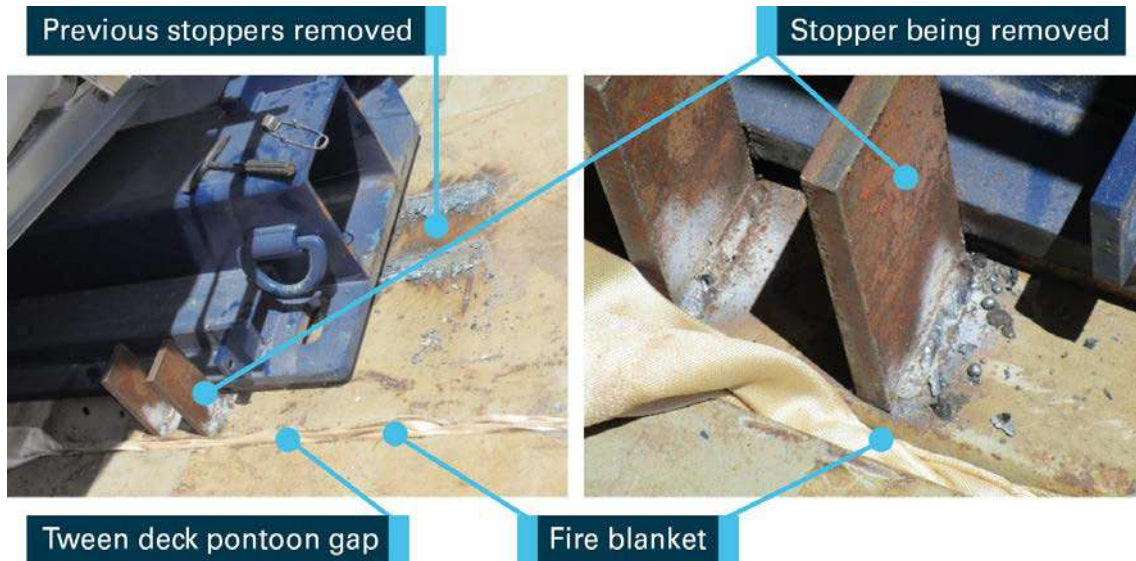
Figure 2: Worksite showing stoppers, after the incident

The work commenced in the number two cargo hold tween deck.² In preparation for the hot work, gaps between the tween deck pontoons were filled and covered with fire blankets (made from woven fibre and leather) to stop sparks from falling onto the cloth-covered cargo in the lower hold (Figure 2).

An inspection of the work site following the fire identified that molten metal and other hot material produced by the hot work had burned through the fire blankets. This hot material fell onto the material covering the cargo in the lower hold, resulting in the fire. As a result of the fire, the material covering the cargo was damaged and some surface blemishes were apparent on the cargo itself (Figure 4). No other damage was reported. Subsequent inspection of the cargo covering material found it to be 100 per cent polyester transport cloth with a maximum rated temperature of 200 °C.

Following the fire, all work to remove the stoppers was suspended and the incident was reviewed. Procedures and safety measures were reassessed during a meeting of ship's crew and the shore contract team. The cutting procedure was amended to direct the sparks away from deck openings and containment of sparks around the work area was improved. Further, additional filling material was added to holes in the tween decks used for removable hand rails, and the lower hold fire watch was directed to monitor the area directly below the work rather than the general vicinity. Work resumed at 1315 and continued to completion without further incident.

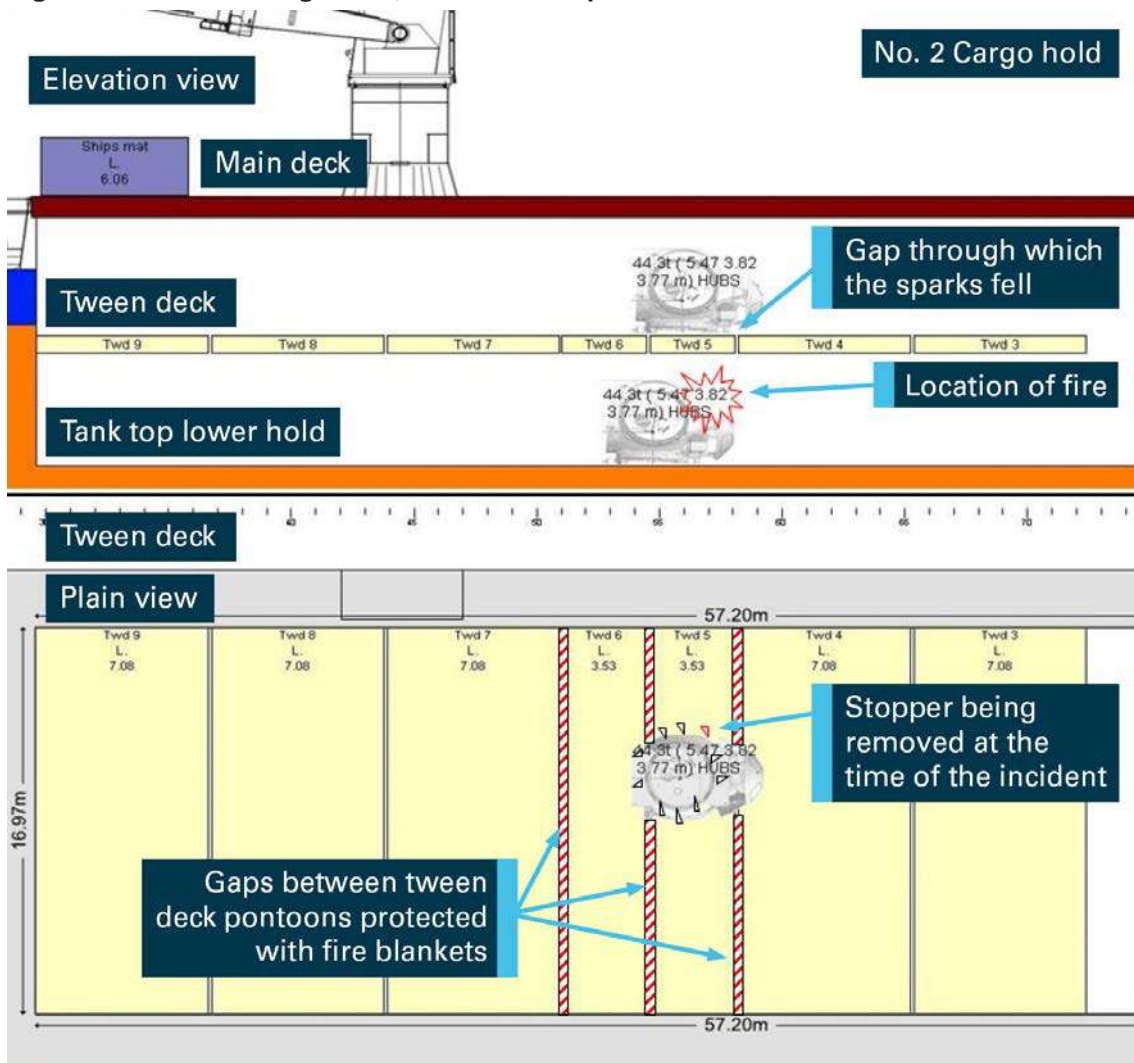
Figure 3: Number 2 cargo hold, elevation and plan views of worksite

The work continued as expected and, at 1100, the boilermaker stopped to relocate to the next stoppers on the tween deck. As part of checking the new work area, he lifted a fire blanket and could see small flames and smoke in the lower hold through the gap in the tween deck pontoons. He immediately raised the alarm. The lower hold fire watch was notified on the radio. At the time he was notified he was not near the area directly under where the work was being conducted. After moving to the relevant area, he quickly extinguished the fire using the water hose and water spray. Figure 3 shows the location of the work site and the fire in the ship's hold (elevation view and plan view).

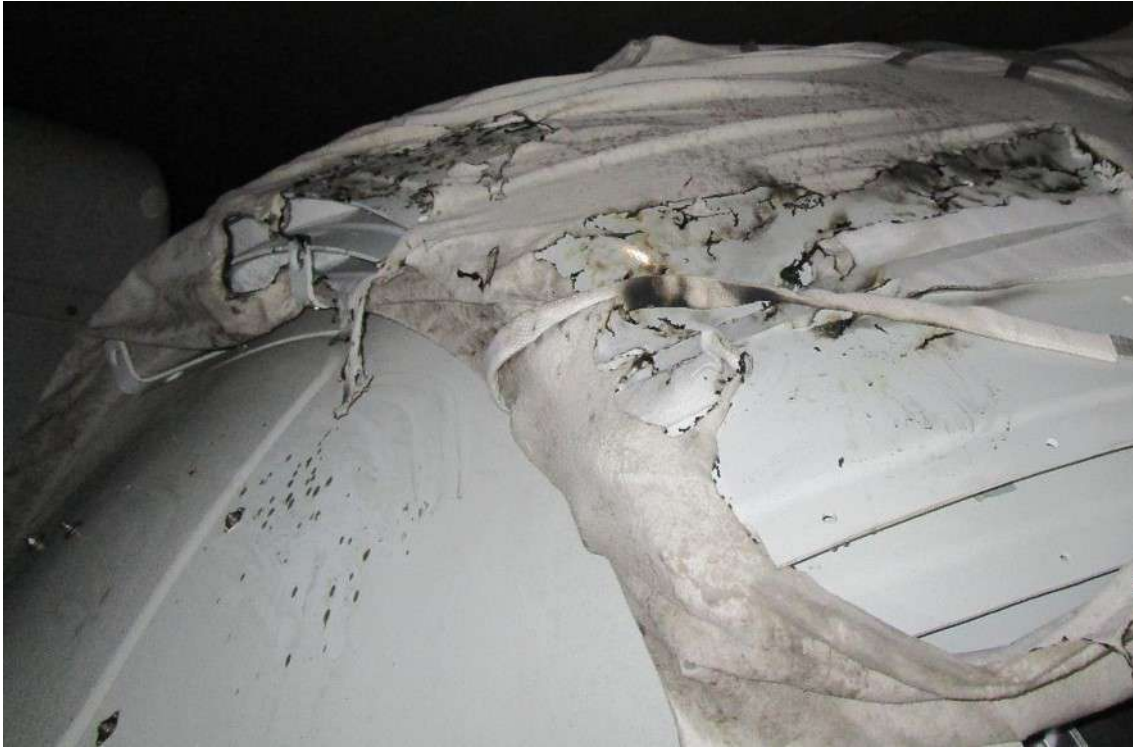
Figure 4: Cargo covering material and cargo surface damage

The work area and the gaps/holes in the pontoons were protected by fire blankets. However, the molten metal produced was of sufficient size and intensity to burn through the protective fire blankets and fall onto the cargo stowed in the deck below. This cargo was covered with transport cloth to protect it during transport but was not protected from the hot debris by covering with fire blankets. Transport cloth is made of 100 per cent polyester and will ignite if directly exposed to fire. As a consequence, when the hot material fell onto the unprotected transport cloth it resulted in the fire.

Despite the safety actions taken after previous fires, flammable cargo coverings were again ignited during sea fastening removal on this occasion. Careful consideration must be given to the use of such materials. Prior to hot work, cargo coverings should be carefully assessed and adequate protection against damage or fire due to hot material should be provided.
