**REPUBLIC OF CYPRUS
MARINE ACCIDENT AND INCIDENT
INVESTIGATION COMMITTEE**

Investigation Report No: 75E/2018

Very Serious Marine Casualty

**Manoverboard Fatality from Bulk Carrier “EVNIA” in the
Port of Chittagong-Bangladesh on 04 June 2018**

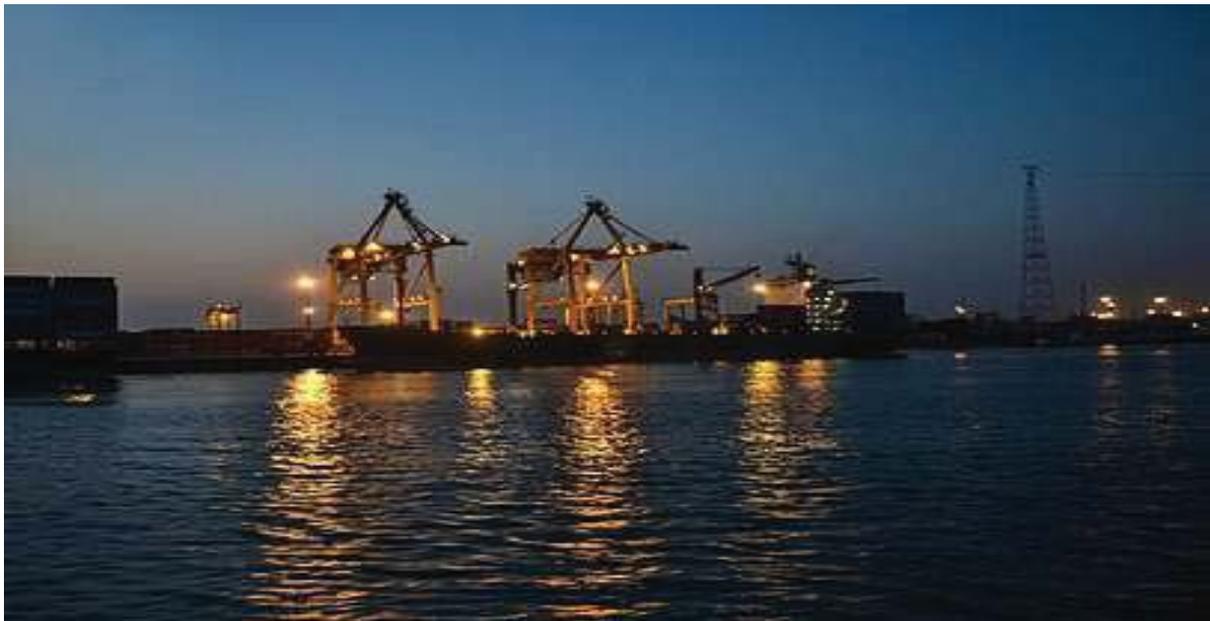
On Monday 04/06/2018 at 20:55 hours LT, it was falling tide, downstream, with the tidal current at its highest velocity, estimated approximately 3.8 knots. Therefore, the environmental conditions, i.e. the tidal current were a contributory factor to the accident because it had moved quickly the Master away from the position of fall where a life buoy was thrown.

The environmental conditions (tidal current) were a contributing factor to the accident.

Karnaphuli "western river" at night.

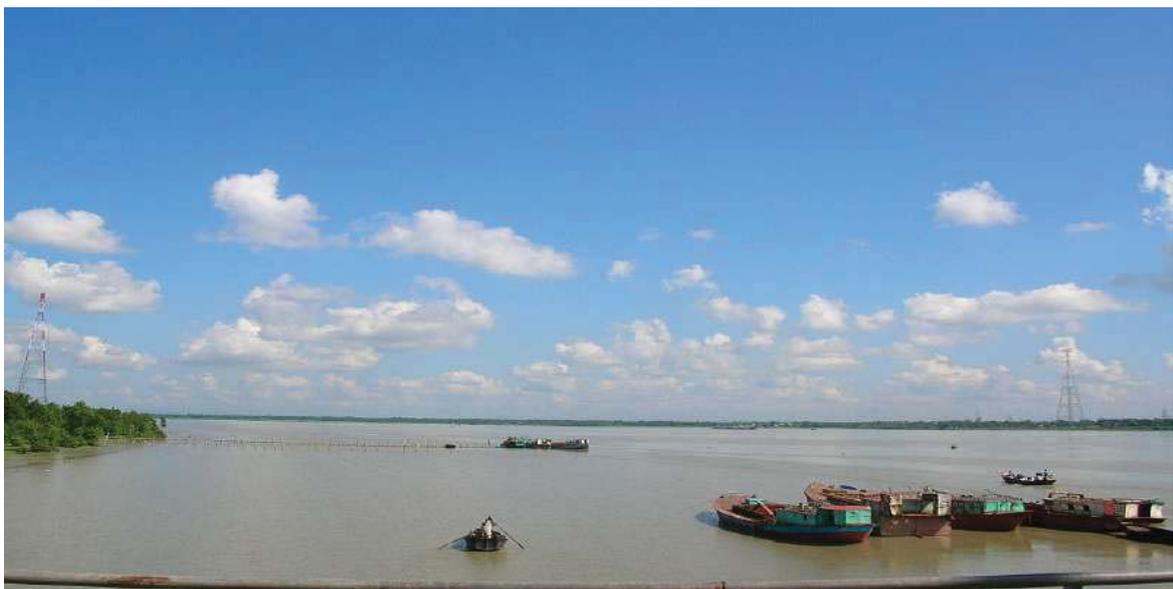
View of the Karnaphuli "western river".

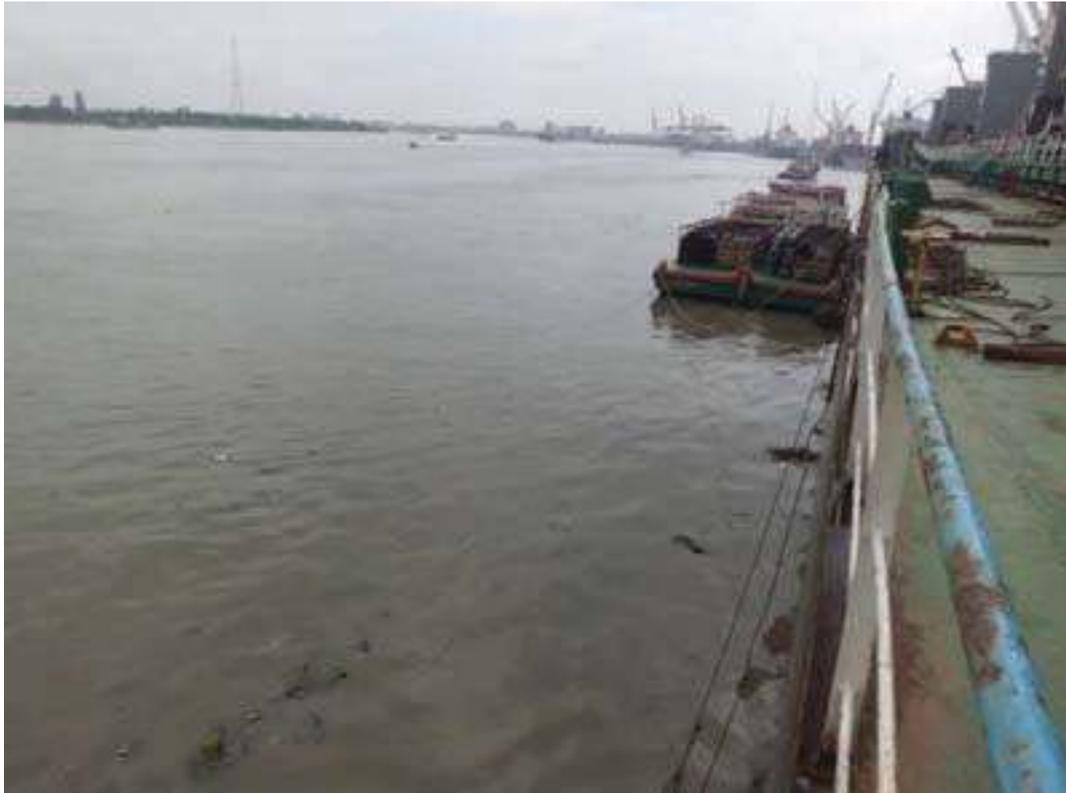
16. The Master drifted by the current towards the Bunker Barge fasted alongside at port side in way of cargo hold No.3 and 4. His body went underneath the Bunker Barge.

Port side view. Bunker barge fastened between No.2 and No.3 cargo holds.

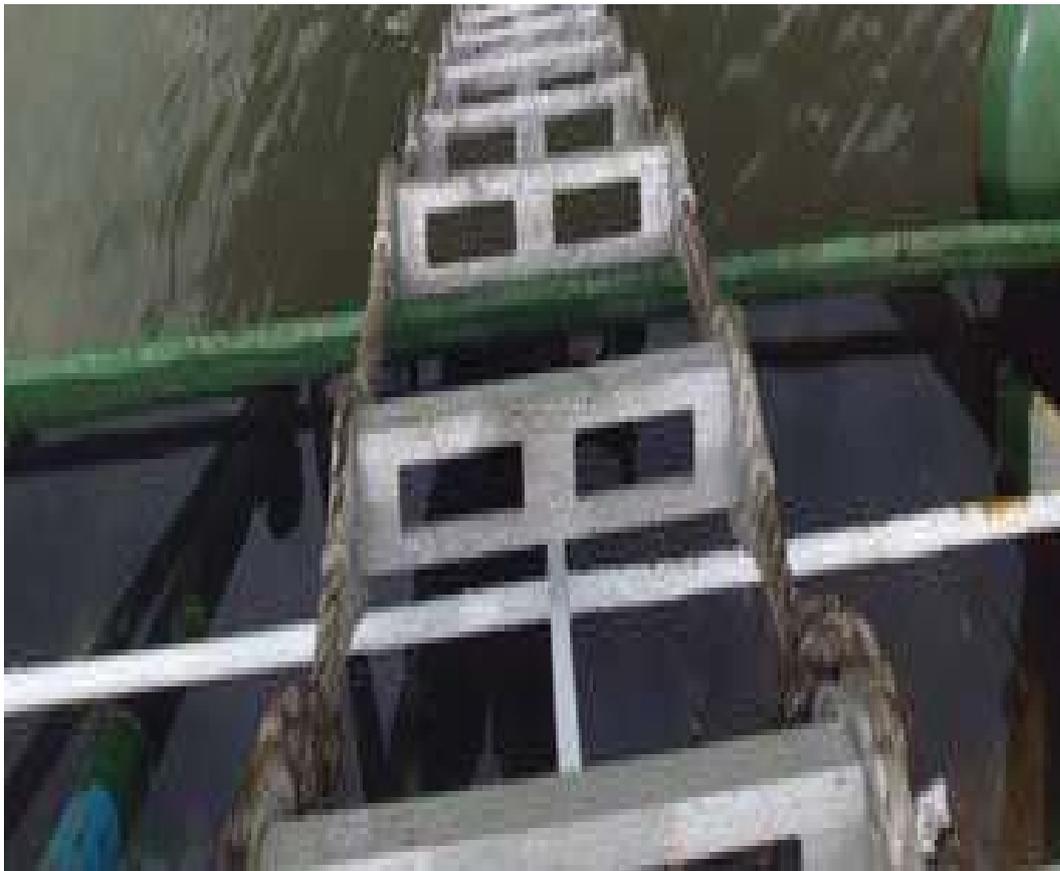
9. A rope ladder was already rigged at the aft port side.
10. The C/O stated, that he pointed out to the Master to wear the appropriate personal protective equipment (PPE) and he brought him a safety harness but the Master ignored him.

11. The Master went down the ladder.
12. At appr. 19:55LT the Master while was climbing up, at about 1m from the poop-deck level, slipped and fell in the river.

View from poop deck of the rope ladder rigged for aft port side draft checking.

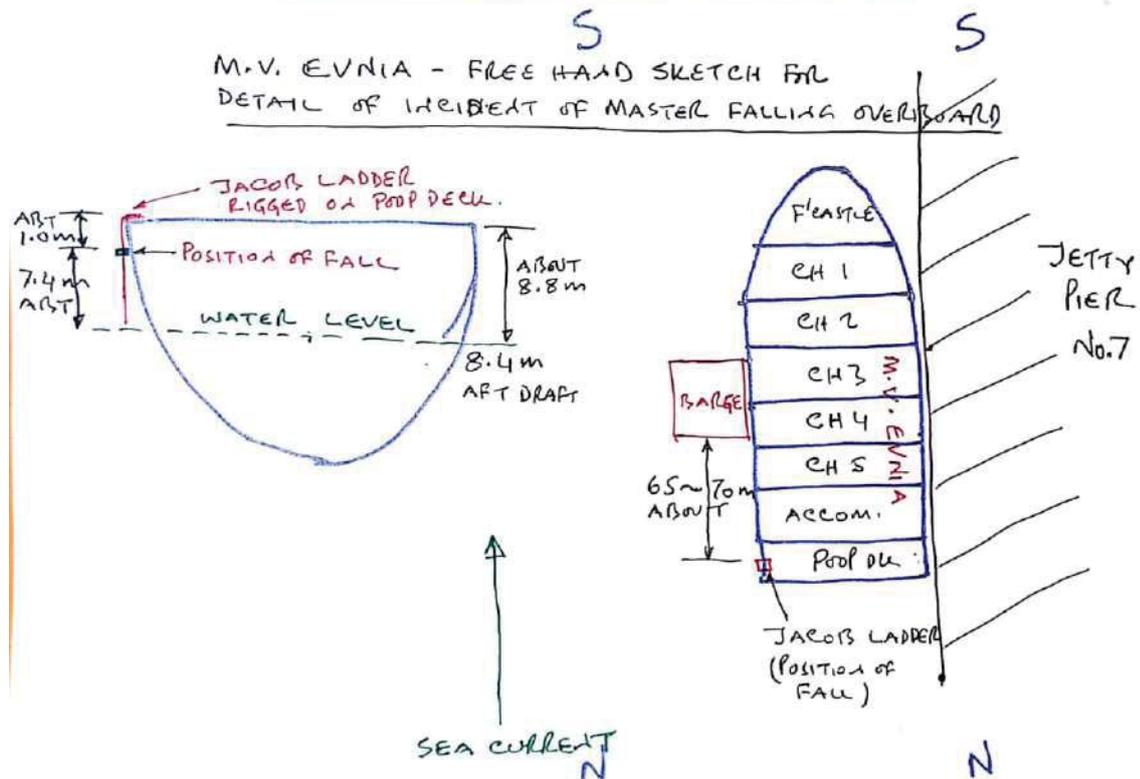
The sketch on the left, indicating the rope ladder rigged on the rails of the poop deck and the appr. ship's draft. (At Frame No.5(P).

The sketch on the right, indicating the Bunker Barge where the Master went underneath after his fall from the rope ladder. Also, the direction of the current is noted.
