MARINE SAFETY INVESTIGATION REPORT

**Safety investigation into a crew member fatality
inside the cargo hold on board the
Maltese registered general cargo**

KATI

MARINE SAFETY INVESTIGATION REPORT NO. 11/2019

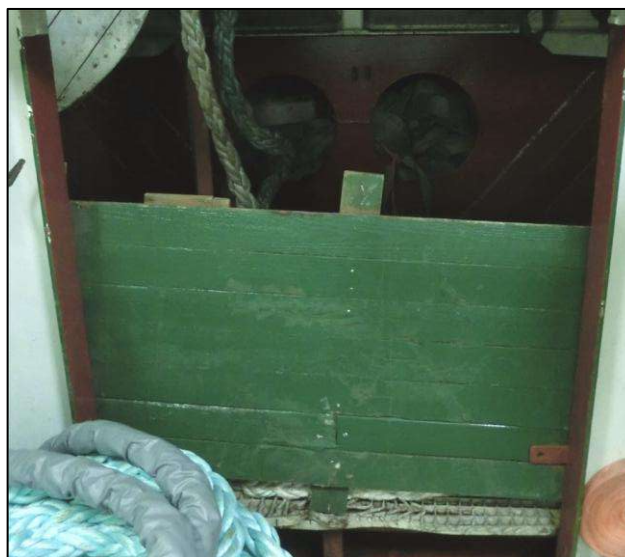
Figure 3: Wooden boards in use to block access

However, with the current cargo of wooden logs, it was not found necessary to block the manhole since there was obviously no danger of cargo spilling inside the space¹.

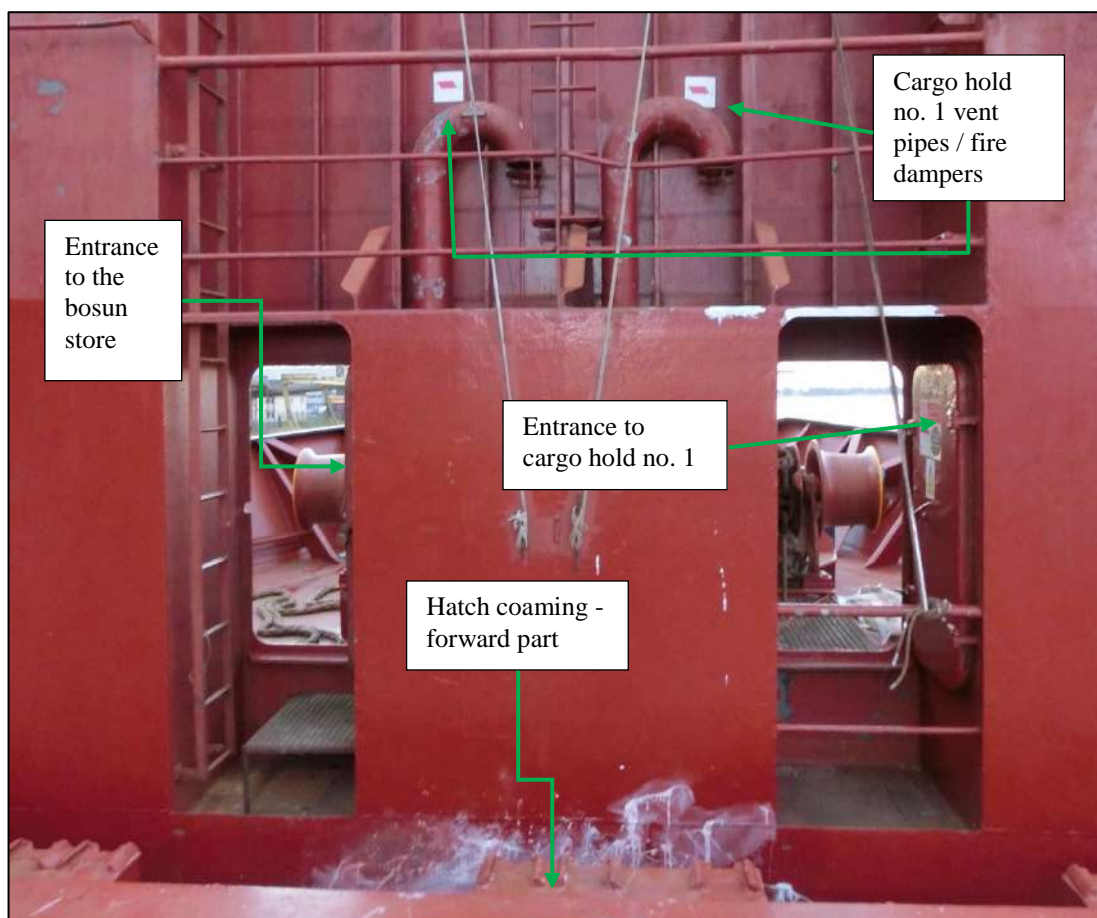
Figure 4: Wave breaker with entrance to bosun store and cargo hold no 1

Following the cabin inspections, the customs officers started searching technical spaces of the ship, with the assistance of the ship's crew members. The second mate and the bosun proceeded to the forecabin where the bosun store was located, assisting customs officers in their search through this part of the ship (Figure 4). After checking the bosun store, the second mate and the customs officer proceeded with the inspections in other spaces in the forecabin area. At this point, the bosun noticed that the entrance door to cargo hold no. 1, which was normally kept locked, was open.

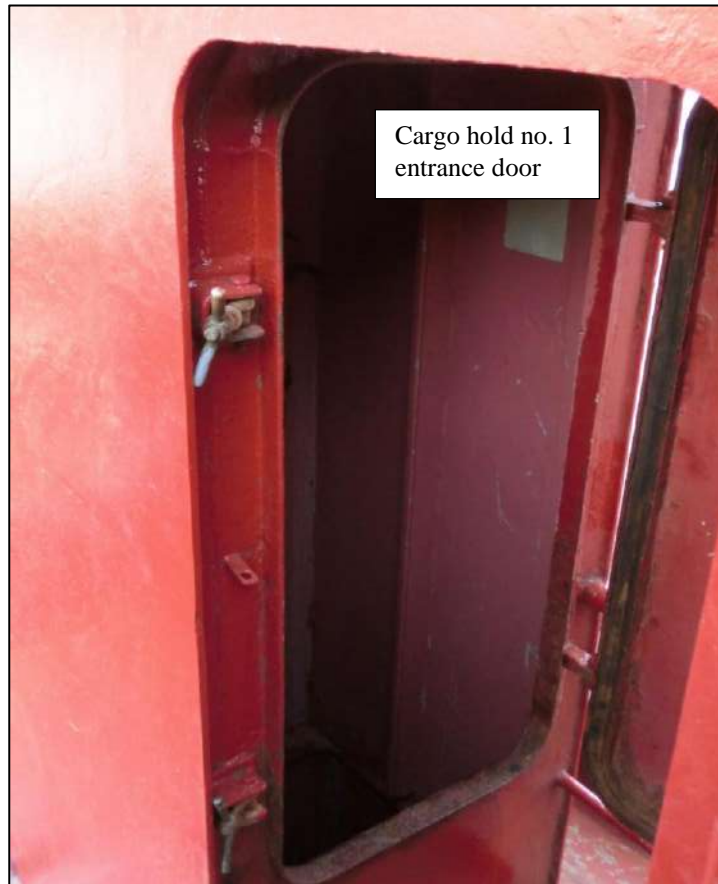
Figure 5: Entrance to cargo hold no. 1

At approximately 1335, the bosun went to have a look inside the cargo hold entrance (Figure 5) and noticed a person lying on the deck, approximately eight metres down at the bottom of the access duct. The bosun notified the master by VHF about his findings. Together with the chief officer, the master immediately proceeded to the forecabin.

The chief officer brought a multi-gas detector and conducted an atmosphere test inside the duct leading down to the cargo hold. This test gave an oxygen level reading of 2.1 %. The master instructed the bosun and the chief officer to prepare the breathing apparatus (BA) sets from the bosun store. Cargo operations were suspended and the master requested the customs officer to immediately alarm the local emergency management services, while he contacted the Designated Person Ashore (DPA) to inform the Company about the situation on board. The master assessed that recovering the person from the cargo hold would require special equipment, which he figured that the fire brigade ashore would have.

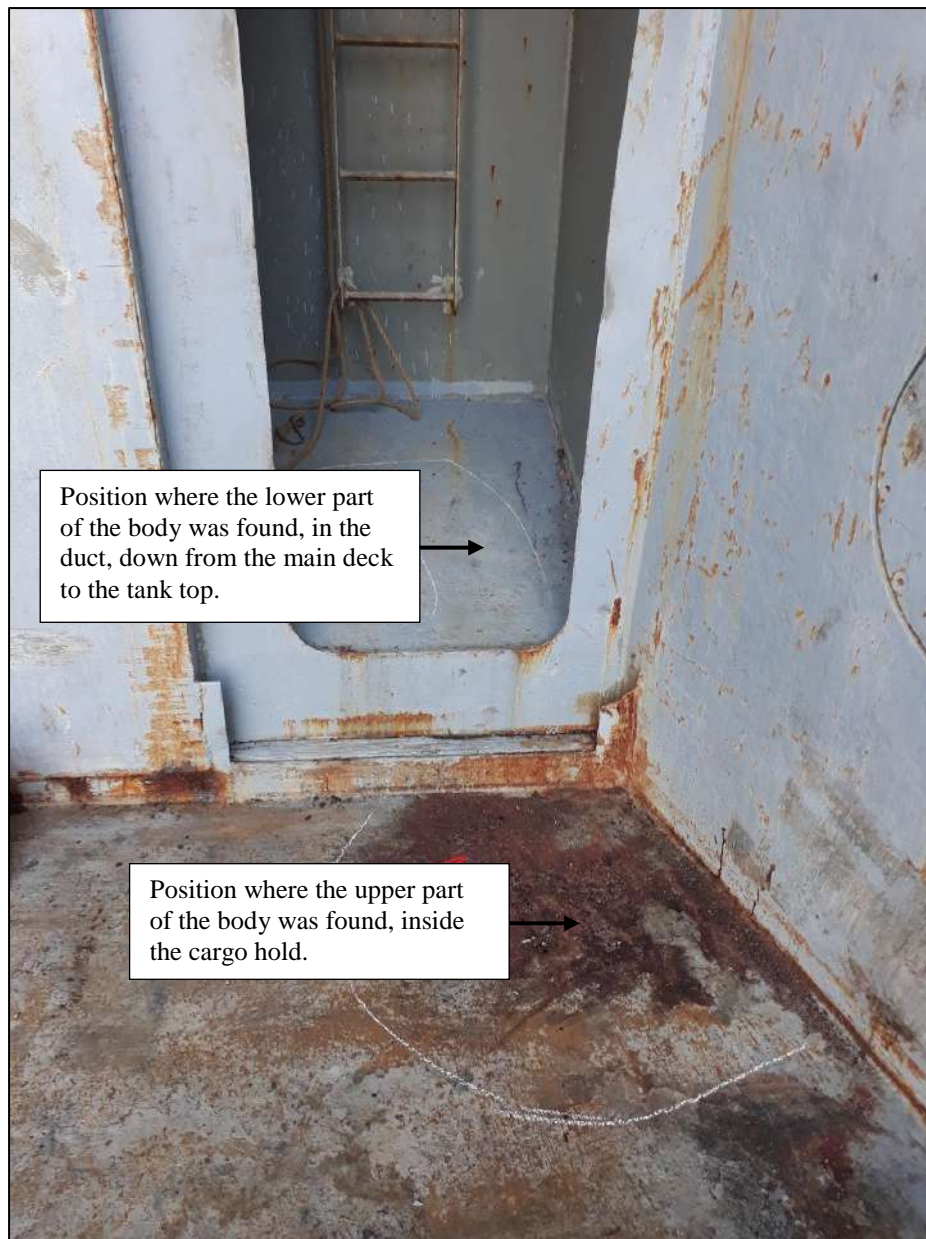
Figure 6: Location where the crew member was found, in close proximity to the access duct

In the meantime, the crew members tried to call the distressed person lying on the tank top (Figure 6) but no reaction was observed. The second officer donned his BA set and climbed down the ladders to check the condition of the person inside the cargo hold. Down inside the cargo hold, it was noticed that the person was the AB missing

The AB was found with injuries to his head. Although the MSIU could not verify the cause of these injuries, it was considered that probably, he had fallen off the ladder in the access duct for cargo hold no. 1 during his descent and before reaching the tank top, as a result of the above mentioned symptoms.

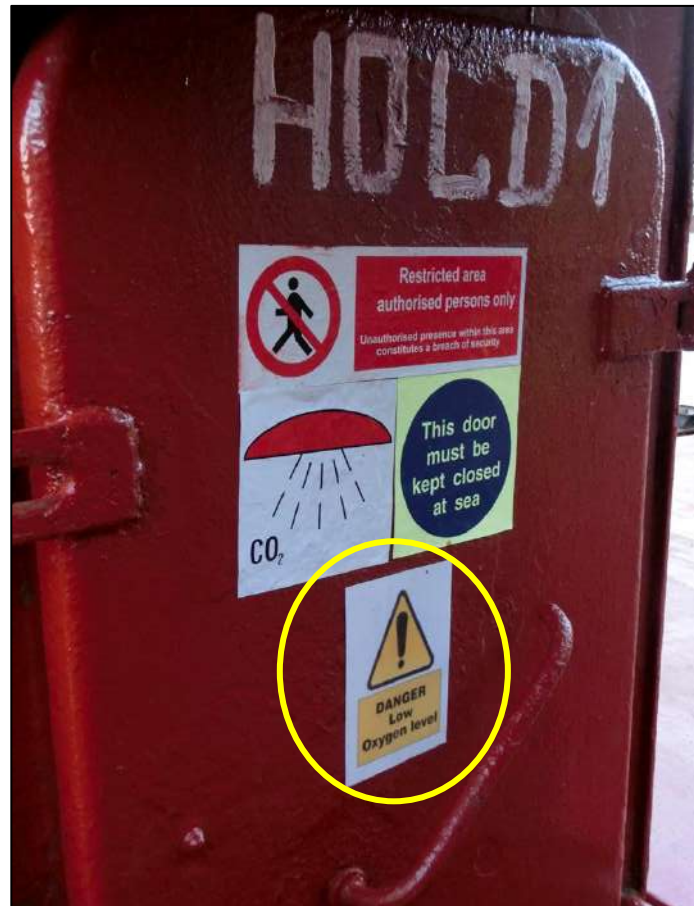
Figure 12: Warning sign affixed to the cargo hold access door

- .3 The entry to the cargo hold was accessible to the crew member, with no signs posted to remind of / mark the dangers which were inside as a result of the nature of the stowed cargo;

Immediately following the accident, notices cautioning of the potentially hazardous situation on board were affixed on the access door to cargo hold no. 1 (Figure 12).
