ACCIDENT REPORT

Report on the investigation into

the listing, flooding and grounding of

Hoegh Osaka

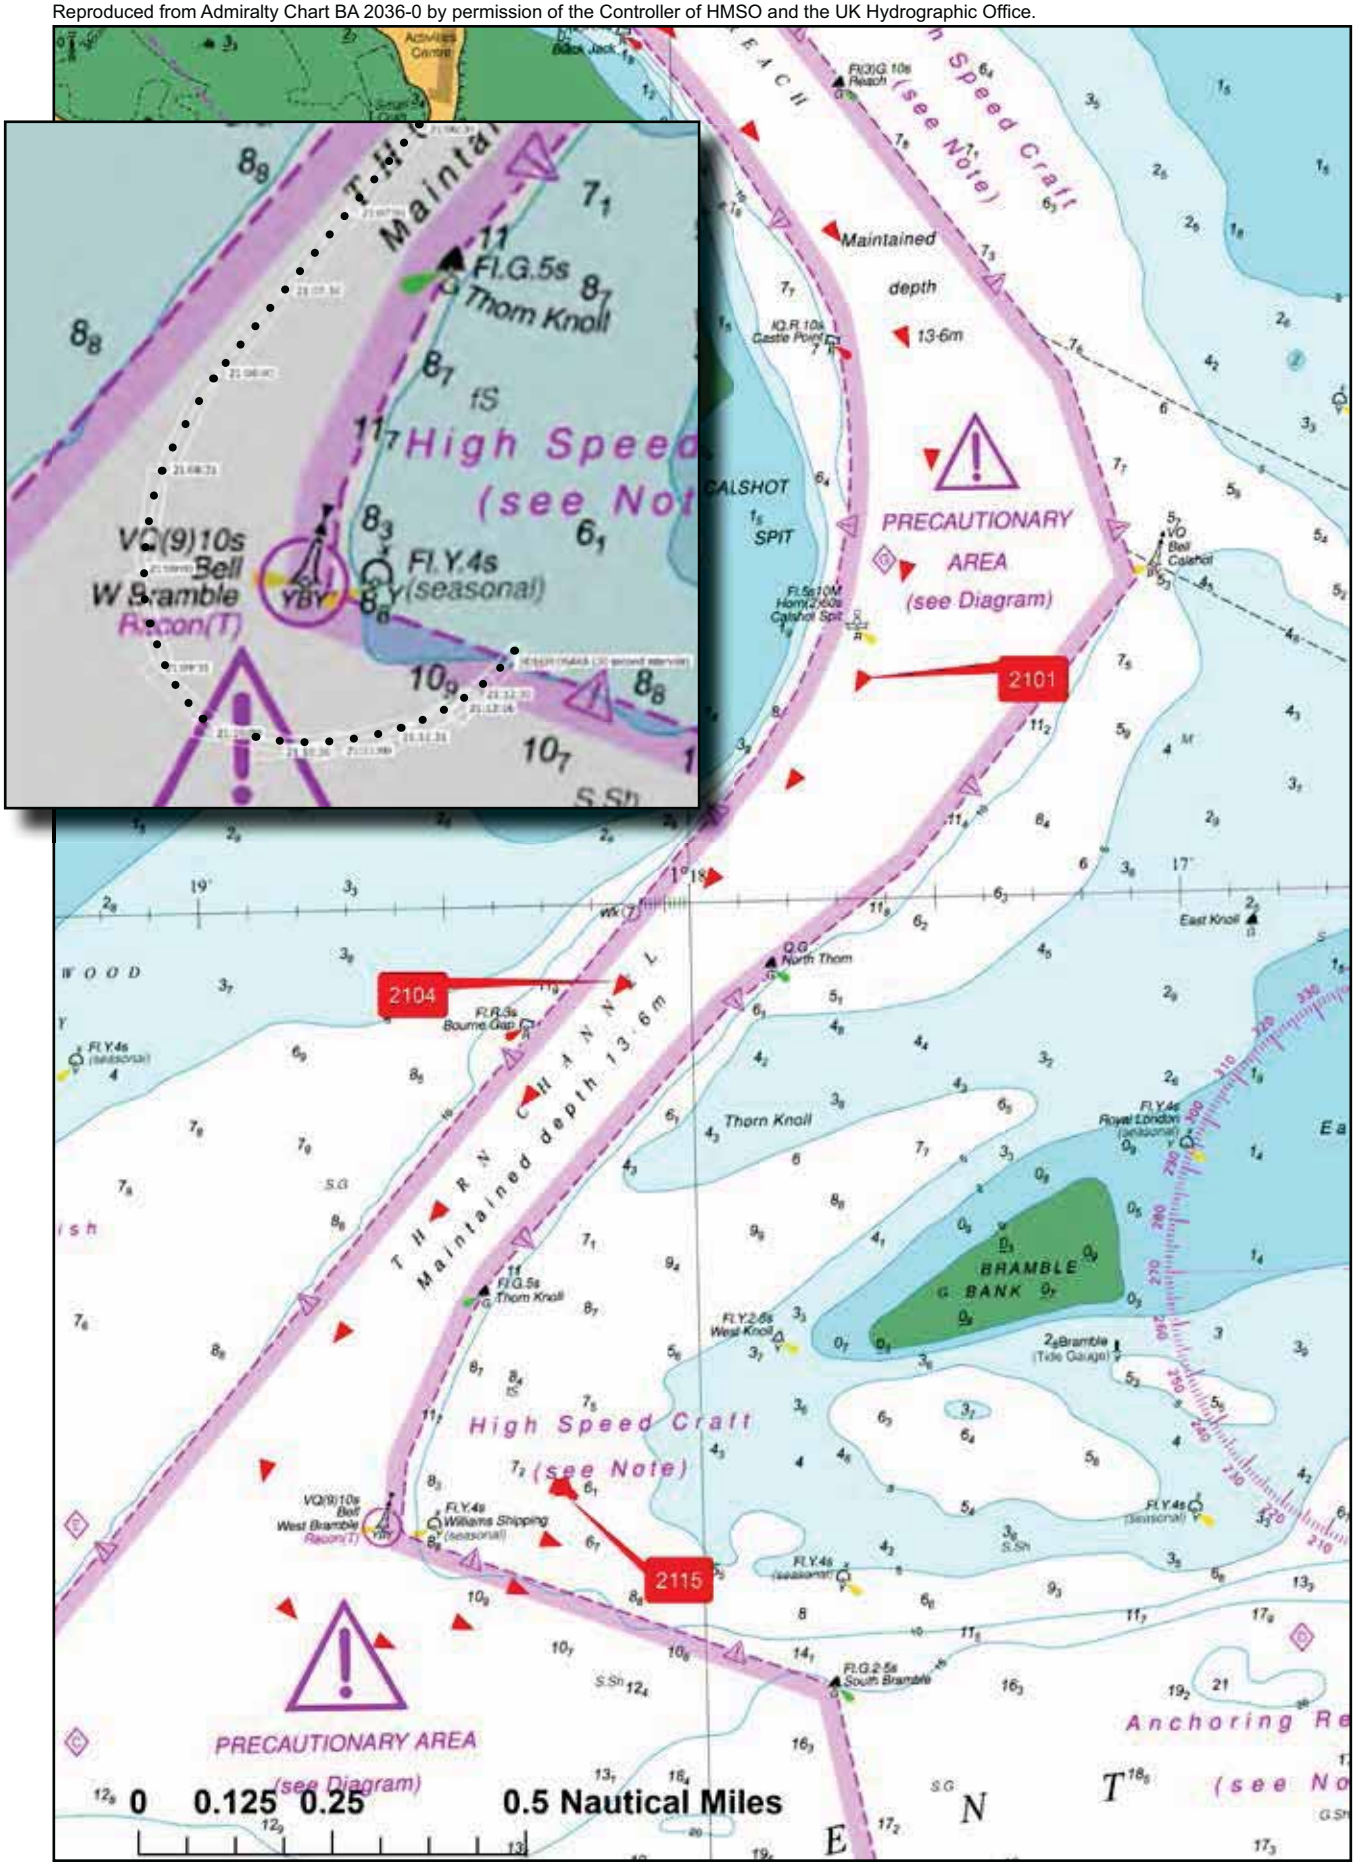
Figure 4: AIS track showing grounding position (with inset showing reconstruction of track)

At 2115, *Hoegh Osaka* grounded on Bramble Bank **(Figure 4)**. The pilot observed the inclinometer on the bridge, which was indicating a list of 40° to starboard. This angle was not increasing and it was clear to the pilot that the ship was now aground.

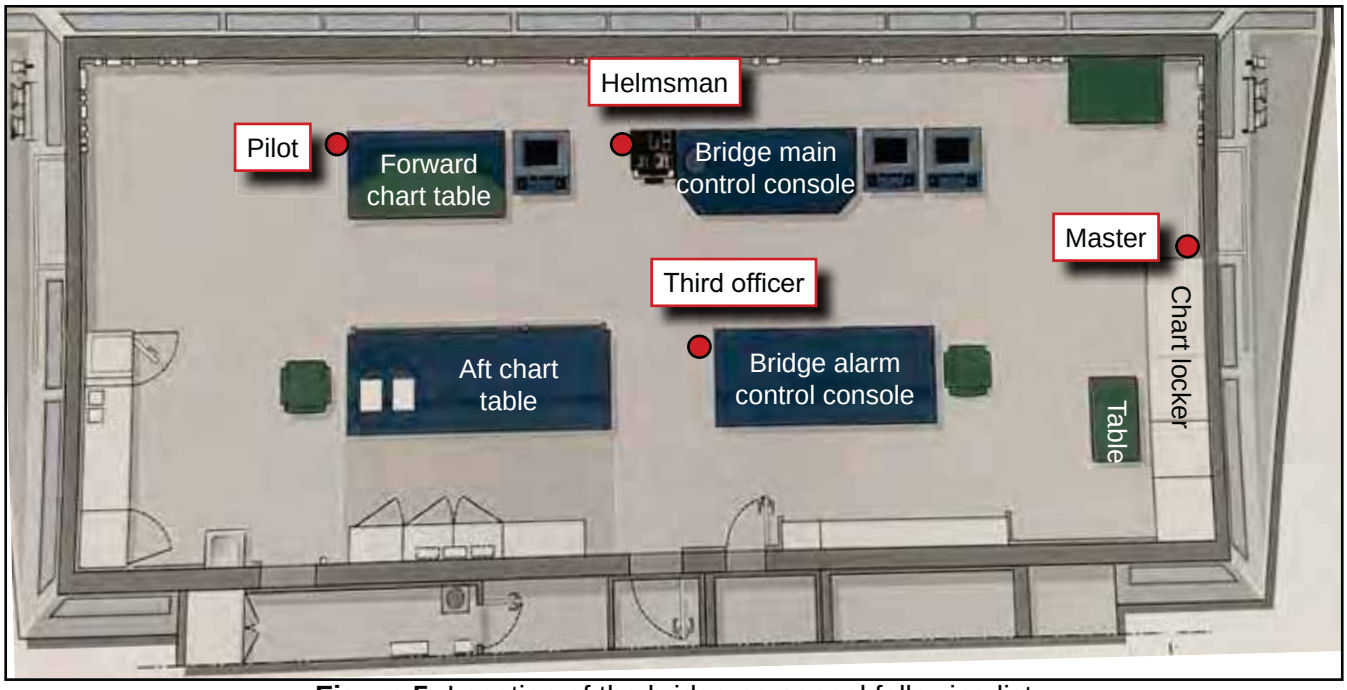
Figure 5: Location of the bridge personnel following list

Following the accident, it was not possible to stand or walk on the bridge. The pilot was initially on the port side, the high side of the bridge. He was able to brace himself against the port side of the forward chart table **(Figure 5)**. The master had slid along the bridge deck and found himself on the low side of the bridge, against the starboard bridge wing door. The third officer was able to wedge himself between the bridge consoles, and the helmsman was able to remain between the helm console and the pilot radar. The fire alarms sounded throughout the ship.

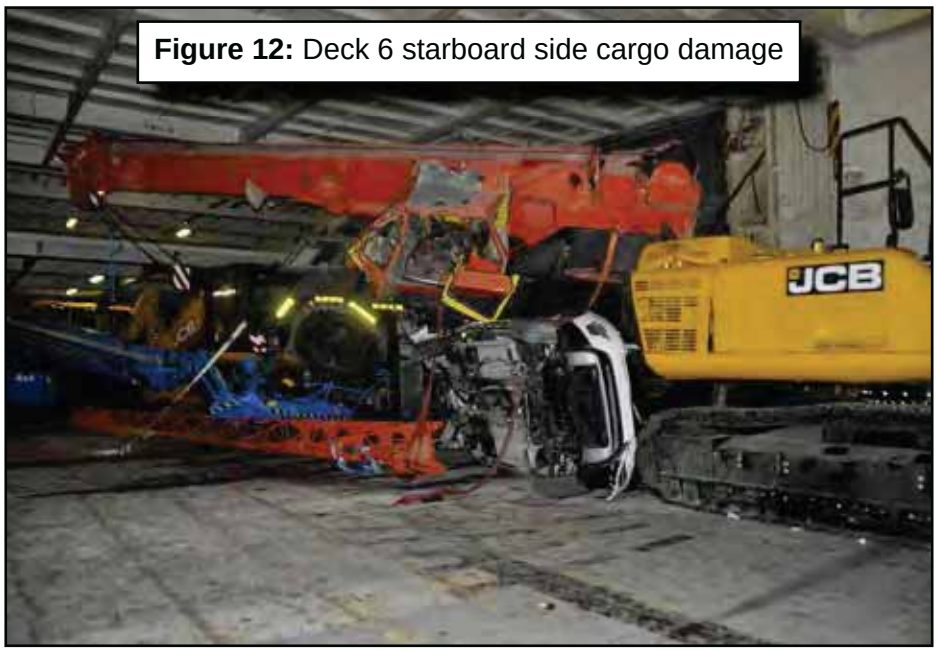
Figure 12: Deck 6 starboard side cargo damage

Although the vast majority of cargo remained in position, 27% of the cargo sustained damage **(Figures 12, 13** and **14)**, varying from repairable scratches and dents to severe damage resulting in total loss **(Table 1)**.

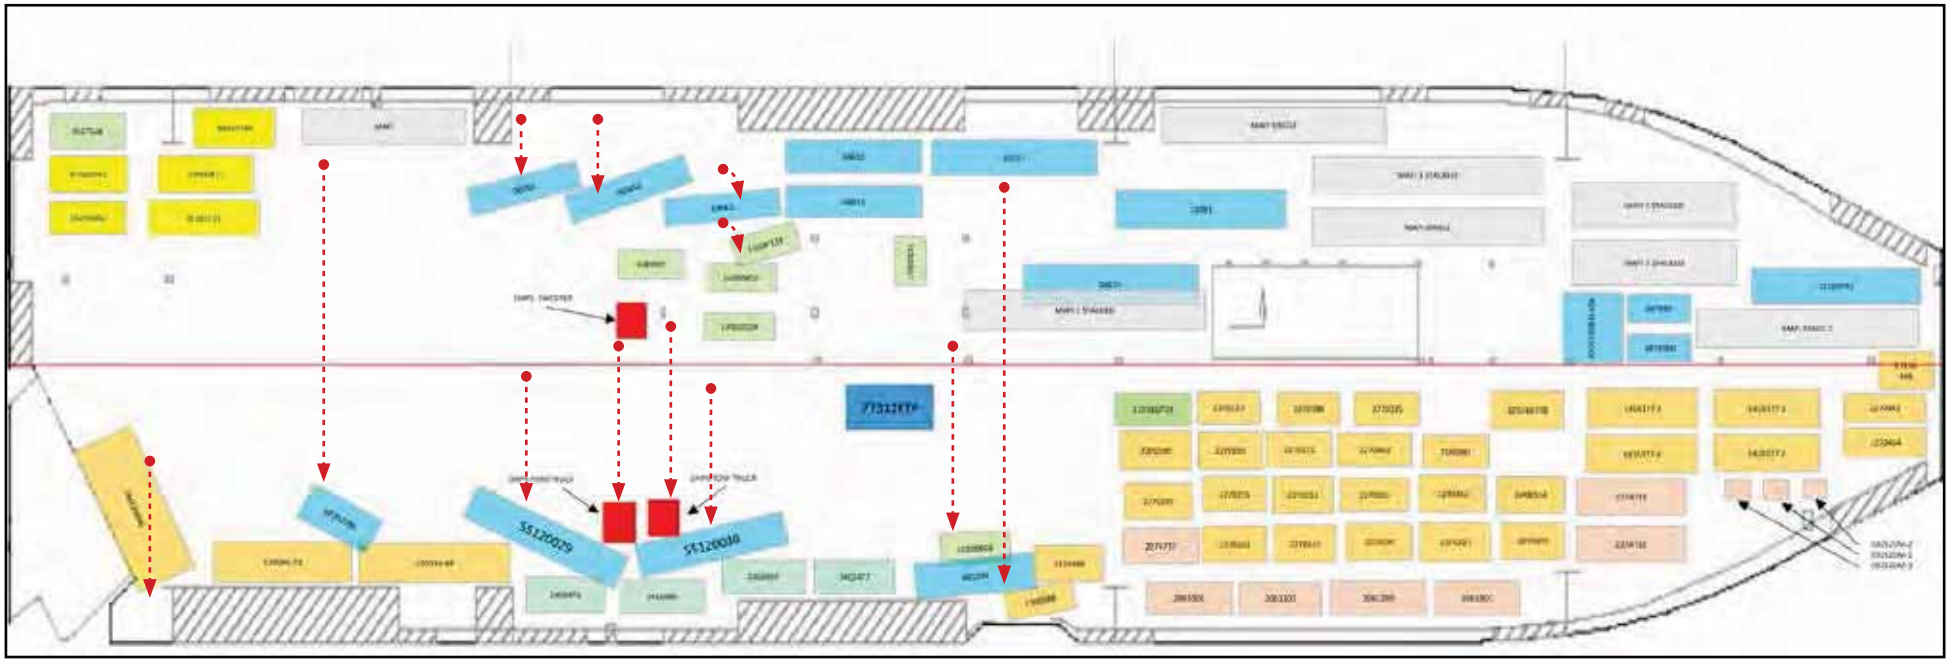
Figure 15: Deck 6 - original stowage and direction of shift of displaced cargo

An initial cargo shift occurred as *Hoegh Osaka* heeled; other cargo shifted later. Cars that were damaged were in localised pockets, in general caused by one vehicle breaking its lashings, resulting in a domino effect as the loose vehicle moved into adjacent vehicles. As the majority of the cars were tightly stowed, the build-up of momentum was relatively small, limiting the extent of the damage. However, not all of the high and heavy cargo was tightly stowed. As such, when their lashings released or broke, the size and momentum of the high and heavy cargo caused significant damage to adjacent vehicles **(Figures 15, 16** and **17)**.

Figure 16: Track-type bulldozer, original stowage position on port side and final resting position to starboard

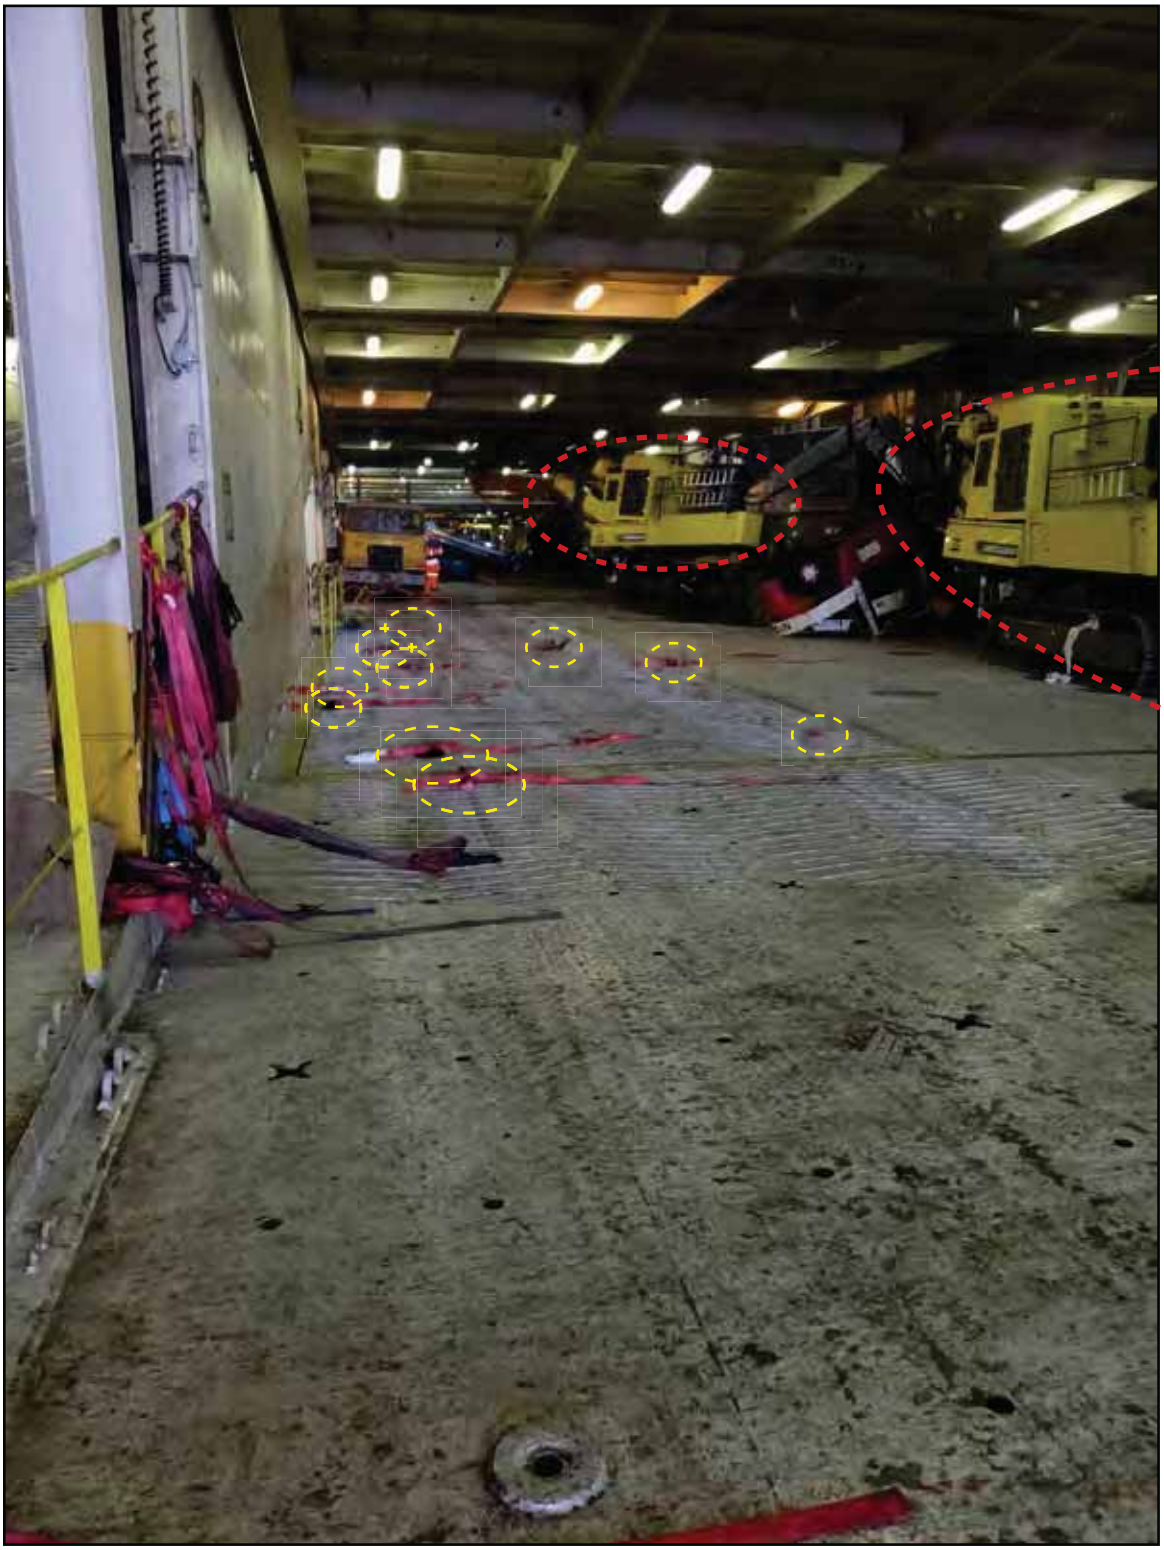
Figure 17: Original stowage position of two powercrushers, broken lashings visible on deck. Post-shift positions to starboard

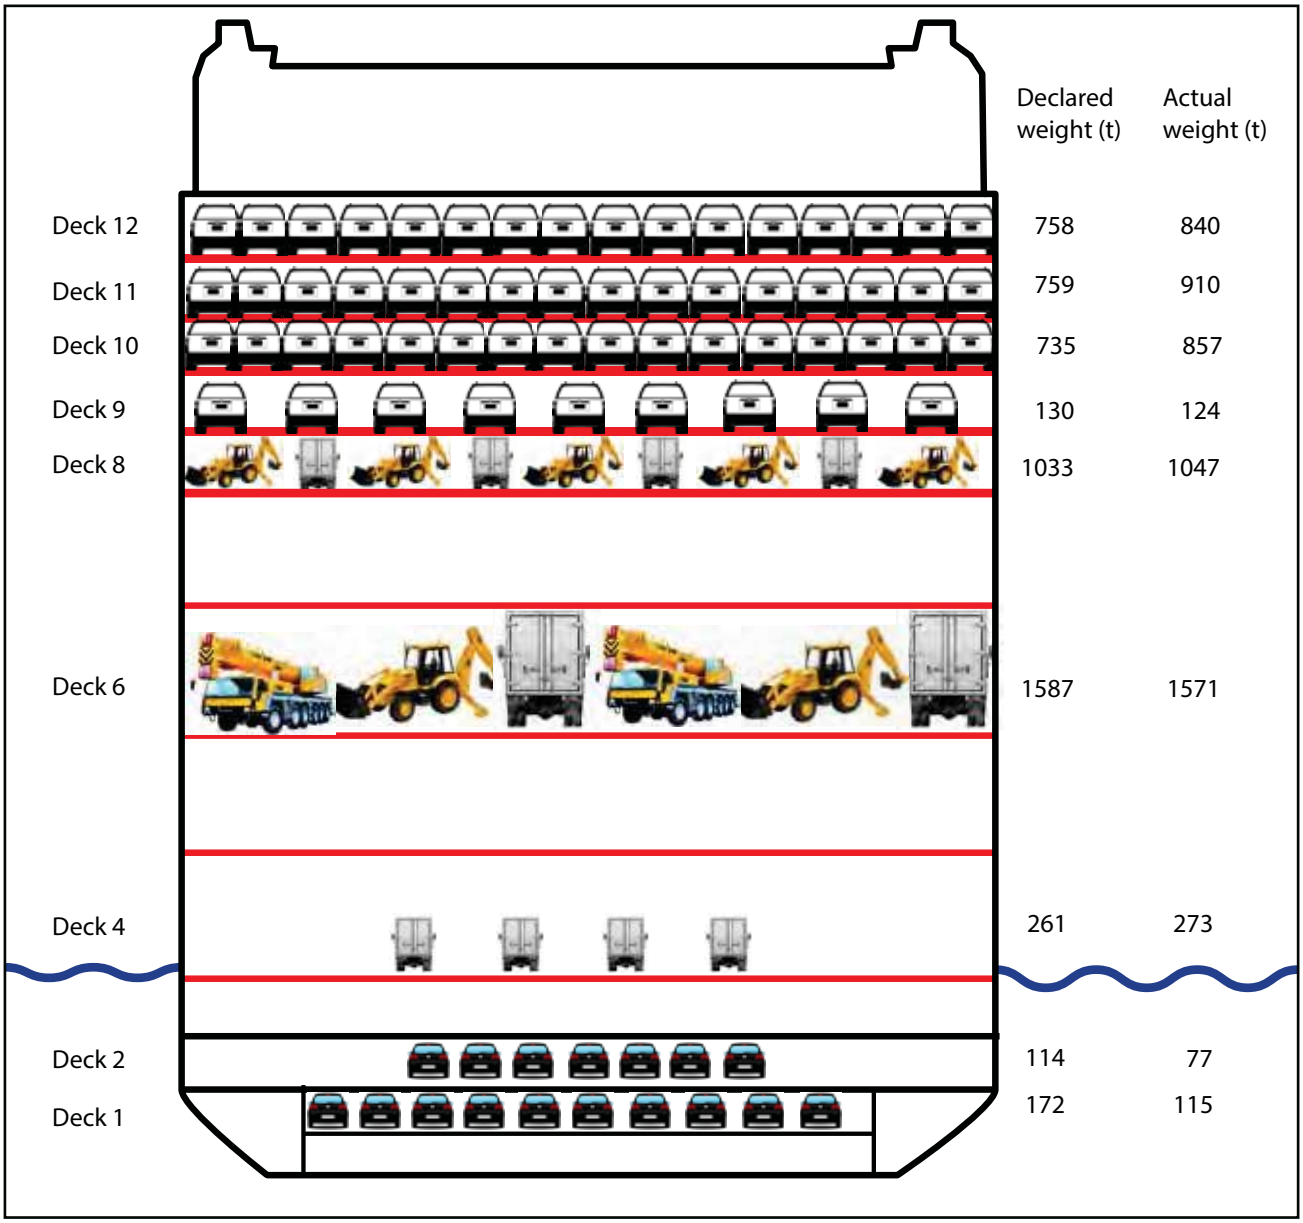
Figure 22: Indicative deck plan - including weights

Table 4 shows the cargo that was on board *Hoegh Osaka* at the time of the accident and its distribution by deck. Following analysis by the MAIB, Table 4 shows the weight that was provided to the ship in the final cargo tally and the actual weight of cargo that was on each individual deck **(Figure 22)**.

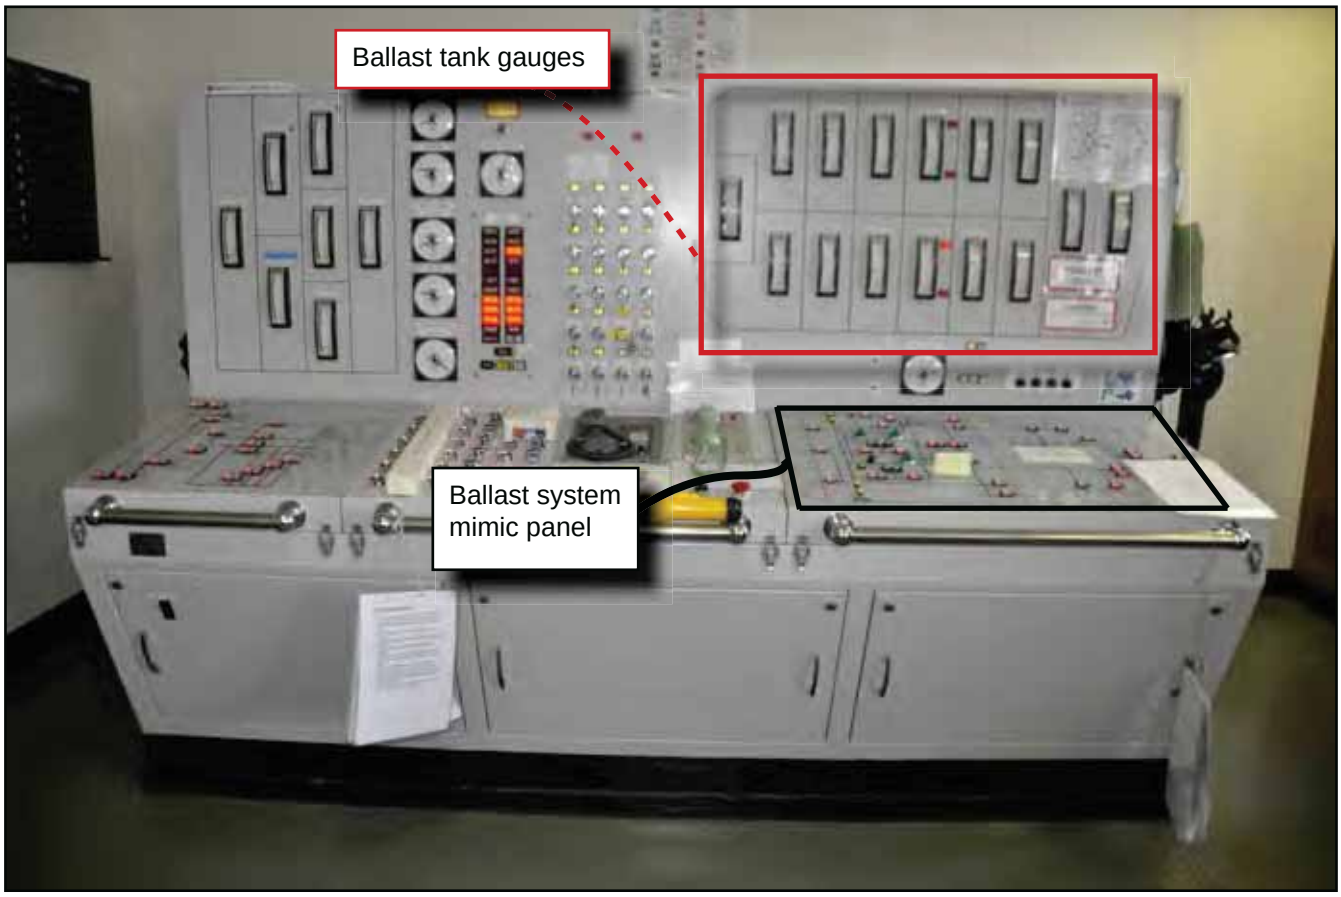
Figure 24: Ballast system control panel and tank gauges

The only gauge that was operating at the time of the accident was that of the fore peak tank. All of the other gauges had been inoperative since *Hoegh Osaka* was taken under Wallem's management in July 2014. The gauges were recorded as defective in the ship's handover survey and also noted as defective during Wallem's technical superintendent's visit to the ship in November 2014. Repair of the defective gauges had not been deemed a priority by Wallem as the ballast tank soundings could be taken manually.

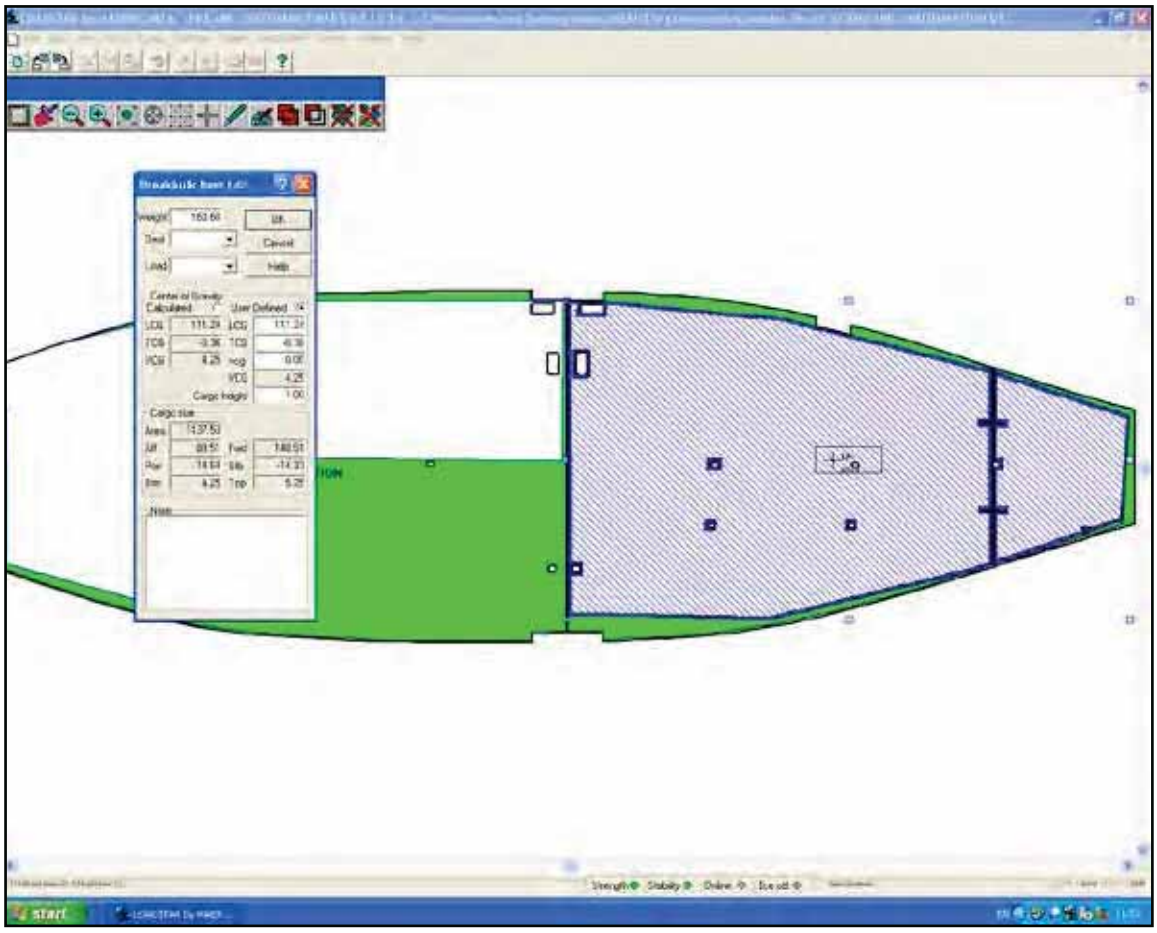
Figure 26: Screenshot from loading computer

The last condition saved on the Loadstar computer related to *Hoegh Osaka*'s arrival in Southampton on 2 January. Examination of a selection of the previous arrival and departure conditions established that the VCG of the cargo was always left to default to deck level.

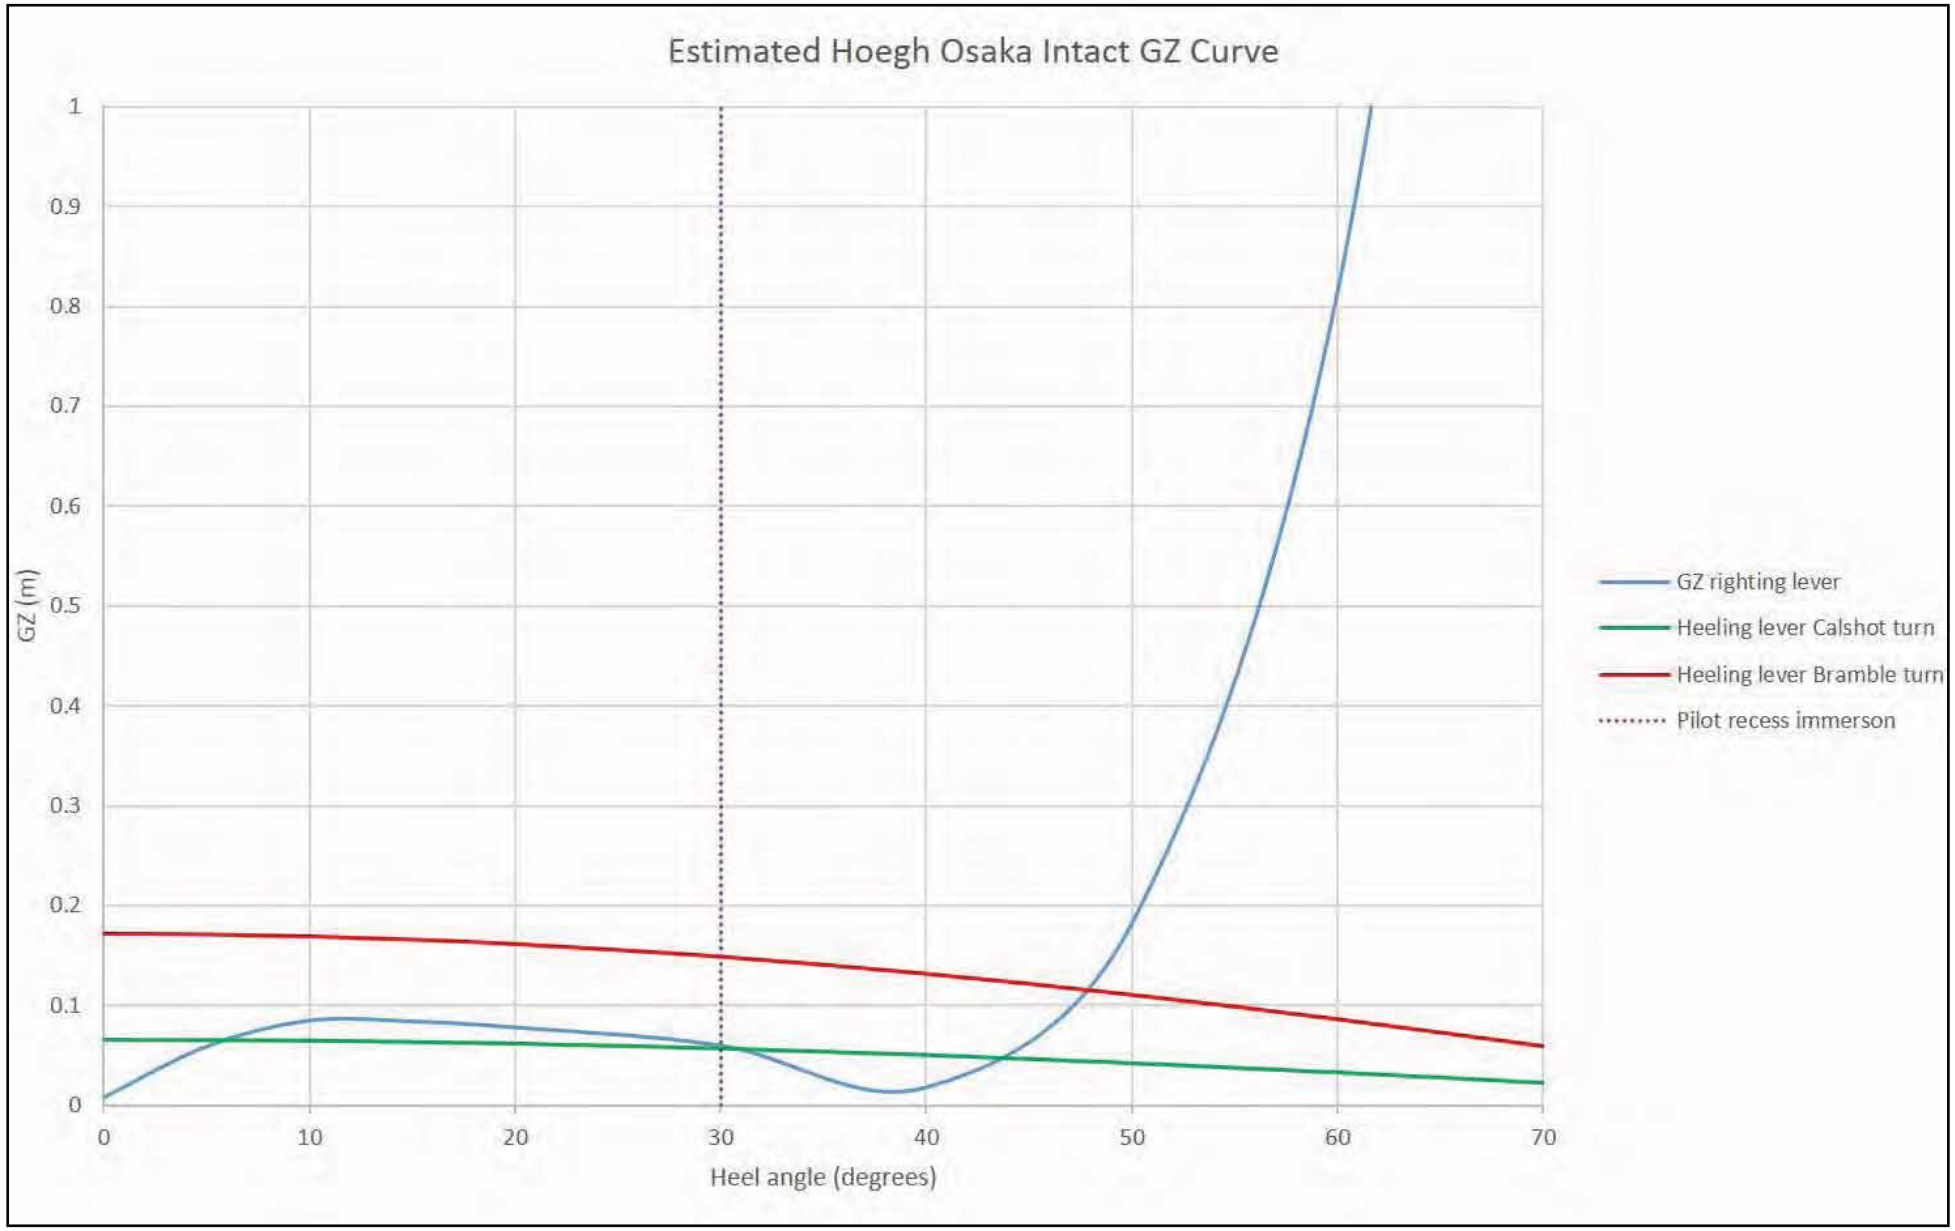
Figure 30: Estimated *Hoegh Osaka* intact GZ curve

While *Hoegh Osaka* left its berth with positive stability (GM>0), its estimated condition did not comply with IMO stability requirements. The estimated righting lever curve (GZ) is reproduced in **Figure 30**. The very low area under the GZ curve (blue line) is indicative of the righting moment that was available to resist the heeling moment of *Hoegh Osaka* when turning to port in the vicinity of Bramble Bank (red line). However, there was sufficient righting moment to resist the heeling moment at the Calshot turn (green line). The angle at which the shell plating damage in the vicinity of the starboard gangway void was submerged was estimated at 30°, although at what heel angle this damage occurred is unknown. However, at some stage beyond 30° heel, flood water would have entered the ship. As the ship heeled further to starboard, the available righting moment would have increased as the hull side became immersed.

Hoegh Osaka had inadequate residual stability to survive the Bramble Bank turn at 12kt, but had sufficient residual stability to survive the Calshot turn at 10kt. This was because the heeling moment when turning is proportional to the square of the speed (44% greater heeling moment).
