The Swedish Club

Dealing with engine room fires

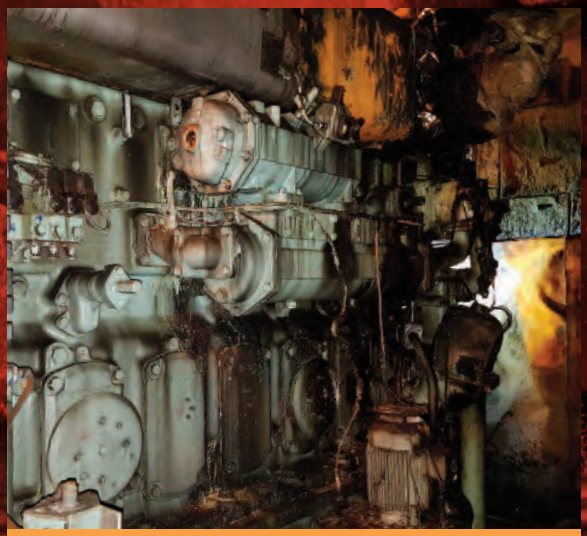
The fire was triggered by a diesel oil leak from the port side engine coming into contact with the hot metal of the engine. This leak was caused by a broken pipe from the return line of cylinder fuel pump no. 3 of the port side main engine.

Further investigation showed that the emergency quick closing valves were not properly shut when remotely activated by the Chief Engineer at the time of the casualty.

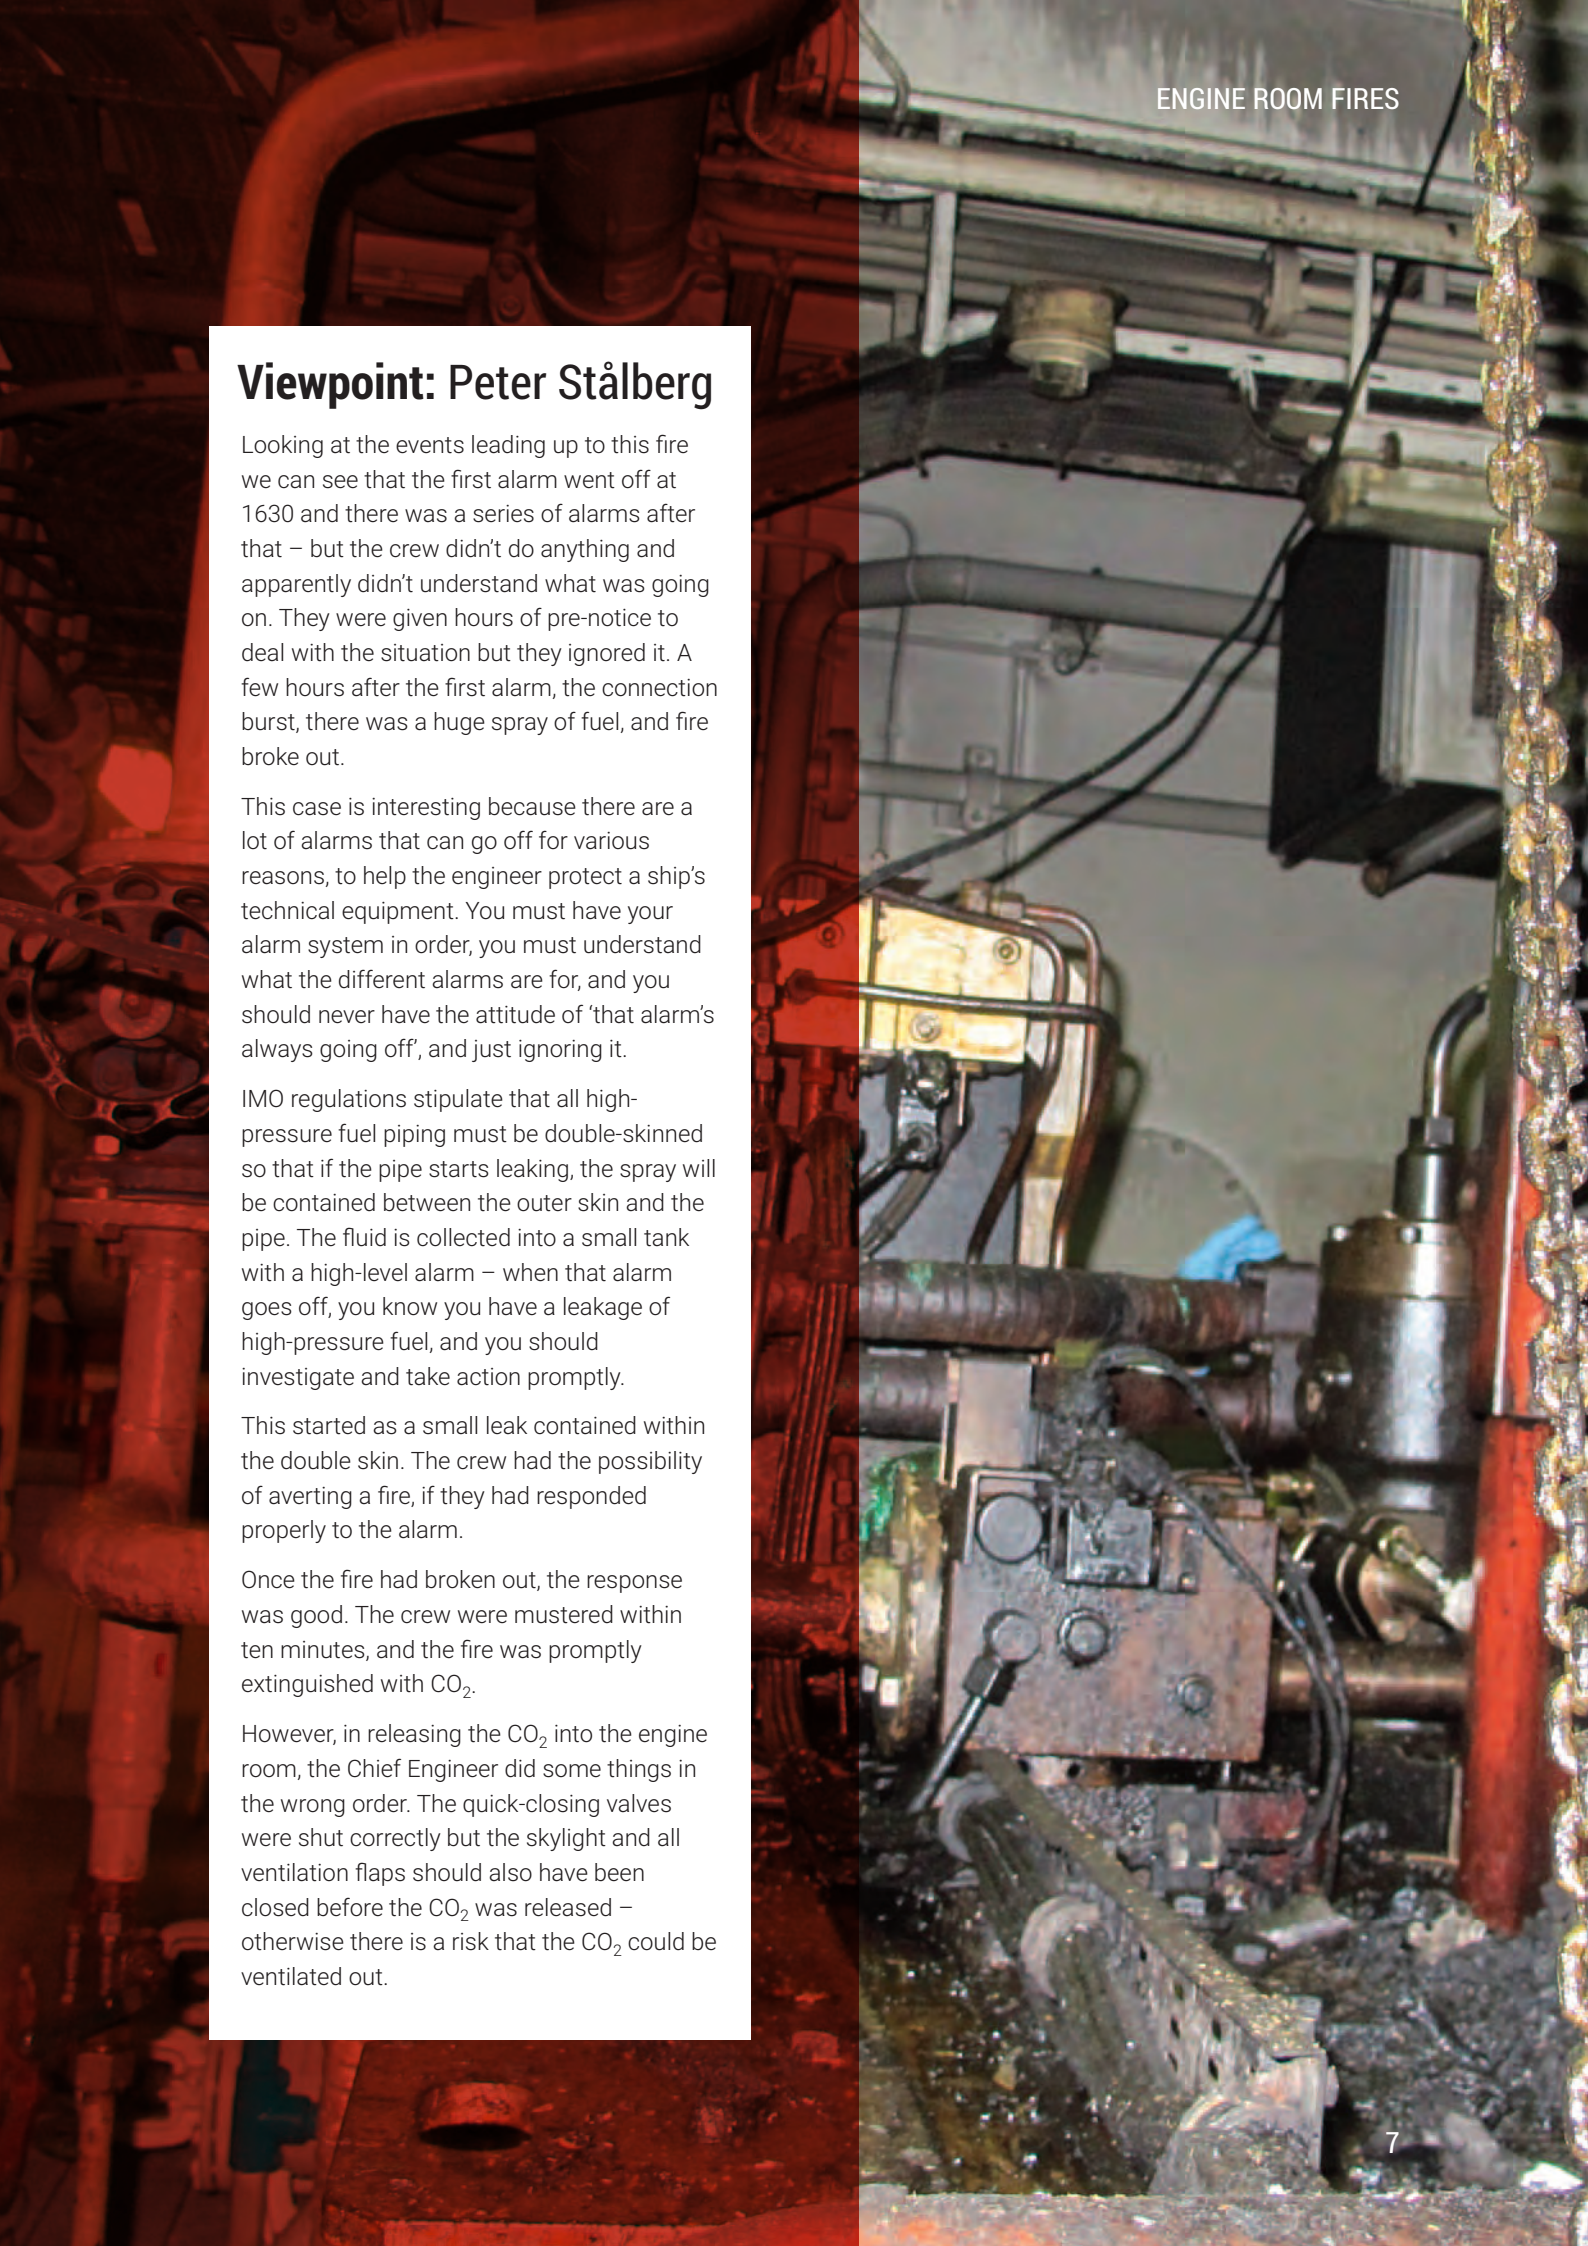
The survey concluded that the main cause of the fire in the engine was related to the failure of the aft fuel oil high pressure pipe of unit No. 4. The pipe had fractured and severed completely at the thrust bushing at the fuel pump side.

According to the information provided by the ship's staff it is unknown if the correct tightening pressure of 190 Nm was applied as recommended in the MAN service instruction manual.
