National Transportation Safety Board

Marine Accident Brief

Engine Room Fire Aboard Cruise Ship *Carnival Liberty*

Accident no.	DCA15FM035
Vessel name	<i>Carnival Liberty</i>
Accident type	Engine room fire
Location	West Indian Company Dock, Charlotte Amalie, St. Thomas, US Virgin Islands 18°20'N, 64°55.3'W
Date	September 7, 2015
Time	1133 Atlantic standard time (coordinated universal time – 4 hours)
Injuries	None
Property damage	\$1.725 million est.
Environmental damage	None
Weather	Daylight, clear skies, temperature 86°F (30°C), southeast winds at 10 knots
Waterway information	Port of Charlotte Amalie, St. Thomas

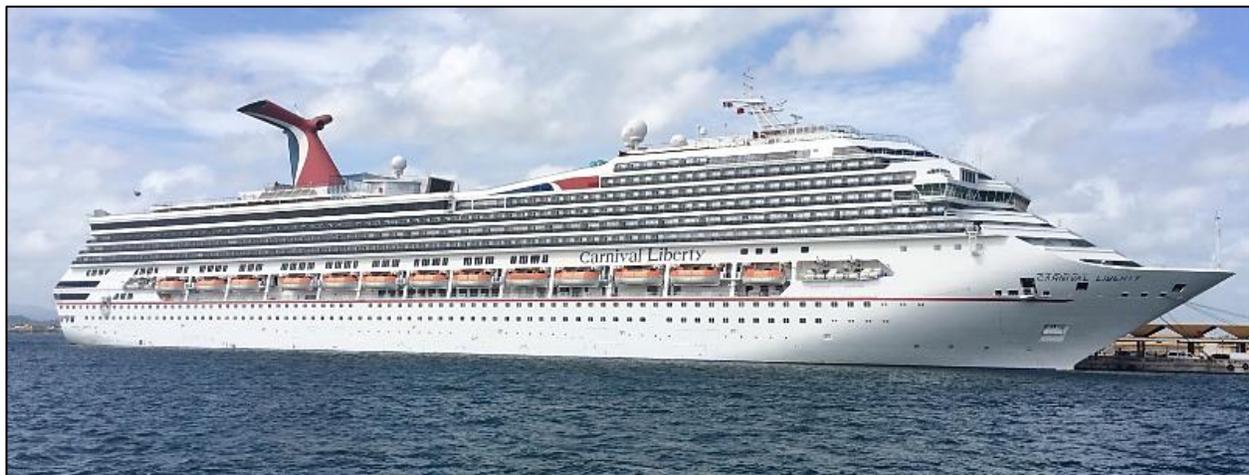
The *Carnival Liberty* in San Juan, Puerto Rico, about 1 week after the accident.

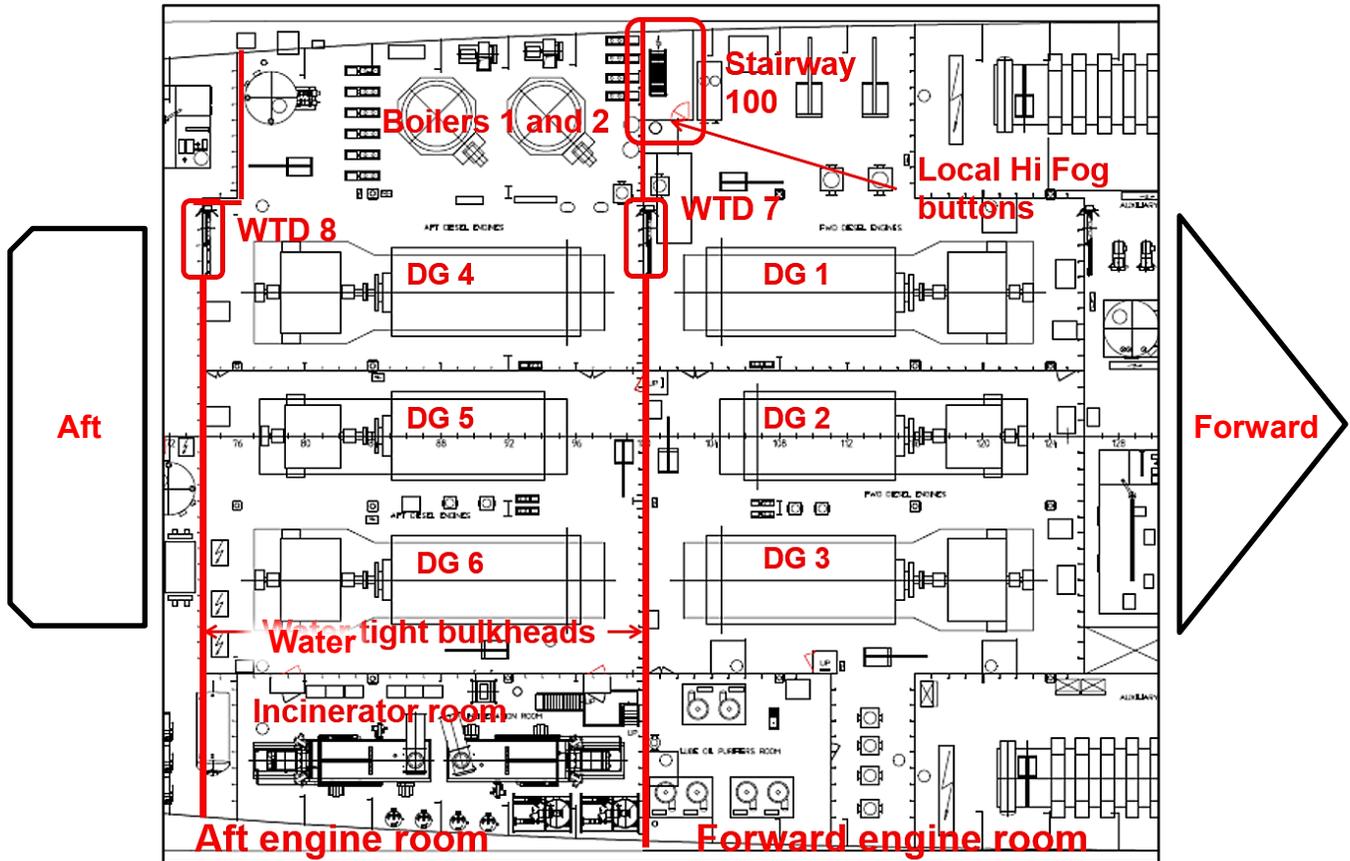
Forward and aft engine rooms on deck C aboard the *Carnival Liberty*, with DGs 1–3 arranged side by side from port to starboard in the forward compartment, and DGs 4–6 side by side in the aft compartment. (Image provided by Carnival Cruise Line)⁵

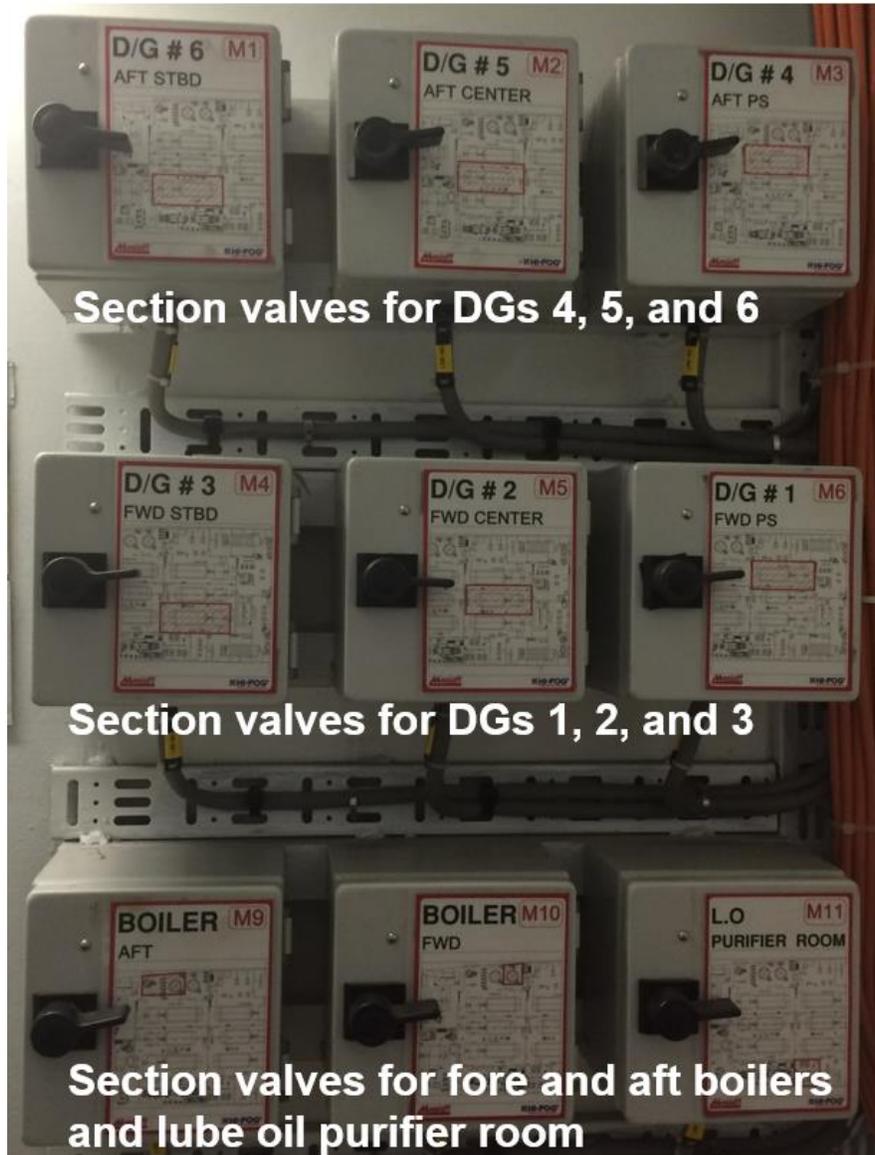
At the stairway, the fire patrolman met the third engineer and the motorman who had already started opening the manual-release boxes to activate the HI-FOG system locally. According to the third engineer, he activated all the buttons that were available at that location because he was not able to see the exact location of the fire in the aft engine room once the watertight door was closed. The ship's IAS recorded the first HI-FOG release at a section valve for DG 4 at 1134. Immediately thereafter, IAS documented the release of HI-FOG section valves also for the aft engine room port cable trays, the aft boiler, the forward boiler, DG 5, the aft engine room starboard cable tray, and DG 6. After a few more seconds, at 1135 according to IAS, the section valves released for DGs 1–3, the forward port and starboard cable trays, the forward engine room bilge, and the forward engine room (port and starboard).

Once the buttons were pushed, the third engineer exited the forward engine room by stairway 100 and returned to the ECR; the fire patrolman remained behind. He told investigators that he once again pushed the HI-FOG buttons for DGs 4–6 because he was unsure if they had activated (he could not see into the aft engine room behind the closed watertight door, but he saw the HI-FOG system operating in the forward engine room). He exited the area shortly after hearing the alpha code announcement and went to his emergency station, where he joined the quick-response team. Before leaving, the fire patrolman instructed the welding contractors to evacuate the area, which they did.

HI-FOG activation boxes inside stairway 100 on deck C in the forward engine room.
