Report on the investigation of the
grounding of the ultra-large container vessel

CMA CGM Vasco de Gama

Thorn Channel, Southampton, England

22 August 2016

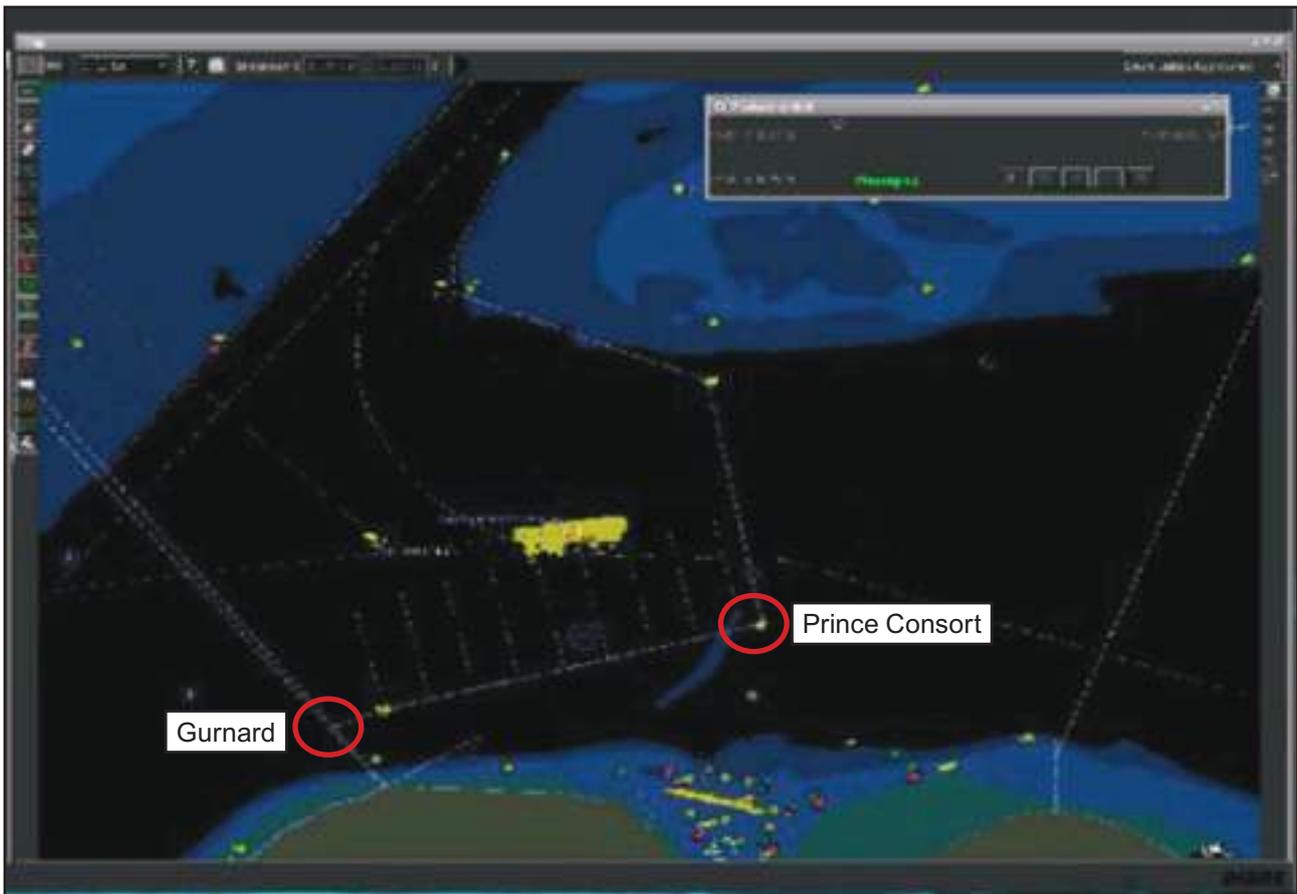
Figure 7: VTS officer's radar screenshot showing the countdown to the Gurnard buoy

At 0021, *CMA CGM Vasco de Gama* passed abeam of *Cap Hatteras* on a heading of 289° in a position 0.5nm to the east of the Prince Consort buoy. The lead pilot then gave the helmsman a series of courses to steer that, over the next 4 minutes, brought *CMA CGM Vasco de Gama* onto a heading of 260°. During the turn, the vessel passed 0.25nm north of the Prince Consort buoy (**Figure 6**) at a speed of 11.9kts. The VTS officer began his countdown on the VHF radio when the vessel was 6 cables away from the Gurnard buoy (**Figure 7**).

At 0026, on the VTS officer's count of 3 cables, the lead pilot gave a helm order of "starboard 10°". Twenty seconds later, as the VTS officer's countdown reached 2 cables, he ordered full helm to starboard (35°). Shortly afterwards, he increased the engine speed to full ahead.

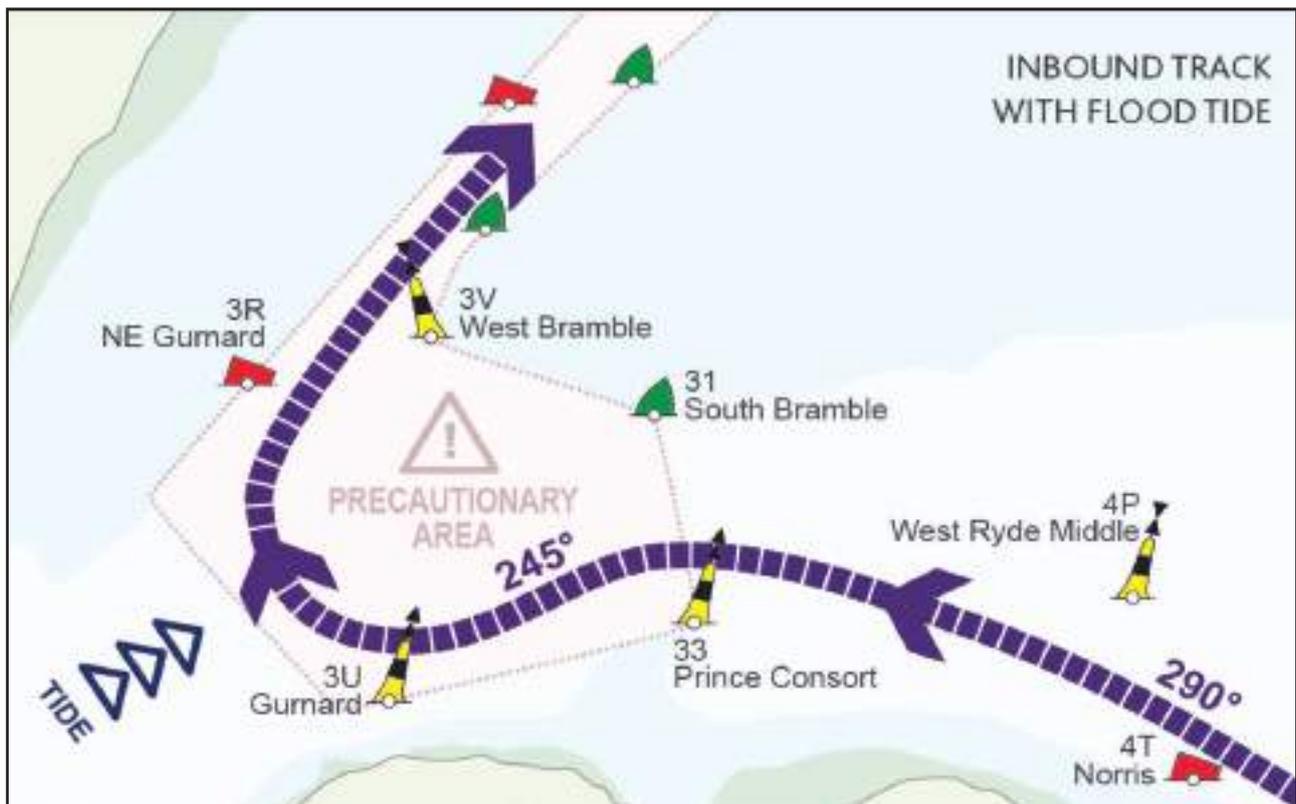
Figure 14: Execution of the Bramble Bank turn

The turn around Bramble Bank into the Thorn Channel was known to be difficult for large vessels, particularly when inbound. It involves two substantial course alterations: one to port abeam of the Prince Consort buoy of up to 40° and one to starboard, close to the Gurnard buoy, of about 140° (**Figure 14**). The prevailing winds in the Solent are typically south-westerly and there is a significant tidal stream direction and rate change at the southern end of the Thorn Channel Precautionary Area. For ultra-large container vessels, the turn was typically undertaken at a speed of between 10 and 12kts.

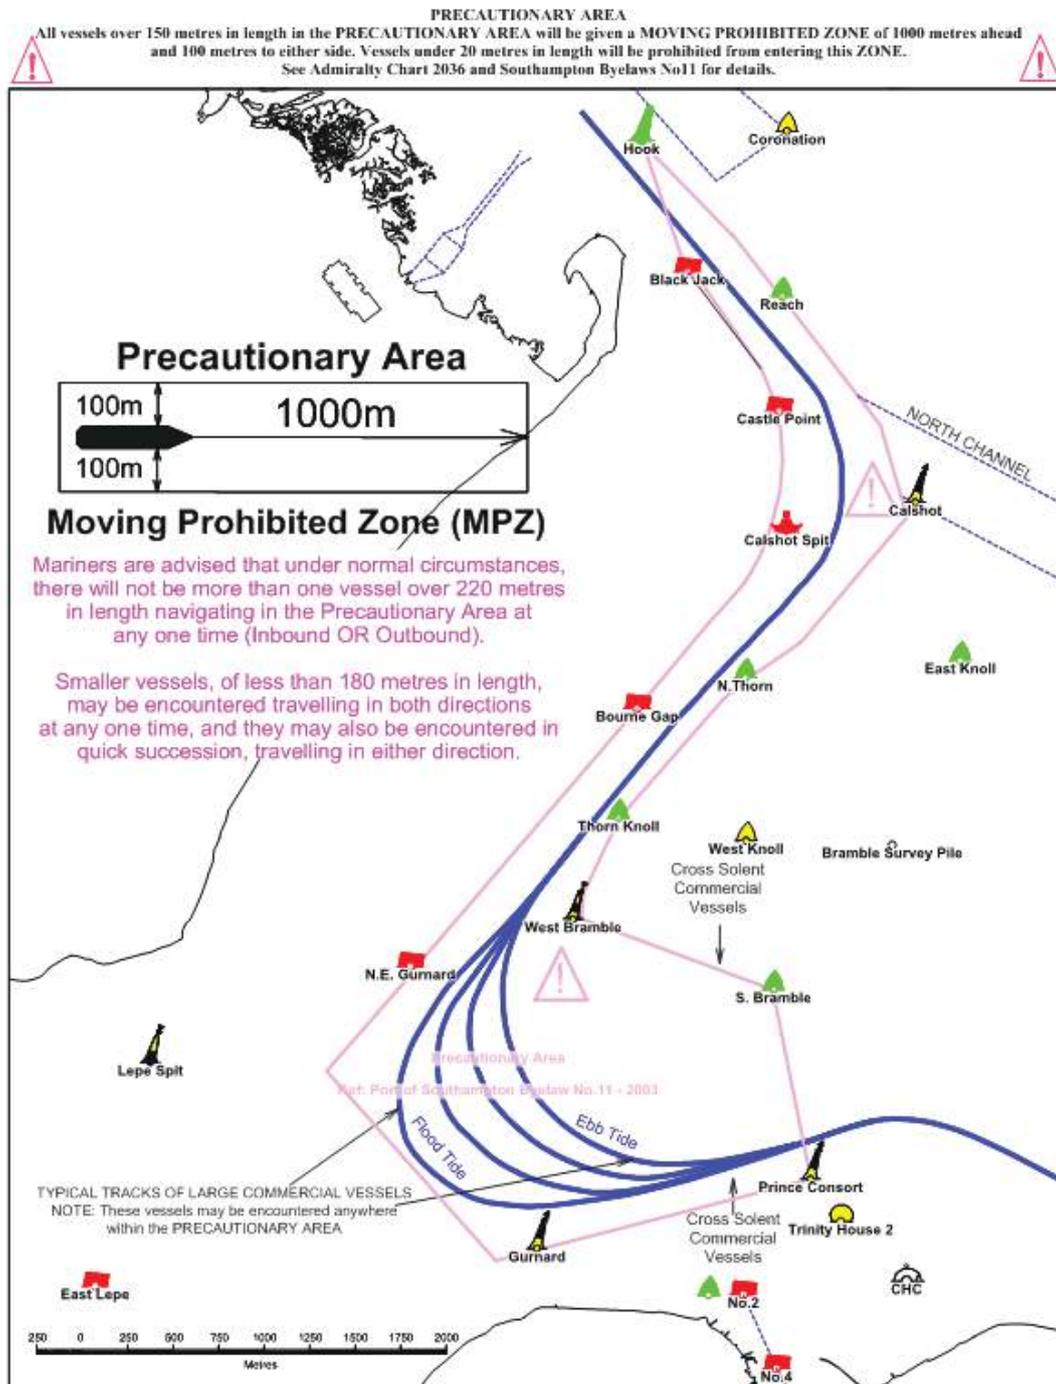
Figure 15: Typical tracks of large container vessels illustrated in ABP Southampton's Port Users Information and Navigational Guidelines

Guidance on the use of the Precautionary Area, particularly by larger vessels, was provided by the port in its Notice to Mariners No.03 of 2016: *Port of Southampton – Precautionary Area (Thorn Channel)*. The notice included specific guidance on the typical inbound tracks to take for varying tidal conditions (**Figure 15**). For a flooding tide the notice advised that:

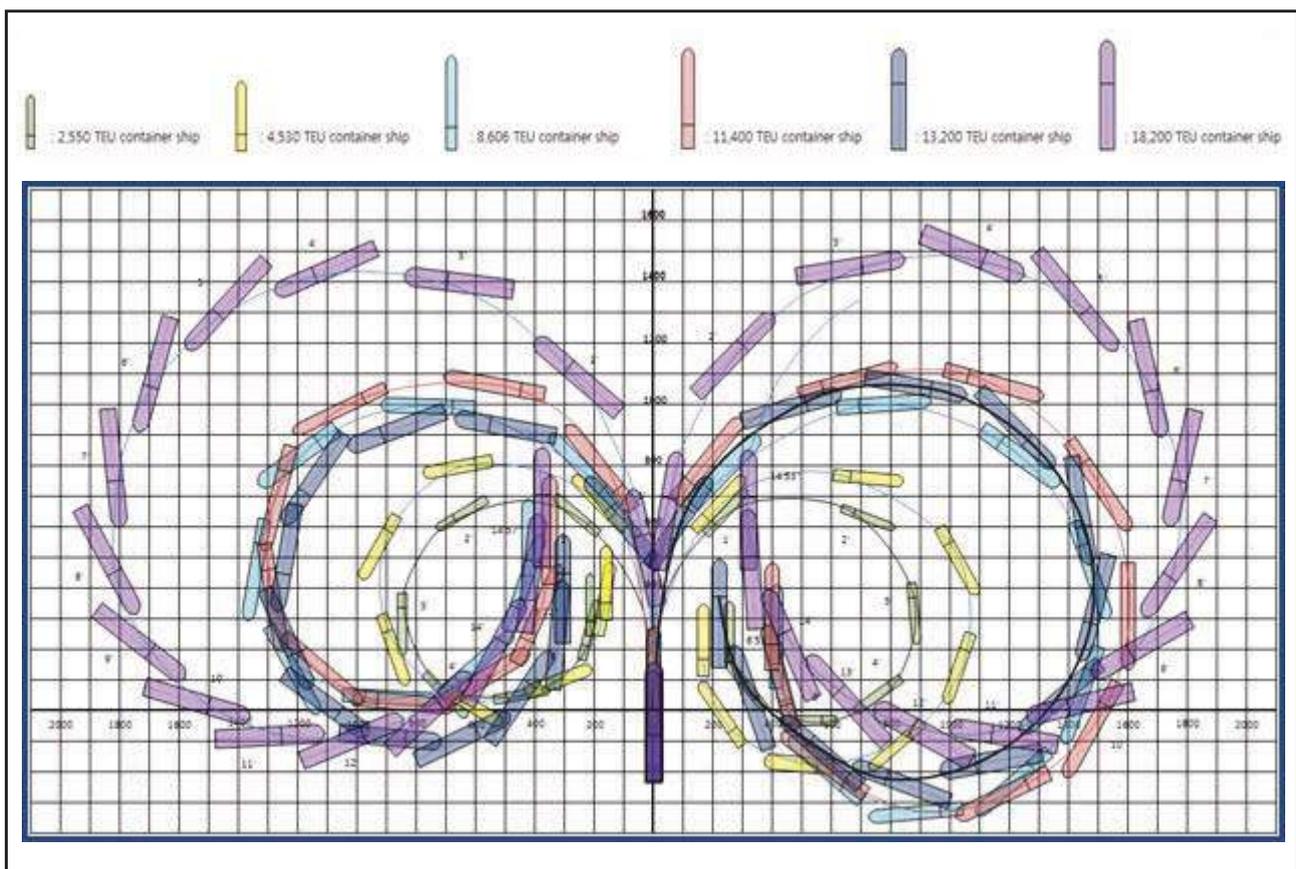
Figure 16: Illustration of typical turning circles of various sized container vessels

The ROT that a vessel can achieve is determined by its design characteristics (**Figure 16**), its speed, and angle of the rudder. ROT is affected by environmental conditions acting on the vessel such as strength and direction of wind and tidal stream. The amount of this effect is governed by the volume of the hull, superstructure and deck cargo above the water, and the volume of the vessel underwater. For example, a large deep draught tanker will be less affected by windage than a large fully loaded container vessel.

the under keel clearance (UKC), the greater the interaction effect with the seabed, which reduces the ROT and therefore increases the turning circle diameter.

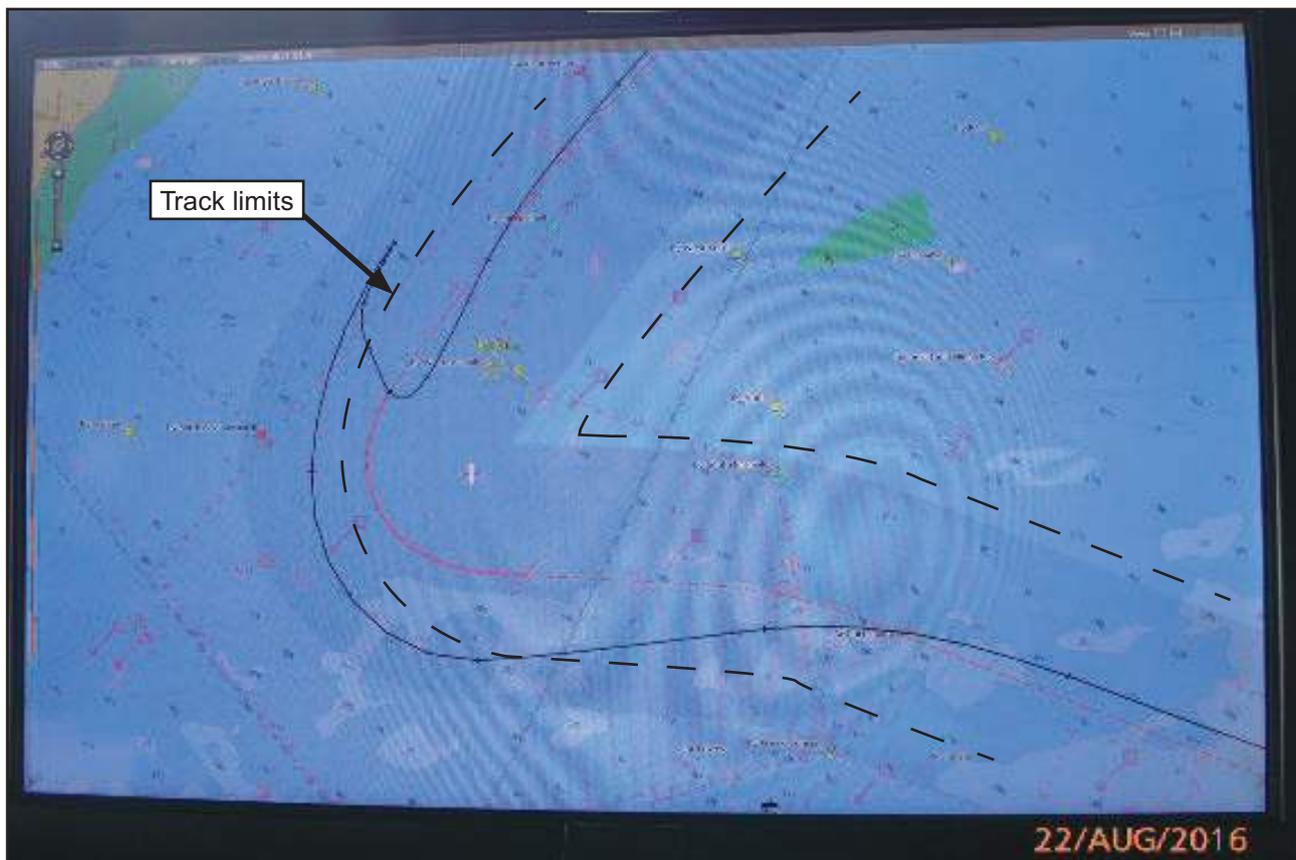
Figure 19: ECDIS track limit settings

A *preparation for arrival* checklist (**Annex J**) was completed by CMA CGM Vasco de Gama's 8 to 12 OOW and countersigned by the master prior to the vessel's arrival at Southampton. The checklist indicated that all mandatory alarms had been set in ECDIS, the parallel index had been set on the radar and the cross-track error had been set to 0.5nm. The track limits were not adjusted for each leg of the pilotage section of the passage. When the vessel grounded, it had not gone outside the set permissible track limits (**Figure 19**) and no ECDIS alarms sounded.
