Ministry of Infrastructure and Transport

DI.G.I.FE.MA.

3RD DIVISION - MARINE INVESTIGATIONS

Fires on board ro-ro pax ferries *Lessons learned*

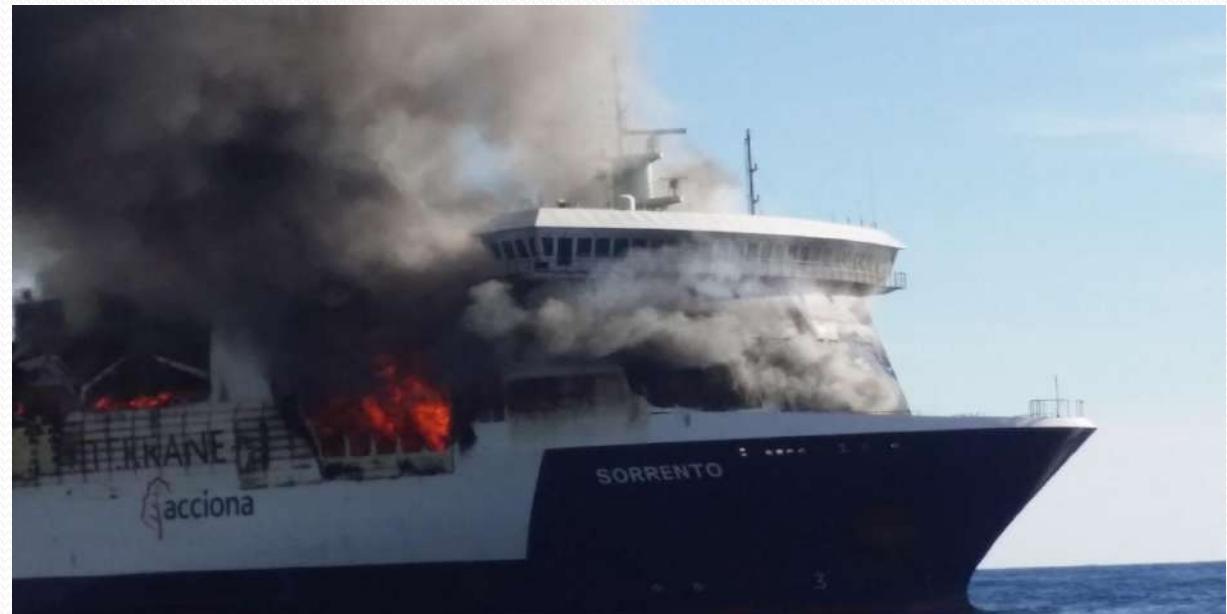
- On the 28/04/2015, **M/V Sorrento** was in navigation from Palma de Mallorca to Valencia.
- At 12.45 UTC the ship transmitted the distress signal, indicating Fire on Board.
- Fire developed at **deck 4 – Frame 168**.

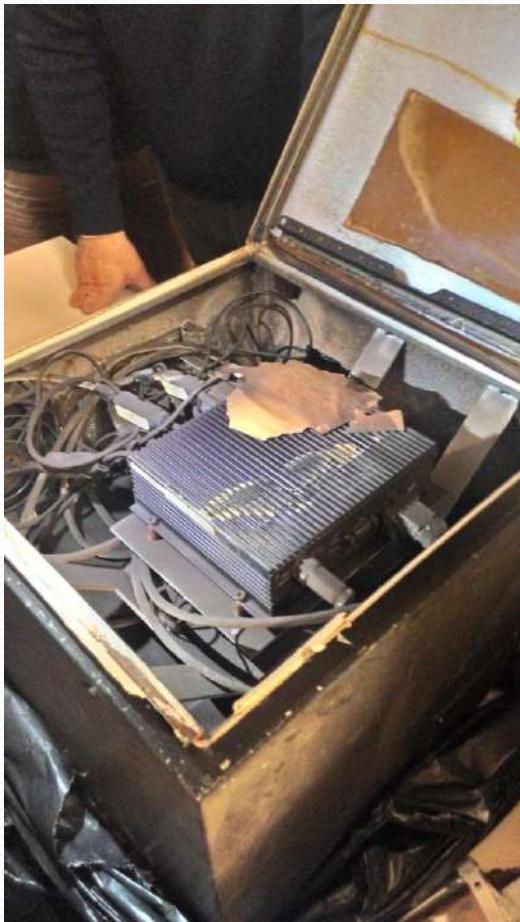
NA - Information retrieved from the VDR

- ✓ On 22 Jan 2015 an hearing has been carried out and an attempt for retrieving data from the NA's FRM (VDR capsule) was performed successfully. Nonetheless, the audio part of the recording didn't work. **During the last hearing, carried out on 25 sep, the audio was recovered**
- ✓ The device is actually seized by the Judicial Authority that is evaluating the possibility to send the HD (damaged by the fire) to the manufacturer for attempting data retrieval
- ✓ Also **AUTRONICA** was analysed but no significant information were retrieved

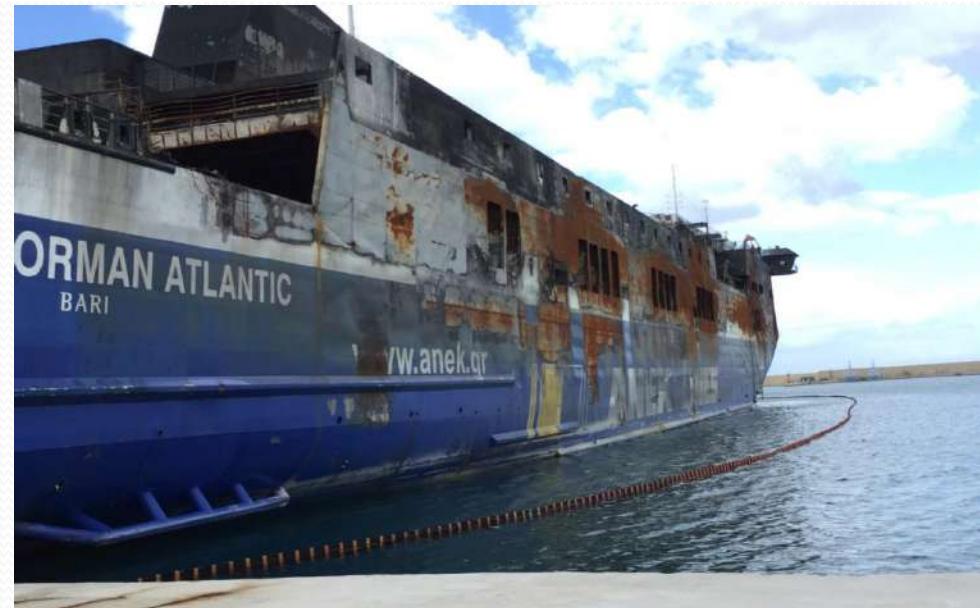
The preliminary analysis of the behavior and the performance of the fume plume to cross-wind, the environment in which it developed the fire (deck 4) is considered particularly important since it is similar to a garage with **large side windows and one side, the stern one, completely open** and with no means of closing.

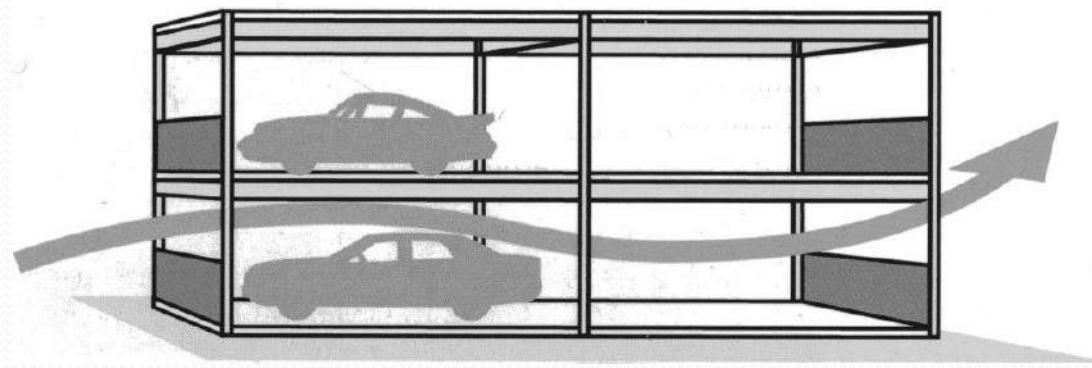
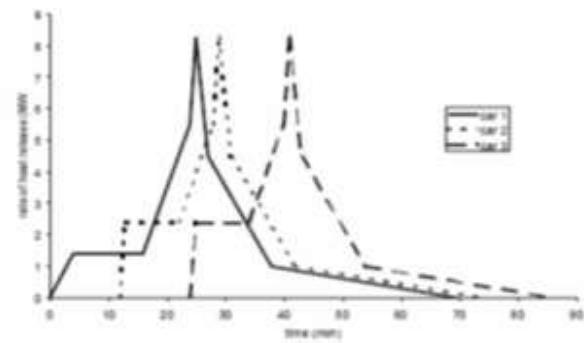
In windy conditions, the smoke-detectors placed right over the fire could therefore not be activated and fire could have spread quicker.

- ▶ Burning amount of time between two vehicles: 12 minutes

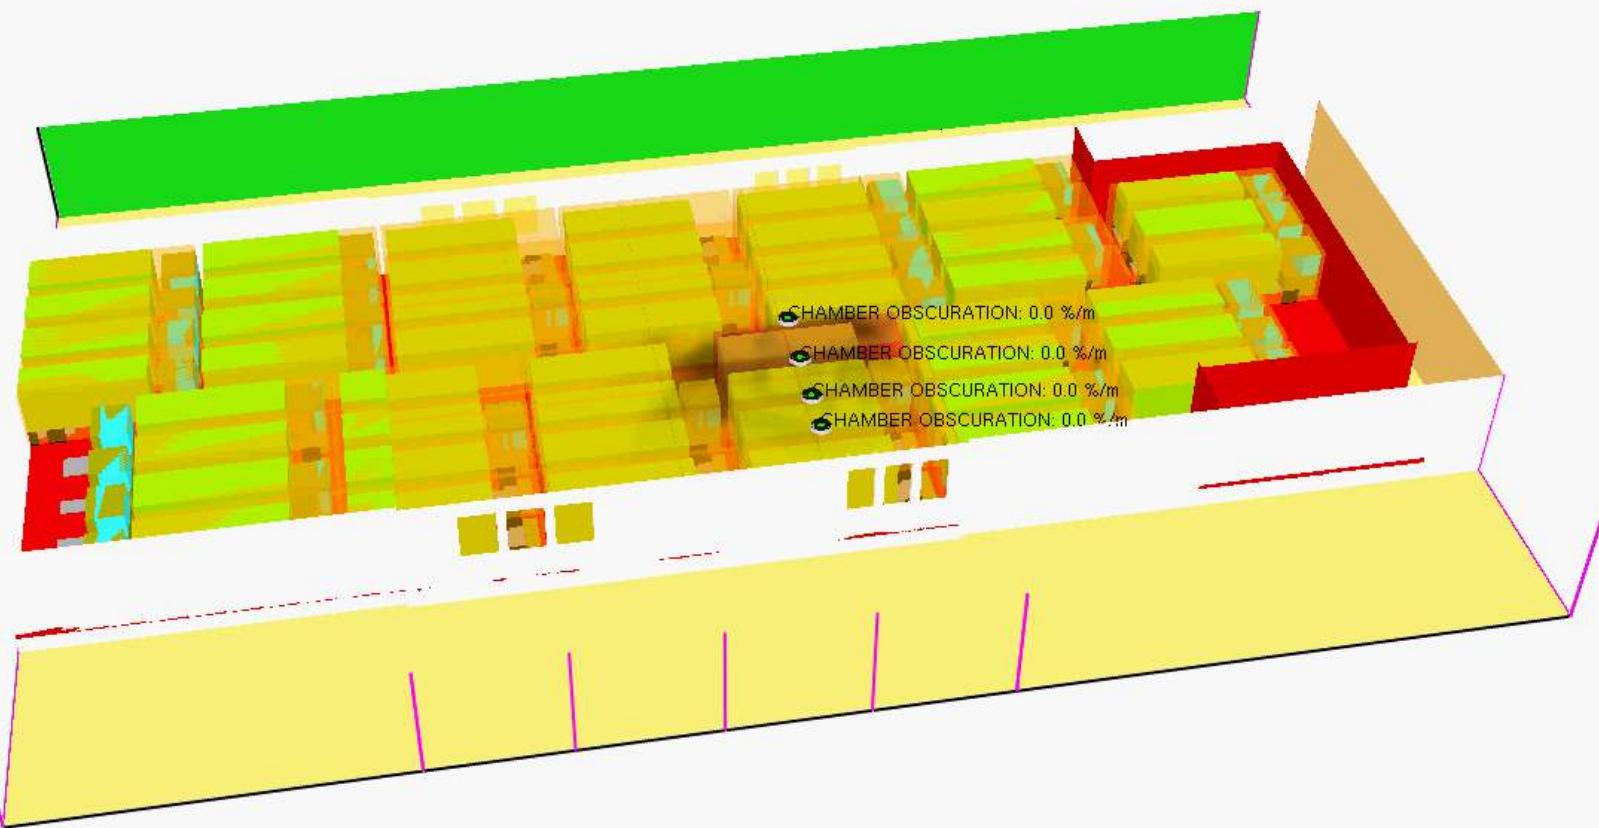
A simulation has been carried out taking into consideration the presence of a fire at Deck 4 Frame 156 originating by CHP system of a reefer, placed in the back side of the truck and the following values/weather conditions:

The detrimental effects of the wind are highlighted by the deformations that can be found on the ship.

Evidence of major deformations of the structure due to the heat caused to the high fire load and effect of the wind direction

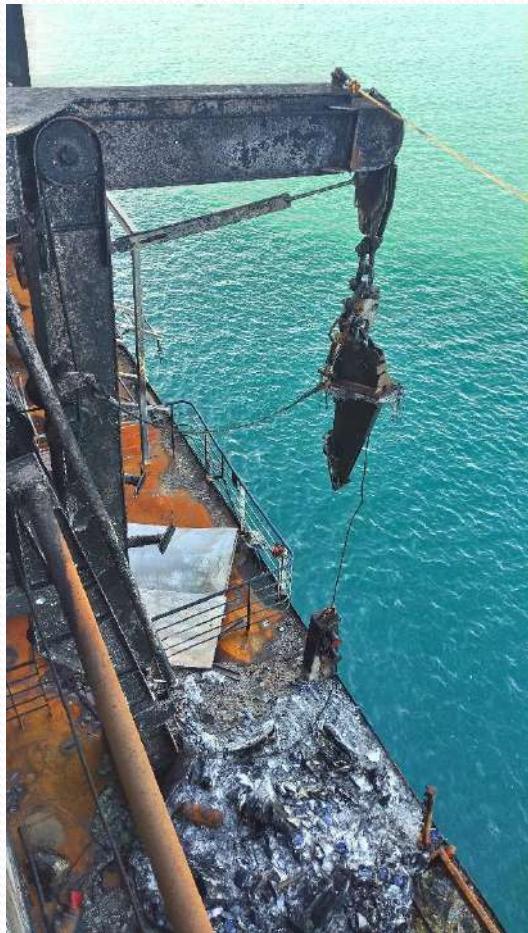
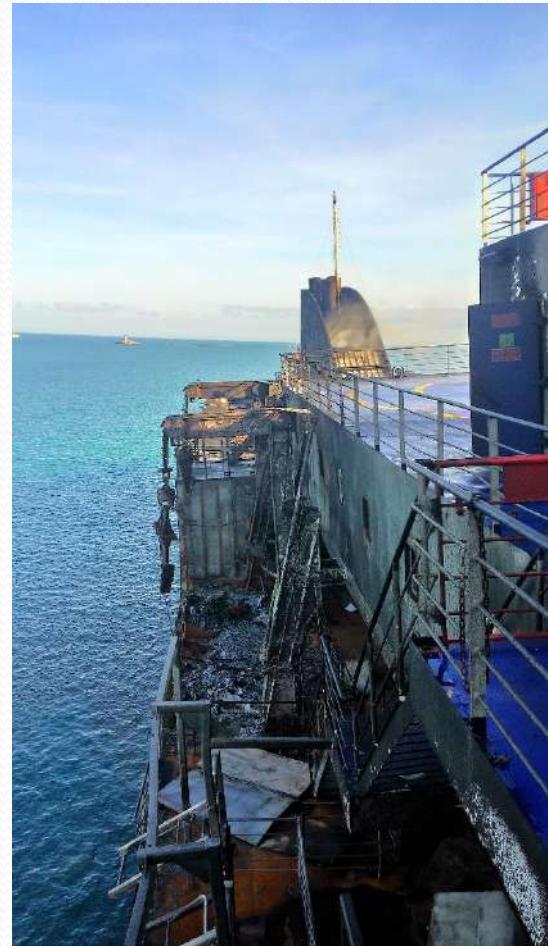
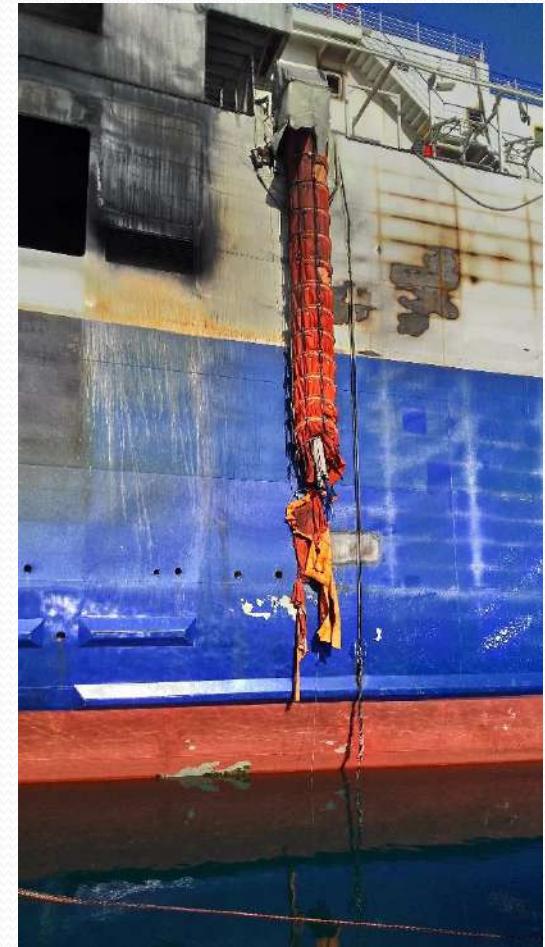
LSA status

- Captain of Norman Atlantic reported that the rafts were launched into the sea directly by passengers without a specific order;
- The chute was unusable because obstructed by two people who had remained trapped inside and damaged due to adverse weather conditions and flames.
- The many attempts to tow had a negative result. The tugs could only place the bow of the unit toward the direction of the wind in an attempt to limit roll movements and control the direction of the smoke;
- SAR naval units suffered damages in an attempt to get closer to the hot hull.

- The mini-chute on the port side was unusable because of the missing liferaft. By the evidences collected so far, it appears that the first two people entering the chute, when arrived in the liferaft connected to the device and cut the rope in order to escape.
- The starboard lifeboat was - at a certain point in time - unserviceable due to the damages caused by the high flames spreading through the side openings and the high temperatures in the garage, despite of the A.60 class fire insulation fitted at the garage's outer boundaries.
