MARINE SAFETY INVESTIGATION REPORT

**Safety investigation into a crew member fatality
inside the cargo hold on board the
Maltese registered general cargo**

KATI

MARINE SAFETY INVESTIGATION REPORT NO. 11/2019

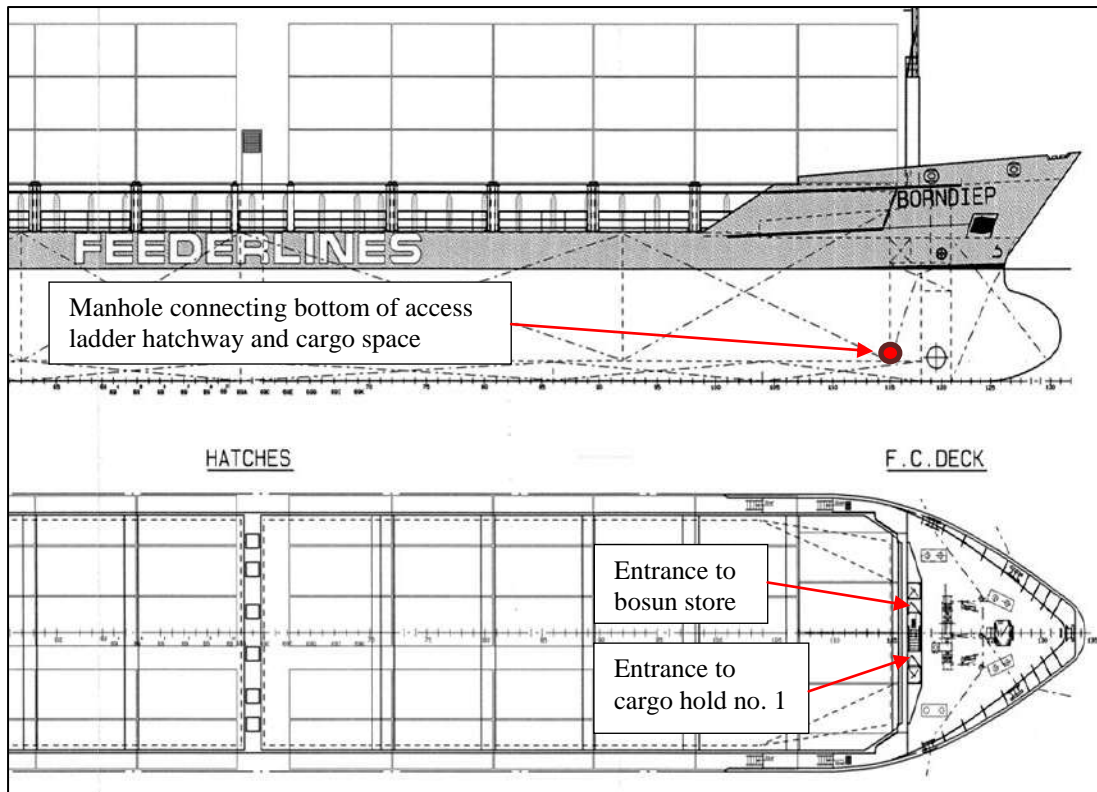
Figure 2: Access points iwo the wave breaker

The access door to the hatchway, leading down to cargo hold no. 1, was located further to starboard and within the wave breaker's structure. Vertical ladders led to the tank top (Figure 2), approximately nine metres below.

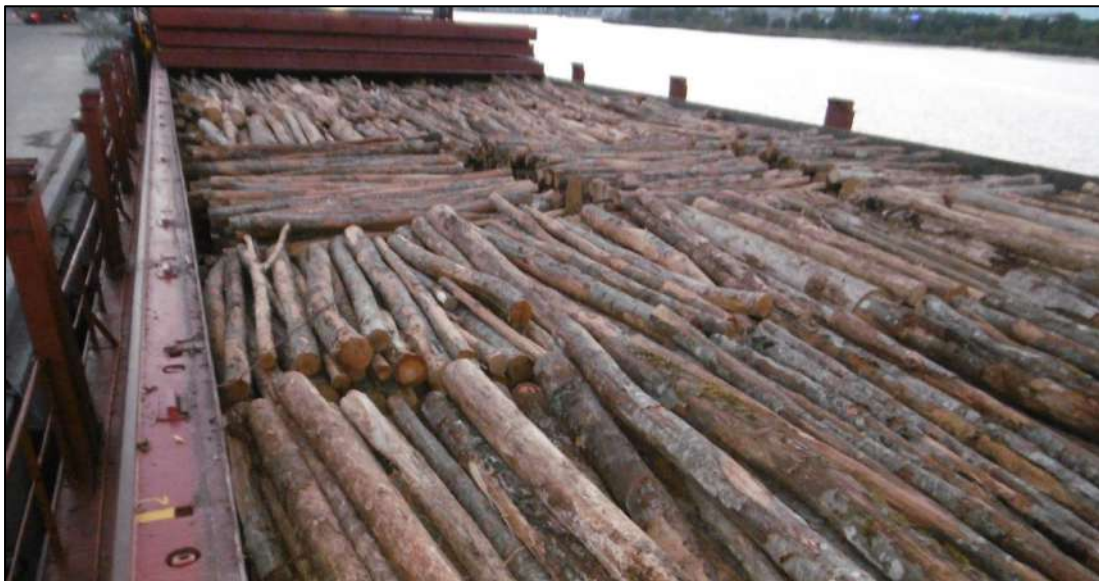
Figure 7: Fuel logs loaded on board in Pärnu

Kati had 2,767 mt of fuel logs in bulk (Figure 7).

The master, who had sailed once before with this type of cargo on *Kati*, was provided with a cargo manifest, a bill of lading, and a document with cargo information for solid bulk cargoes, which specified additional information on the properties of the cargo. This included procedures to handle the cargo and in particular, it referred to

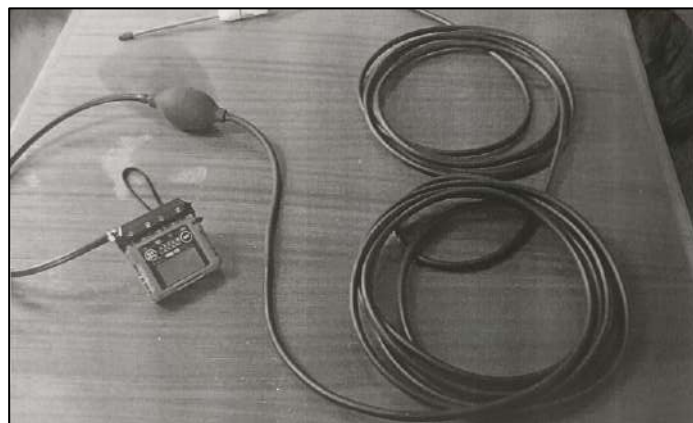
Figure 10: The multi-gas detector available on board

A Formal Risk Assessment (RA) concerning cargo handling had been carried out as part of the safety management system (SMS) procedures implemented on board. The RA record revealed that the risk of low oxygen during cargo handling had been identified and that it had to be mitigated through measurements of the atmosphere in the cargo space (Figure 9). To carry out the atmosphere measurements as laid out in

the risk assessment, the multi-gas detector carried on board had to be used (Figure 10).
